## AVIATION SHORT INVESTIGATION BULLETIN

**REPORT # AO-17-002160**

**INVESTIGATION TITLE: N340DP INCIDENT**

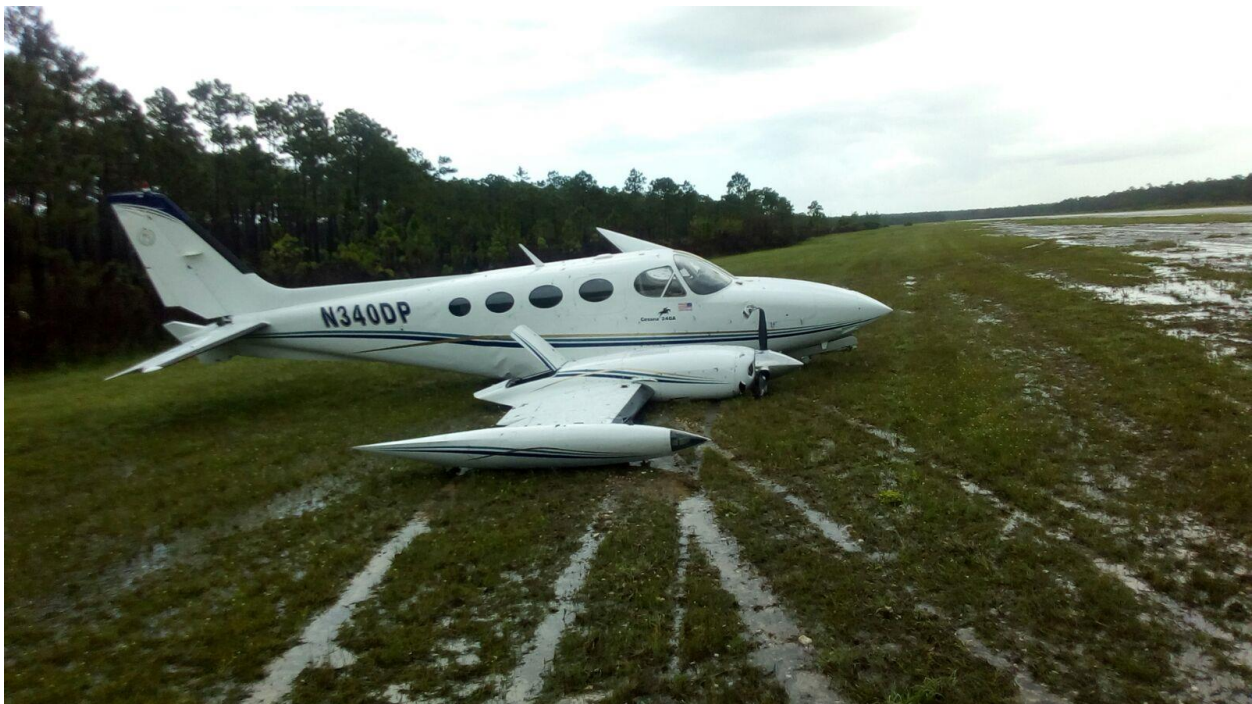
After slamming into the runway, there was a collapse of the landing gear which subsequently led to the aircraft spinning out of control and then veering to the left of runway 14. The aircraft exited the runway at approximately 3,000 ft. and then travelled another 714 ft. to the left of the runway before coming to rest.

The aircraft received substantial damages to its undercarriage, propellers, etc but the two souls on board only suffered minor injuries.
