AVIATION OCCURRENCE BULLETIN

DATE: 8TH OCTOBER, 2019
REPORT # AO-19-000055
AIRCRAFT REGISTRATION: N38677
INVESTIGATION STATUS: COMPLETED

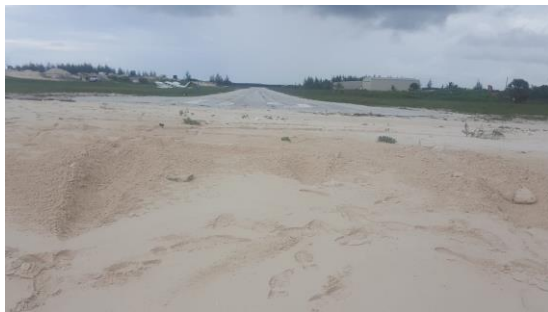
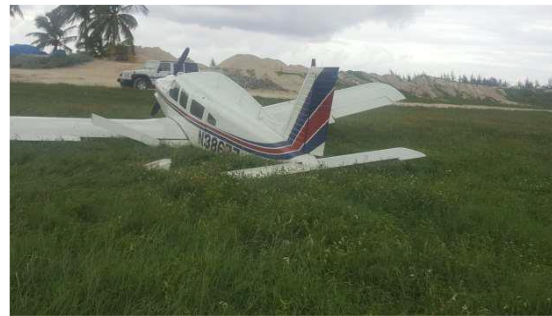
Aircraft details	
Aircraft Type and Registration:	Piper PA-32-300, N38677
Year of Manufacture & Serial #:	1977, 32-7840024
Number and Type of Engine(s)	(1), LYCOMING IO-540 SER
Type of operation:	Private
Information Source:	AAID Field Investigation
Nature of Damage:	Damage to left wing and flap, undercarriage, left main gear detached

Upon approach to landing on runway 09 at MYCP, the pilot reported that he encountered adverse winds. As a result of these strong winds the aircraft made contact with a sand bank located at the beginning of the runway eventually hitting the runway in a hard landing which resulted in the left main gear collapsing and subsequent runway excursion.
