AAIPU# A10-01312

# AIR ACCIDENT INVESTIGATION AND PREVENTION UNIT CIVIL AVIATION DEPARTMENT

## AIRCRAFT ACCIDENT REPORT

LOSS OF CONTROL & UNCONTROL FLIGHT INTO TERRAIN  
ACKLINS BLUE AIR CHARTER  
CESSNA 402C

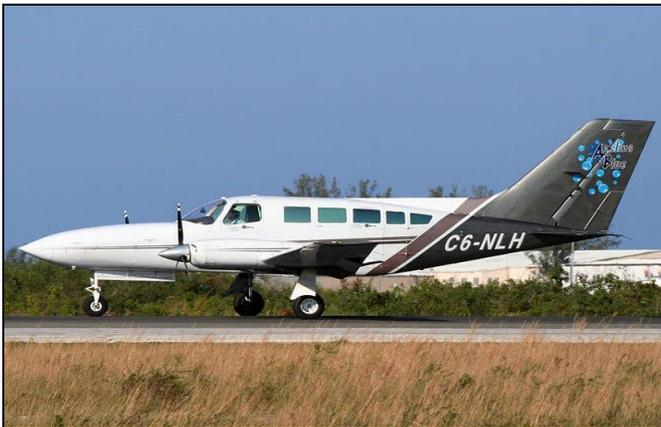
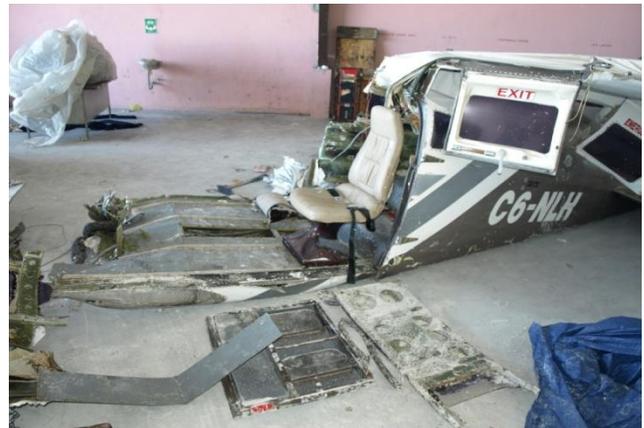
Figure 1 and 1 C6-NLH Pre and Post Accident

The aircraft sustained substantial damage due to the impact sequence and subsequent water submersion. It was later recovered from the crash site and transported to a secure facility for the field investigation.

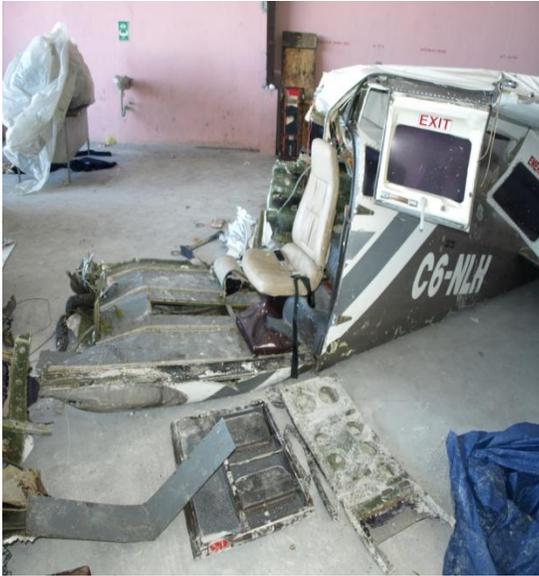
Figure 4 Fuselage post accident

Both fuel selector valves were found in the "OFF" position. The fuselage structure below the floor had been crushed and distorted in the crash. This was the area of the fuselage's first impact with the ground and it is likely, therefore, that the cables to the selector valves may have been trapped and moved at first impact.

The possibility that the cable was moved prior to, or during the impact, before being trapped in the "OFF" position cannot be discounted.

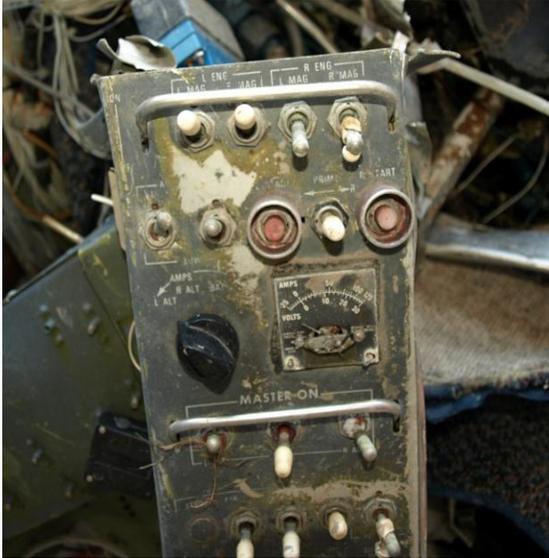
**Figure 6** Actual console Panel for C6-NLH

On the console panel located on the left fuselage wall just below the emergency exit, next to seat number 1, the investigation team discovered that both left and right magneto switches for the right engine were found in the "OFF" position, (switches #8) see system description figure 7.

Auxiliary fuel pump for the right engine (switch #7) also found in the "OFF" position see system description figure 7.

The left and right magneto switches for the left engine as well as the left alternator switch for the left engine were found still in the "ON" position.

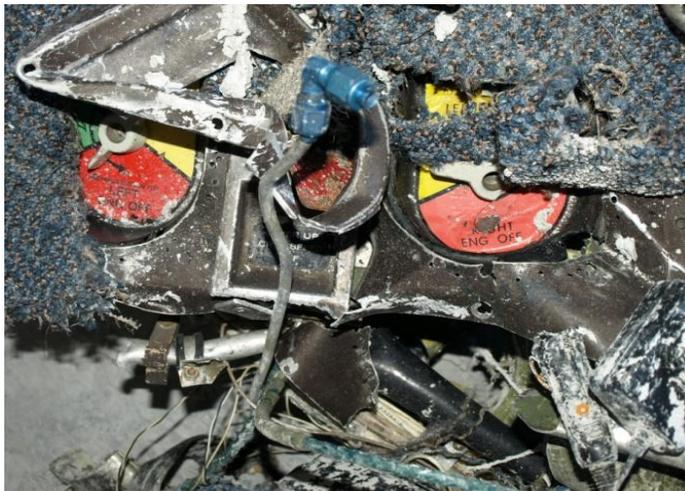
**Figure 7** Fuel Selector Valves Left and Right Engine

Both fuel selector valve knobs located on the floor between the left and right pilot's seat were found in the "OFF" position.

It could not be confirmed whether the knobs were selected by the pilot intentionally or whether they were moved as a result of the accident sequence.

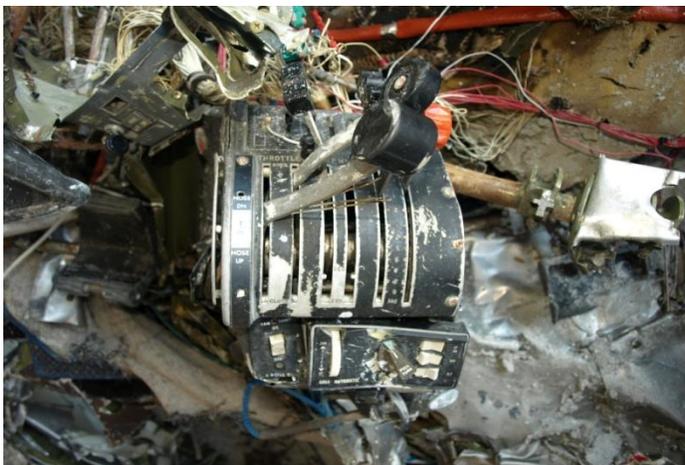
**Figure 8** Power Quadrant

Right throttle lever, left and right propeller lever as well as left and right mixture control levers were all found in the full forward position with the exception of the left throttle lever which was found slightly aft of the full forward position, (which represents full power on that engine).

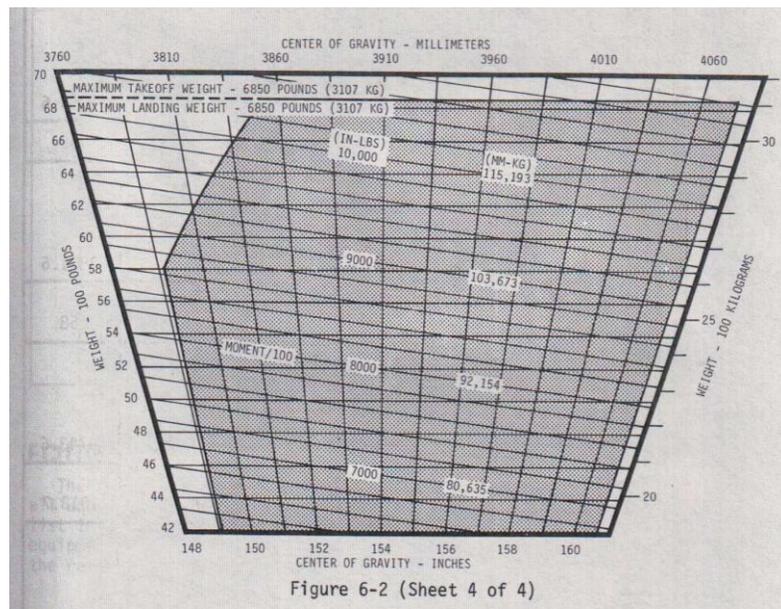
Figure 9 Center of Gravity Graph / Envelope

- Total recovered weight on aircraft **7373# -**
- Max wt allowed for T/O **6,850# =** (Maximum Gross Weight)
- **Amount overweight 523#**

Center of gravity could not be determined as the seat each person occupied in the aircraft is unknown, and the amount of baggage and what compartment it was placed on the aircraft is unknown. As per the center of gravity graph and envelope, once weight and balance are within limits a plotted area should fall within the designated fore and aft limits of the envelope up to the maximum weight limit.

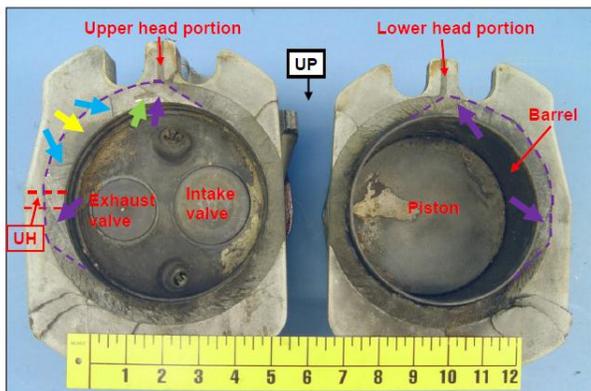
Figure 2. The mating fracture faces on the upper (left) and lower (right) portions of the cylinder head.

The fracture faces are illustrated in Figure 2 with the head portions, the barrel, the piston, the exhaust valve and the intake valve identified. Examination of the fracture faces revealed two zones displaying different surface textures, one located predominantly on the exhaust side of the cylinder head. The zone within the purple dashed line was relatively smooth and the zone outside of the dashed line displayed a rough uniformly grainy surface. The purple arrows in Figure 2 indicate distinct crack arrest marks that were located within the smooth zone, consistent with fatigue.

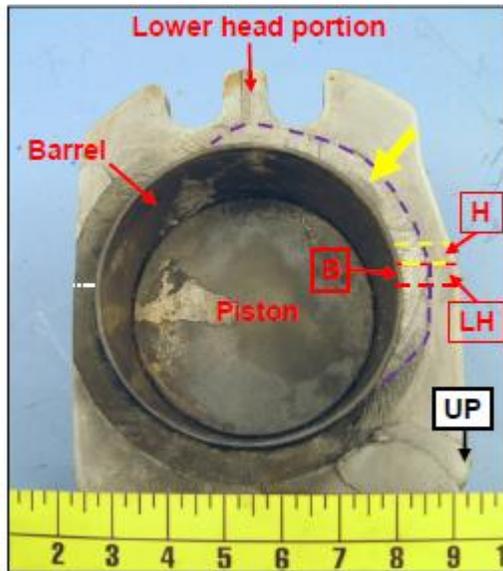
The fracture face around the smooth zone on the lower portion of the cylinder head was solvent cleaned and is illustrated in Figure 3 with the smooth zone contained within the purple dashed line. The cleaning revealed the darker arced area indicated by the yellow arrow which matched the darker arced area indicated by the yellow arrow in Figure 2 and is illustrated later in Figure 4. Examination of the smooth zone revealed that the fracture was relatively flat and oriented perpendicular to the axis of the barrel; features also consistent with fatigue.

Figure 4. The fatigue zone indicated by the yellow arrow in Figure 3.

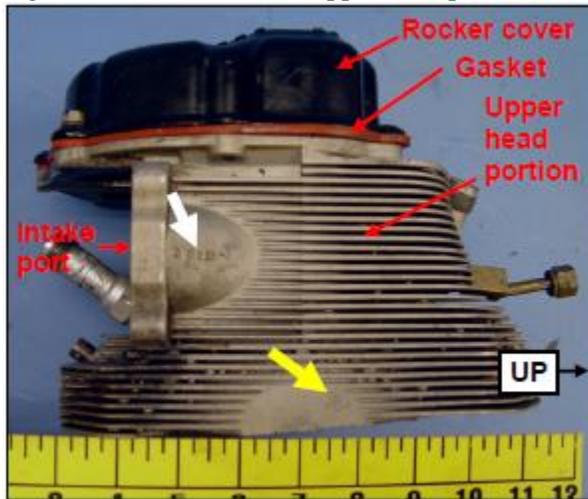
Figure 5. Side view of the upper head portion.

Figure 5 is a side view with the intake port, the rocker cover and the rocker gasket identified. The “up” direction, as installed, is also indicated. The white arrow indicates the serial number, 30213-3, consistent with the August 2008 cylinder history and the yellow arrow indicates the bell profile, consistent with the cylinder being the “FREEDOM™” brand.

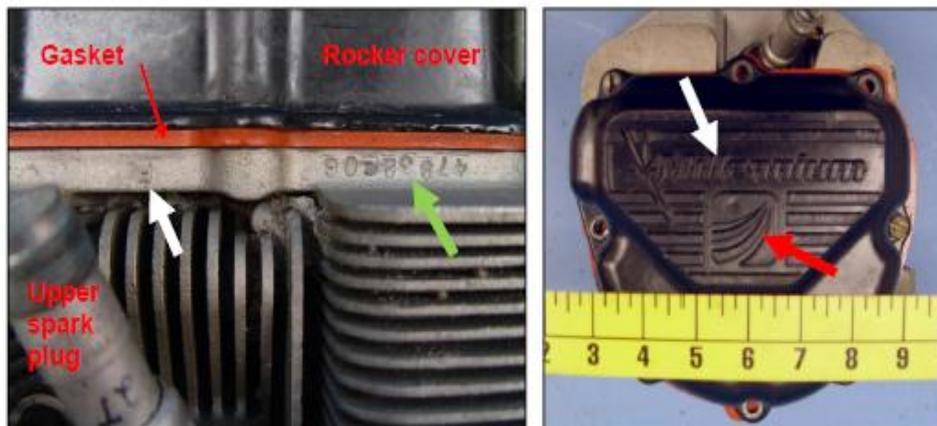
Figure 6. The upper edge of the rocker flange (left) and the rocker cover (right).

The left image in Figure 6 is a closer view of the rocker flange in the area indicated by the green arrow in Figure 5. The green arrow indicates the serial number 47932-06, consistent with the August 2006 cylinder history, and the white arrow indicates the cylinder head casting revision letter, “F”.

Examination of the rocker cover revealed that it was attached to the cylinder head by two screws that were found to be loose, consistent with the rocker cover being previously removed. The rocker cover displayed the SAP16 logo, indicated by the red arrow in the right image in Figure 6, and the word “Millennium”, indicated by the white arrow in the right image. These SAP components are consistent with them being transferred from the SAP cylinder this ECI cylinder replaced, as indicated by the January 2010 cylinder history.

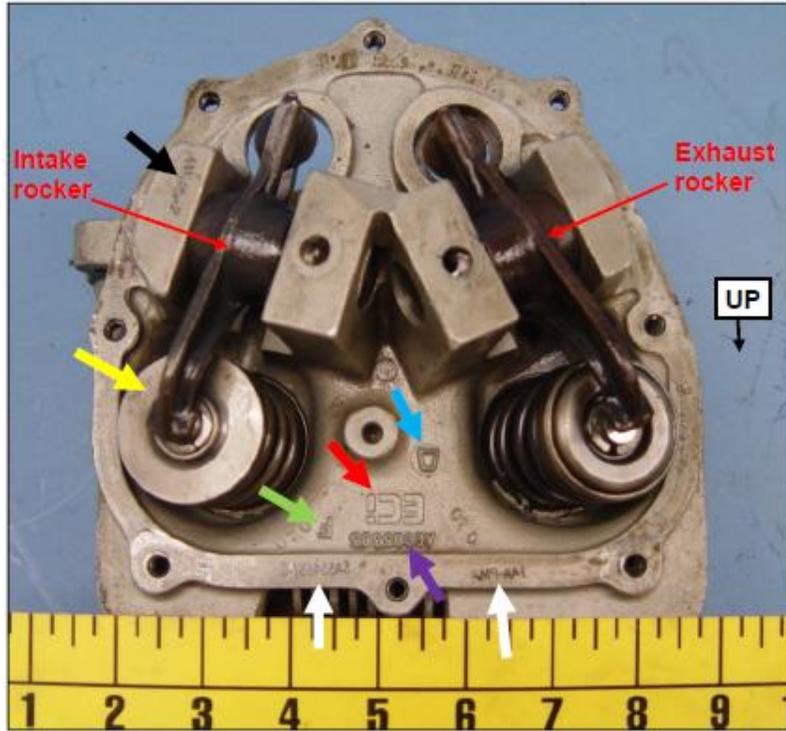
Figure 7. The rocker space in the upper portion of the cylinder head.

The identifications previously observed in the rocker space are illustrated in Figure 7 with a red arrow indicating the ECi logo, a purple arrow indicating the casting part number, a green arrow indicating the casting revision letter and a blue arrow indicating the Oberdorfer trapezium. The black arrow indicates the overhaul number 41525-2, consistent with the January 2010 cylinder history. The yellow arrow indicates a location on the intake valve retainer that displayed the identifications “SA35971” and “FAA-PMA”, consistent with it being an SAP product.

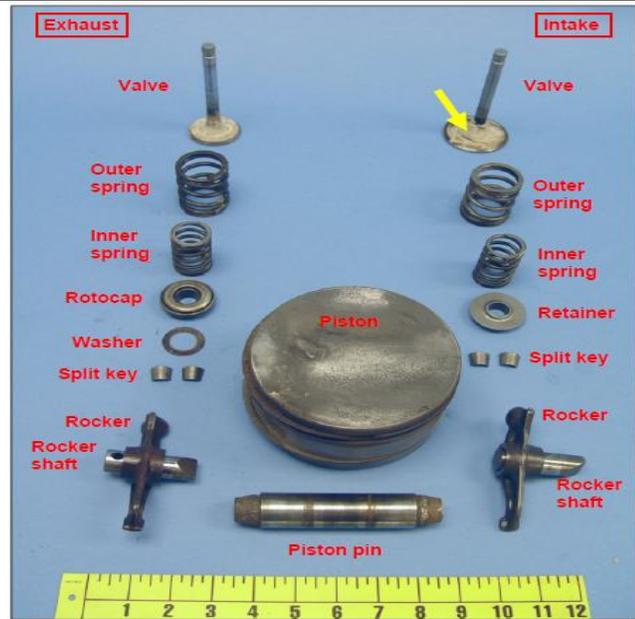
Figure 8. Valve gear removed from the cylinder head and the piston extracted from the barrel.

The valve assembly components are illustrated and identified in Figure 8 with the piston, extracted from the barrel, and the piston pin, extracted from the piston. Removing combustion product from the crown of the piston revealed the part number 654840C, consistent with it being the appropriate TCM piston for the TCM model TSIO-520 engine and agreeing with the inserted number on the Airmark parts list in the January 2010 cylinder history.

The disassembly process revealed a significant, tan colored deposit in the cylinder ports and on the valves reminiscent of soil. Such a deposit would not be present during normal operation but would be consistent with lake bed material being carried into engine cavities resulting from the aircraft impacting the lake bed. A sample of the deposit at the location indicated by the yellow arrow in Figure 8 was taken for the analysis detailed later.

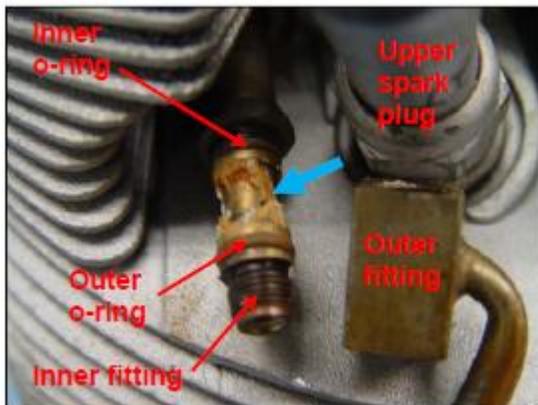
Figure 9. The injector assembly partially disassembled.

Examination of the cylinder head included the injector indicated and identified in Figure 1. The injector is illustrated in Figure 9 with the outer fitting removed to reveal the inner fitting. The inner and outer o-rings are indicated and a blue arrow indicates a mostly tan colored soil-like deposit between the o-rings. The inner fitting was removed from the cylinder head and an examination revealed three mostly obscured holes in the reduced diameter between the o-rings. One side of the inner fitting displayed a partially clear hole and is illustrated in Figure 10 with the inner and outer o-rings identified.

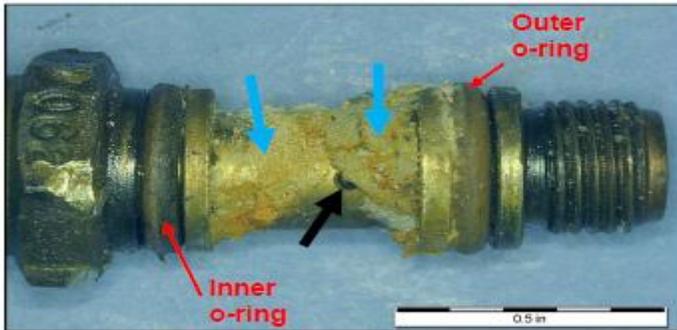
Figure 10. The deposits on one side of the injector.

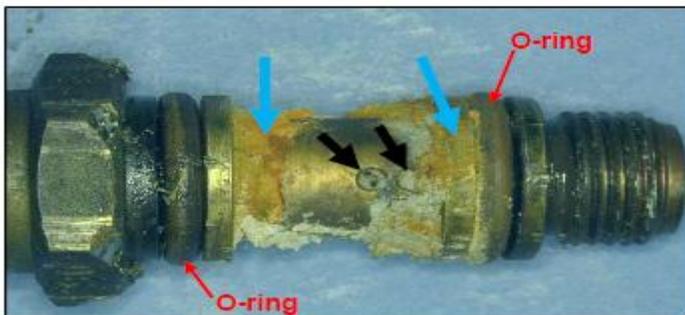
Figure 11. The deposits on the opposing side of the injector to Figure 10.

Blue arrows indicate the deposit and a black arrow indicates a partially clear hole. The opposite side of the inner fitting displayed two mostly obscured holes and is illustrated in Figure 11 with the inner and outer o-rings identified. Blue arrows indicate the deposit and black arrows indicate the two mostly obscured holes. Examination of the central hole in the inner fitting revealed that it was clear of any obstruction. A sample of the deposit was taken for analysis and comparison with the sample removed from the intake valve, indicated by the yellow arrow in Figure 8. Removal of the sample revealed that there were 8 holes (four pair) in the inner fitting, suggesting that the cylinder would require eight holes to be operational and would not be functional with a majority of the injector holes obstructed. The presence of the soil-like deposit would also be consistent with being post impact and originating on the lake bed.
