Aviation Short Investigation Final Report

Power-Plant Malfunction

Cirrus SR-22 N325TE

AAID Aviation Occurrence Investigation # AO-18-000005

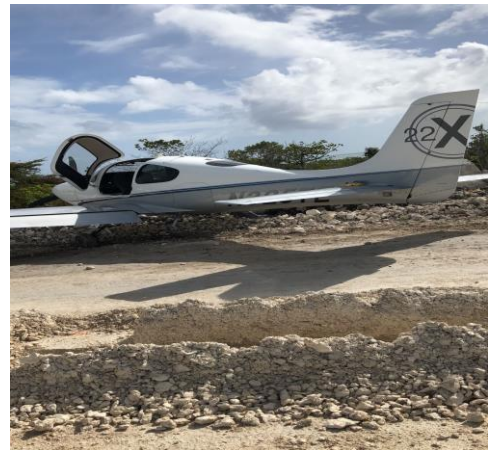
Photo 2: N325TE Deep Water Cay

After consulting with his mechanic via telephone and trouble-shooting, the pilot opted to depart Deep Water Cay and continue his flight, taking off from Deep Water Cay at 1:45 pm. However, only minutes into the flight, the oil sensor indication returned and the engine failed. A decision was then made to perform an emergency landing on a dirt road nearby after realizing he would be unable to return to the field.

He executed the landing and the aircraft received damages as a result. There were no injuries reported related to this occurrence.

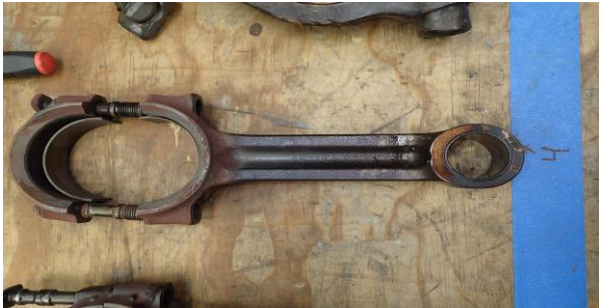
Photo 3: #4 Connecting Rod & Bearings

The #3, #4, #5 and #6 connecting rods, bearings, and journals displayed lubrication distress and damage; the #3 main journal displayed lubrication distress signatures, and the #2, #3, and the #4 main bearings displayed varying amounts of damage consistent with lubrication distress. The #5 connecting rod had release from the crankshaft and the #5 piston was destroyed.

The Air Accident Investigation Department has determined the probable cause of this accident to be engine malfunction related to the lack of oil pressure to the bearings of the connecting rods and the crankshaft journals, thus increasing operating temperatures. The initial causal factor of the oil starvation was not determined.
