## AVIATION OCCURRENCE BULLETIN

**DATE: 18 AUGUST, 2019**  
**REPORT # AO-19-000010**  
**AIRCRAFT REGISTRATION: N2085M**  
**INVESTIGATION STATUS: COMPLETED**

Aircraft details	
<b>Aircraft Type and Registration:</b>	PA-34-200T, N2085M
<b>Year of Manufacture &amp; Serial #:</b>	1977, 34-7870063
<b>Number and Type of Engine(s)</b>	2, TSIO-360SER
<b>Type of operation:</b>	Private, General Aviation
<b>Information Source:</b>	AAID Field Investigation
<b>Nature of Damage:</b>	Damage confined to the nose cone and nose undercarriage

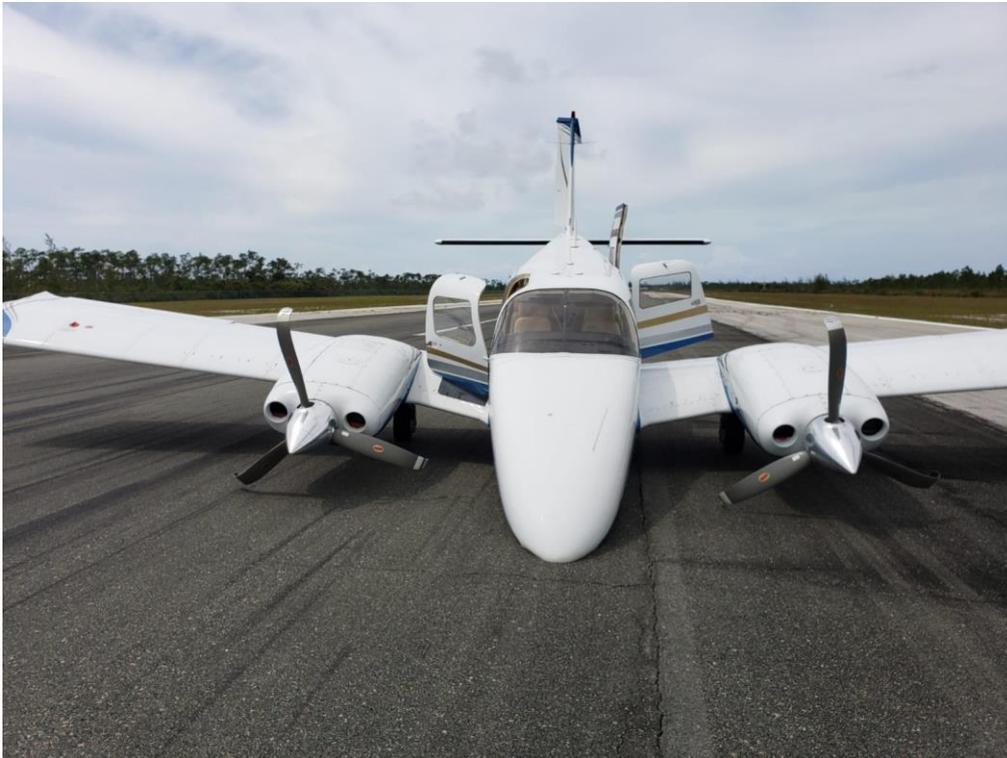
On the 18<sup>th</sup> March 2019, at approximately 2:30 PM LCL, a Piper Seneca aircraft (PA-34) N2085 nose gear collapsed while landing on runway 09 at the Lynden Pindling Int'l Airport, (MYNN). There were six souls on board at the time of the occurrence. The aircraft and its occupants departed Valdosta Georgia, USA, with destination Lynden Pindling Int'l Airport Nassau, New Providence, Bahamas.

The pilot reported that while on short final for runway 09 he observed the nose gear did not extend. Three attempts as well as emergency gear extension procedure was followed to no avail. The pilot eventually decided to make the landing. As a result upon touch down the nose gear collapsed.
