# Aviation Short Investigation Final Report

Gear collapse and runway excursion  
BE65-90, C6-CAM

**Clarence Bain Airport, Mangrove Cay Andros, Bahamas, on  
May 30<sup>th</sup> 2017**

**AO-17-002062**

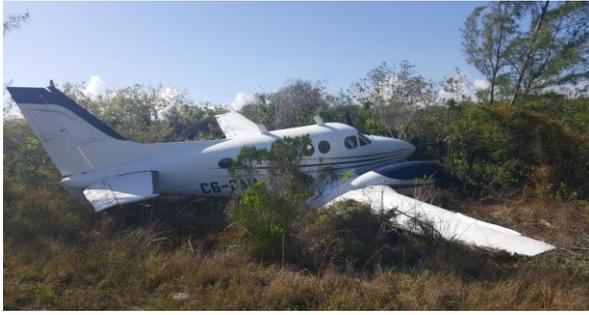
After landing and during rollout, the right main landing gear strut separated from its trunnion.<sup>1</sup> As a result, a runway excursion occurred. The pilot stated he executed emergency procedures, shutting down both engines, fuel and electrical systems. The aircraft veered to the right and came to rest in bushes 101 ft. from the side of the runway. Both pilots subsequently evacuated the aircraft, uninjured.

C6-CAM on right side of RWY 09

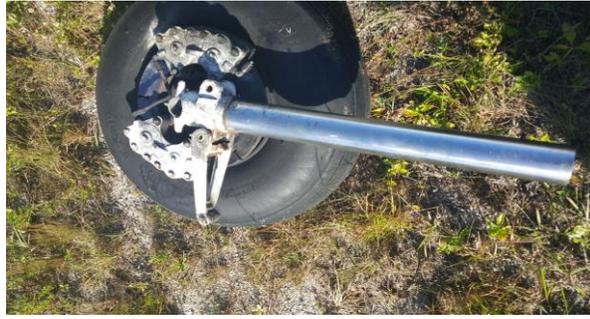
During the onsite investigation, the right wheel assembly (still attached to strut) was discovered on the runway 451 ft. from the point where the aircraft came to rest.

Detached right gear strut and tire assembly

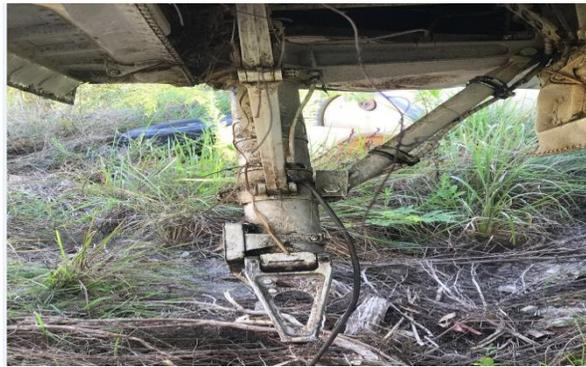
The upper torque knee was found to have fractured at the connection to the lower torque knee

1. The upper torque knee was found to have fractured at the connection to the lower torque knee.
2. Corrosion was found to have assisted the irritation of the crack; propagation was through fatigue. Final fracture was due to ductile overload.
3. Torque knee connection was found to have not been lubricated regularly.
4. Torque knees from LJ-108 were not replaced as recommended in SB 32-3116. The fracture location on the upper torque knee is consistent to the inspection region depicted in Service Bulletin 32-3134.
5. Material conductivity, tensile properties, chemistry and microstructure are consistent with aluminum alloy 2014 in the T6 condition.

Photo 3: Shock absorber assembly  
(Right Main Gear) and Torque Knee

The probable cause of this accident has been determined to be the fracture of the lower and upper torque knees (right main gear) due to ductile overload. Contributing to this fracture was the presence of corrosion and the lack of required lubrication.

With regard to this particular occurrence, the AAID deems it unnecessary to issue associated safety recommendation(s) as there already existed, processes to mitigate against such accidents in the form of Service Bulletin 32-3134 – Landing Gear Torque Knee Inspection (April, 1998) and Service Bulletin 32-3116 – Main Landing Gear Torque Knee Replacement (October, 1999). Therefore, it is incumbent upon the AAID to instead, reiterate and stress the importance of owners and operators adhering to **ALL** applicable service bulletins, airworthiness directives, orders and other industry best practices that lessens the likelihood of their aircraft being involved in an accident or incident.
