AIRCRAFT ACCIDENT REPORT

LOSS OF CONTROL & UNCONTROLLED FLIGHT INTO TERRAIN BEECH B36TC

N6703K

IN WATERS BETWEEN GREAT HARBOUR CAY, AND SOUTH ABACO, BAHAMAS JULY 16, 2012

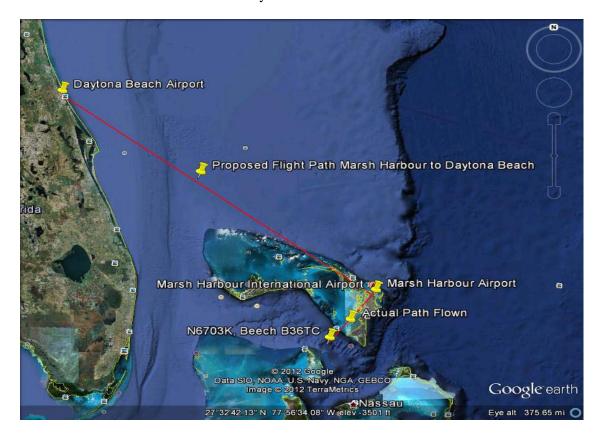
Based on the location of the debris field and the filed route, it appears the aircraft was diverting southwest of its planned northwest course to avoid massive thunderstorm activity in the vicinity of its proposed path. With the report of severe turbulence followed by the loss of communication and radar returns, it appears control was lost before the aircraft made contact with the terrain. It is believed that this uncontrolled flight into terrain was not survivable for the occupants of the aircraft. Weather has been considered as a contributing factor in the accident.

Proposed flight path from Marsh Harbour, Abaco to Daytona Beach, Florida as well as actual flight path up to the point of lost of contact between the Northern Berry Island and Southern Abaco.

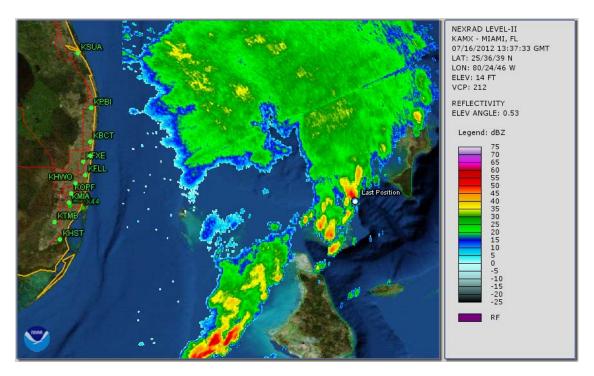
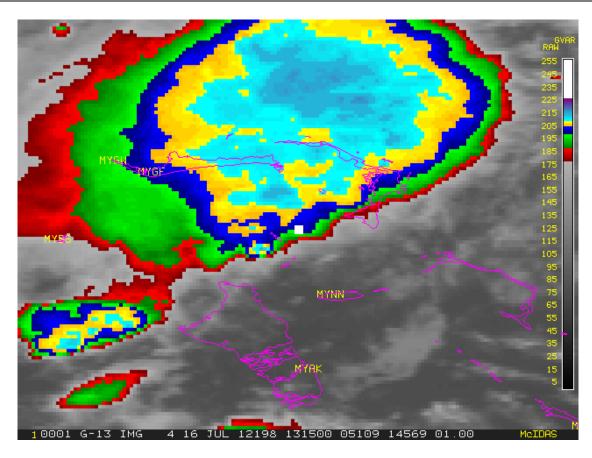
Weather over the Bahamas at the time of the accident and thereafter.

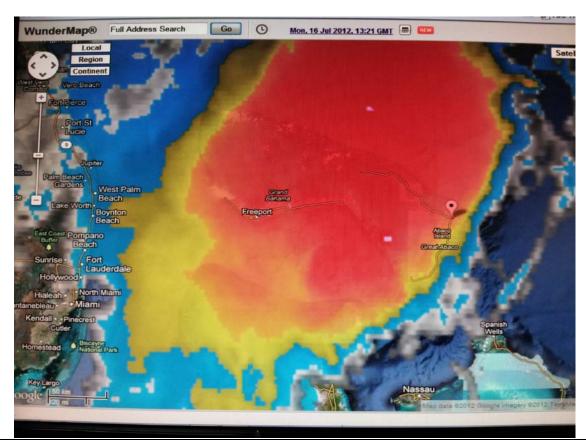
Additional satellite images showing weather in the Bahamas at the time of the accident.
