Short Investigation Bulletin

DATE: 6th December, 2019
REPORT # AO-19-000063
AIRCRAFT REGISTRATION: C6-SDA
INVESTIGATION STATUS: COMPLETE

Aircraft Type and Registration:	C404, C6-SDA
Year of Manufacture & Serial #:	1979, 404-0437
Number and Type of Engine(s)	2; Continental
Type of operation:	Commercial
Information Source:	Field Investigation
Nature of Damage:	Substantial

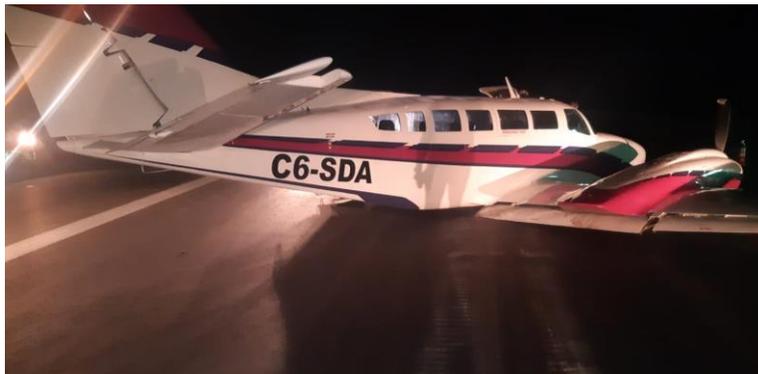
On the 6th December, 2019 at approximately 4:50 pm Eastern Standard Time, a Cessna 404 (C404) aircraft, Bahamas registration C6-SDA, operated by Randolph Holdings Ltd., landed on Runway 10 at the Lynden Pindling International Airport (MYNN) Nassau, Bahamas without the benefits of its landing gears. Nine (9) souls were onboard the aircraft at the time of the accident. No injuries were reported. The aircraft received substantial damages to the propellers, under belly and fuselage.

The pilot reported that prior to landing all three gear safe lights were illuminated and the scent of smoke was in the cabin.

The AAIA investigation team in conjunction with the company's maintenance carried out analysis and operational procedure checks of the aircraft landing gear system in accordance with the manufactures' maintenance manuals. No abnormalities were found that would prevent the landing gear from extending as required when selected to the landing position.

Based on the circumstances of this accident a limited scope investigation was conducted. The AAIA believes that based on evidence from post-crash analysis and maintenance checks, the landing gears may not have been selected to the landing position.

The BCAA, notified the AAIA prior to the release of this report that a re-examination of the airman was required and subsequently conducted satisfactorily.

In light of this action undertaken by the BCAA the AAIA did not issue any further recommendation.
