## AVIATION OCCURRENCE BULLETIN

<b>Date and Time of Occurrence:</b>	January 4, 2018 at 1:39pm		
<b>Location</b>	Freeport Int'l Airport taxiway Hotel		
<b>Persons on Board</b>	Crew	1	Passengers 0
<b>Injuries:</b>	Crew	0	Passengers 0
<b>Commanders License:</b>	Private Pilot		
<b>Occurrence category:</b>	Incident		
<b>Occurrence type:</b>			
<b>Investigation status:</b>	Final Report Complete

Aircraft details	
<b>Aircraft Type and Registration:</b>	Cessna 172E, N5535T
<b>Year of Manufacture &amp; Serial #:</b>	1964, SN 17251435
<b>Number and Type of Engine(s)</b>	1 Continental Engine 0-300 SER
<b>Type of operation:</b>	Private
<b>Information Source:</b>	AAID Field Investigation
<b>Nature of Damage:</b>	Substantial

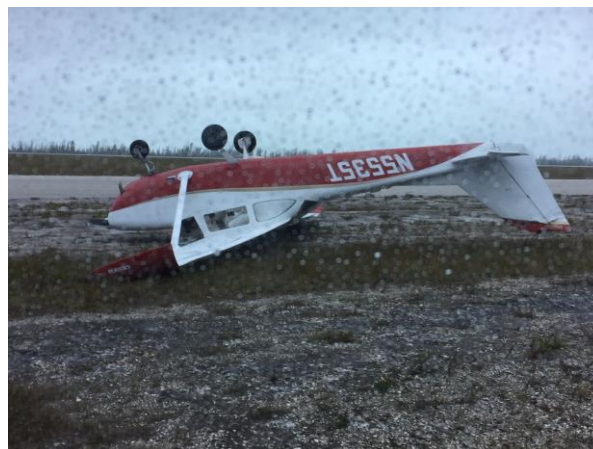
On January 4, 2018 at around 1:38pm local, a single engine, fixed wing, Cessna C172 aircraft was involved in an occurrence at the Freeport International Airport. The pilot of aircraft N5355T reported that while taxiing to the ramp area at the Freeport International Airport, “a gust of wind from the north west (right side of the plane) caused the plane to flip.” The aircraft ended up inverted on the south side of taxiway “H”. The aircraft previously departed Great Harbor Cay in the Berry Islands. The sole occupant of the aircraft received no injuries, however, the aircraft received substantial damages.

At the time of the occurrence the significant forecasted weather conditions included visibility of 6 statute miles, clouds broken at 1,200 feet and winds from the northwest at 29 knots gusting to 44 knots.
