## **AIRCRAFT ACCIDENT REPORT**

**LOSS OF CONTROL AND IMPACT WITH TERRAIN**

**C6-APV**

**GREAT GUANA CAY, ABACO  
BAHAMAS**

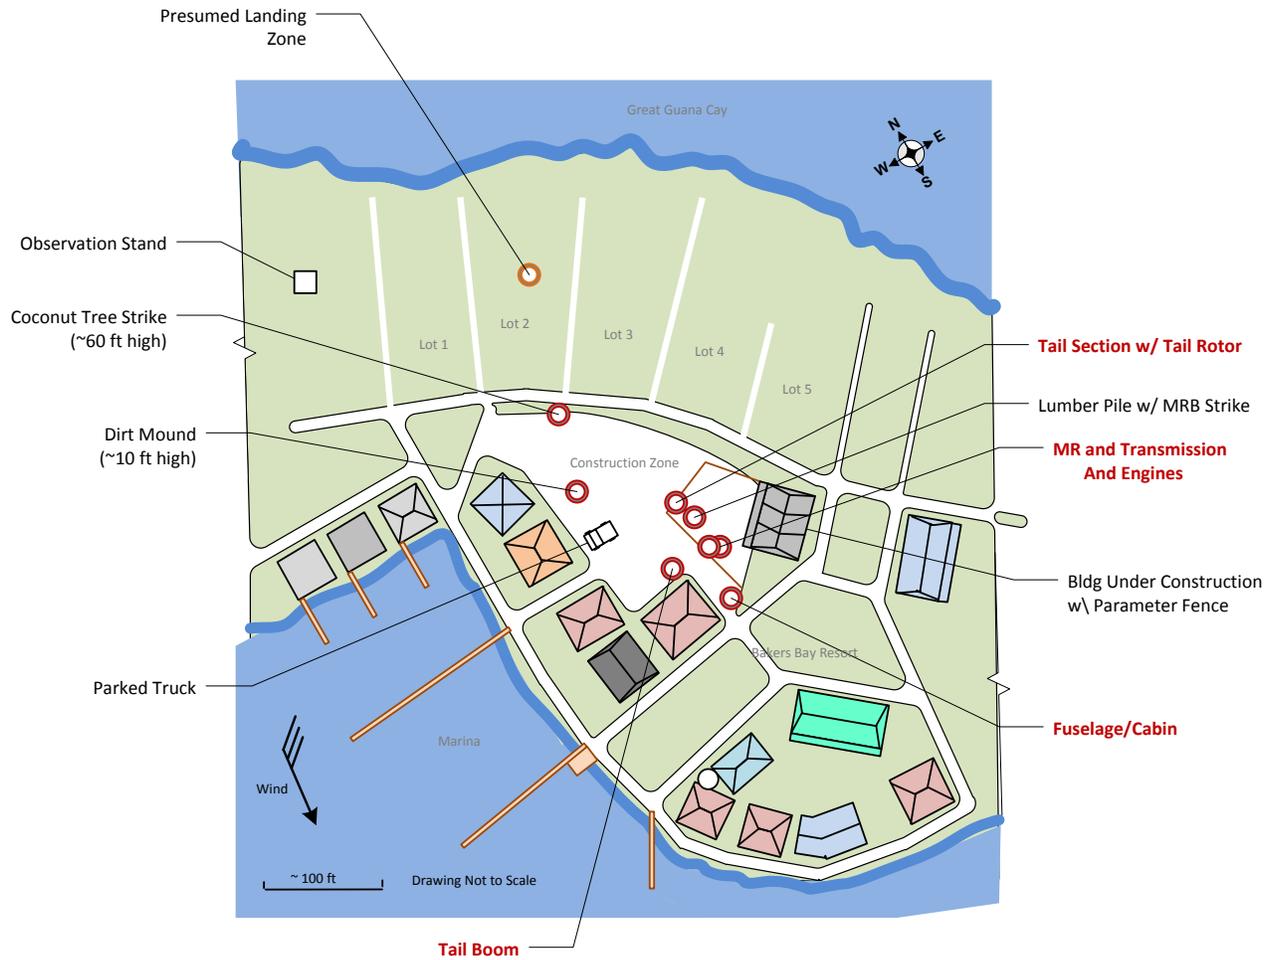
**APPENDIX 1 LANDING ZONE**

Once they arrived in the Baker's Bay Golf and Ocean Club area, witnesses reported seeing the helicopter pass low (approximately 60-100 feet) over the resort's grounds from south to north, out over the water. The helicopter then turned around and flew back to the south with the wind. Witnesses presumed they were attempting to land at the usual designated area which is an empty undeveloped lot near the shoreline. [See Appendix 1.](#)

The tail section separated from the fuselage, striking a parked truck and then separating in-half again, from a MRB strike at the tail boom, just a few feet forward of the horizontal stabilizers. The mid-section of the tail boom came to rest approximately 100 feet southwest of the dirt mound. The aft tail section, with the tail rotor still attached, came to rest approximately 75 feet south of the dirt mound. [See Appendix 1.](#)
