AVIATION OCCURRENCE BULLETIN

DATE: 30TH AUGUST 2019
REPORT # AO-19-000048
AIRCRAFT REGISTRATION: N40702
INVESTIGATION STATUS: COMPLETED

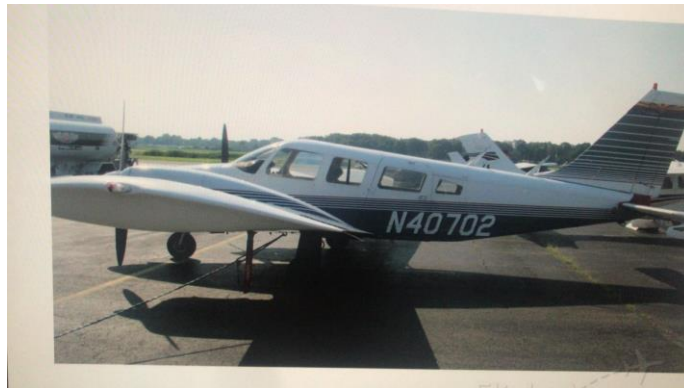
Several days post-accident, attempts were made to recover the aircraft from the ocean for further analysis, with no success.
