## AVIATION OCCURRENCE BULLETIN

**DATE:** 30<sup>TH</sup> AUGUST 2019  
**REPORT #** AO-19-000050  
**AIRCRAFT REGISTRATION:** N602TS  
**INVESTIGATION STATUS:** COMPLETED

Aircraft details	
<b>Aircraft Type and Registration:</b>	Canadair CL-600-2B16, N602TS
<b>Year of Manufacture &amp; Serial #:</b>	#5002
<b>Number and Type of Engine(s)</b>	Two, General Electric CF34 Series
<b>Type of operation:</b>	Private
<b>Information Source:</b>	AAID Field Investigation
<b>Nature of Damage:</b>	Damages to aircraft nose cone, nose gear undercarriage and left main gear.

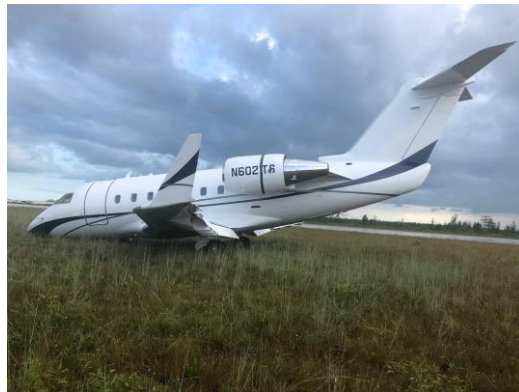
The aircraft received damages to the nose cone, nose undercarriage and left main landing gear. There were no injuries reported.

Convective activities including thunderstorms and rain showers were present in the vicinity of the aerodrome at the time of landing, which may have played a role in this accident. A limited scope investigation was conducted, no safety message or recommendations were issued.
