AIRCRAFT ACCIDENT REPORT FINAL REPORT

Loss of Control after Landing

Westwind WW-1124

N475AT

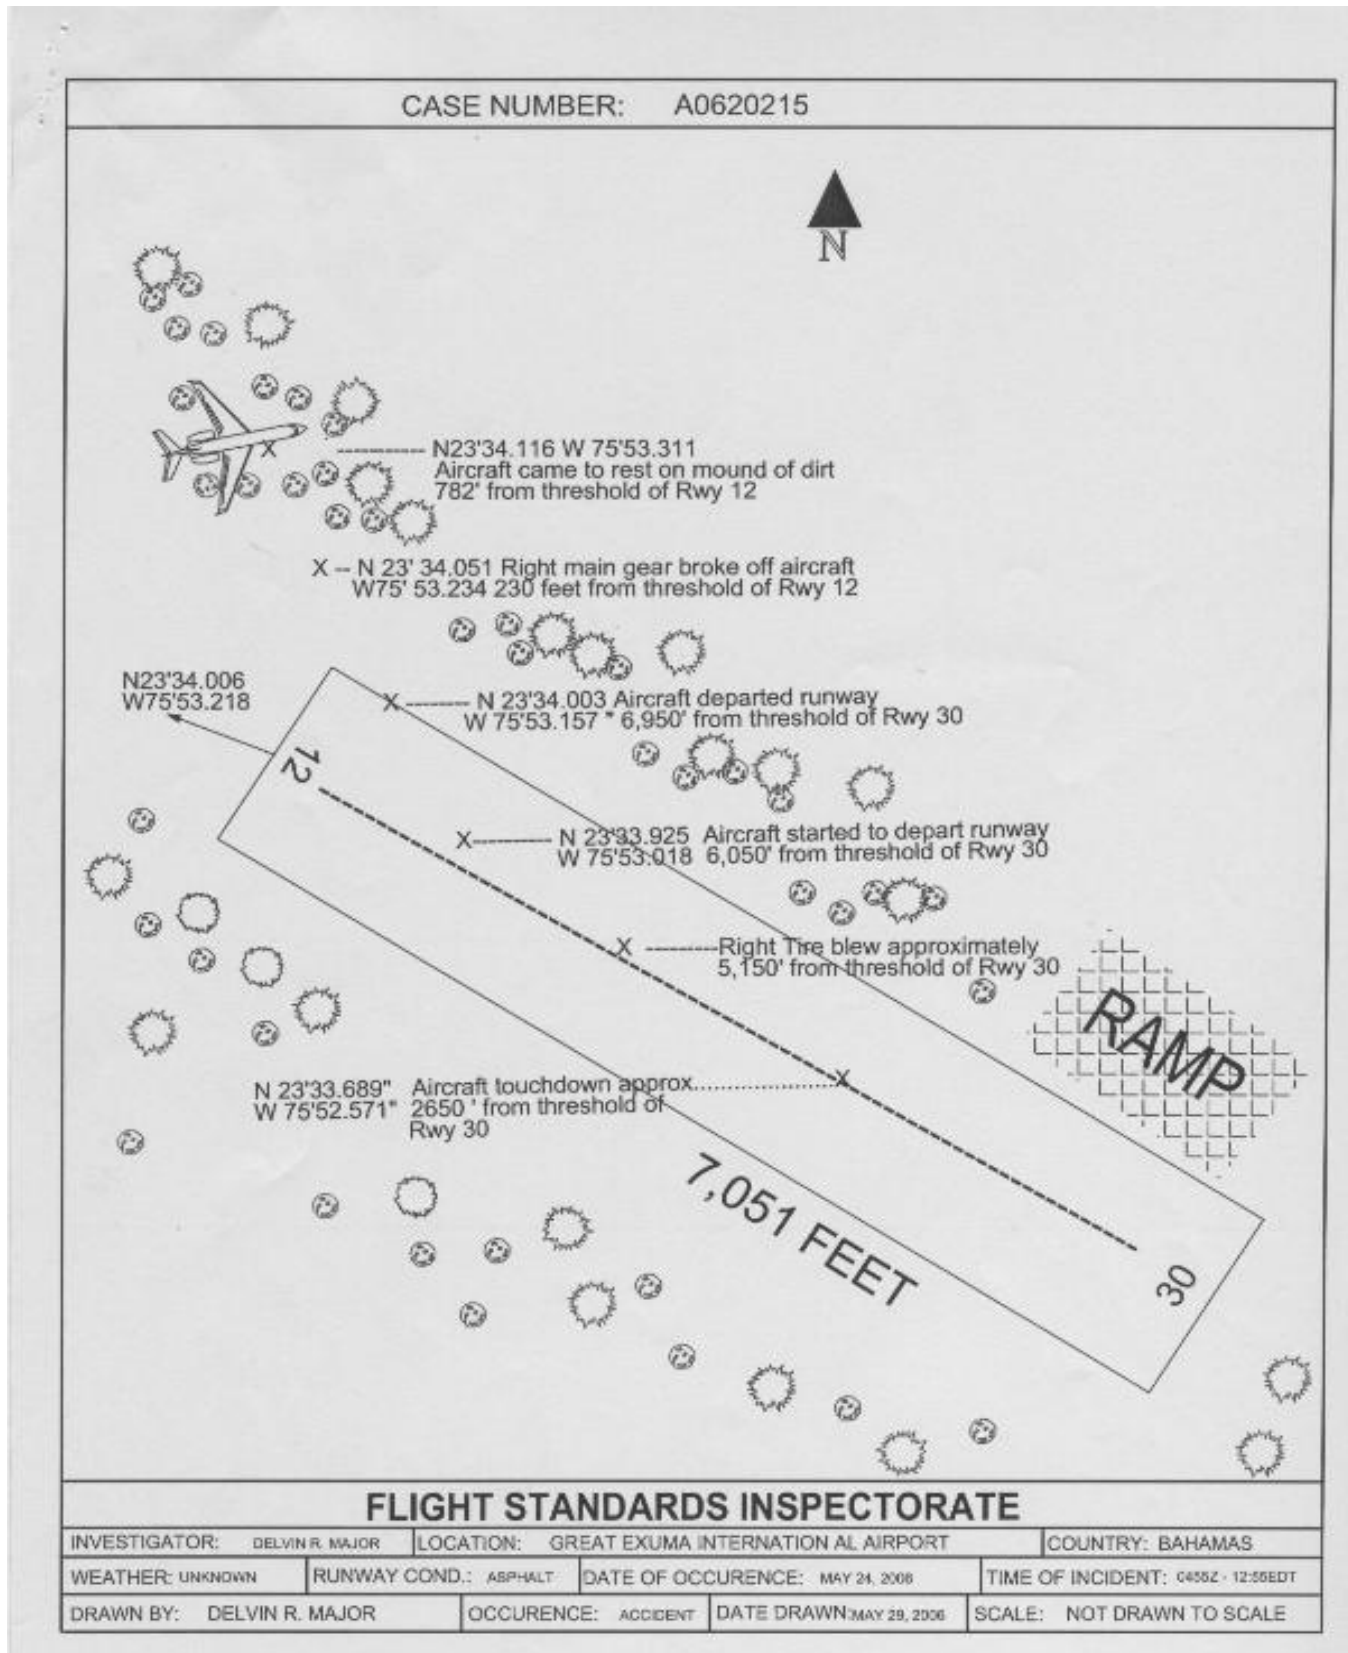
CRASH SCENE DIAGRAM:

The uncontrolled aircraft came to rest approximately 800 feet beyond the end of runway 30 and approximately 300 feet right of the extended centre line of the runway. The aircraft landing gears were sheered off when the aircraft exited the runway, hence traveling into the clearing and then eventually into the bushes on the right side of the runway. The right wing of the aircraft collided with a mound of dirt, causing it to spin uncontrollably, resulting in it coming to rest on an easterly heading at an approximate 30 degree incline.

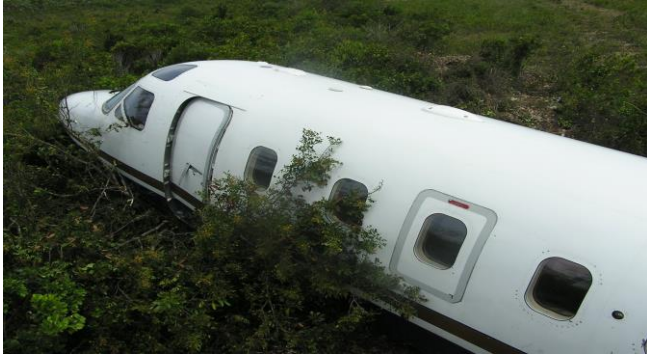
Rear view of disabled aircraft

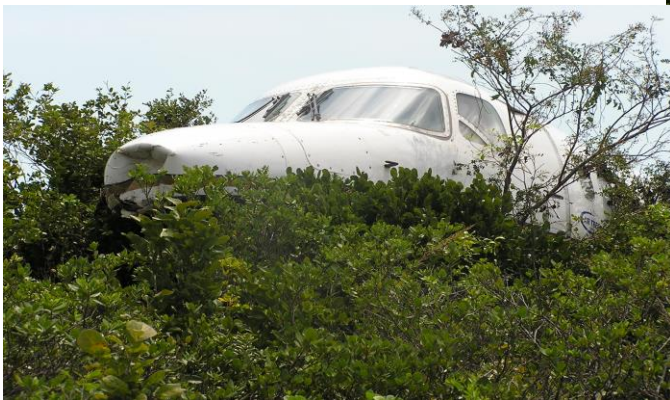
Front view of damaged aircraft.

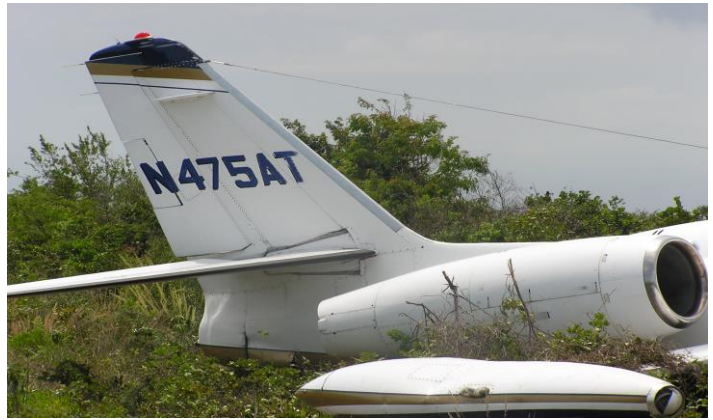
Side view of Damaged Aircraft.
