AVIATION OCCURRENCE BULLETIN

DATE: 19TH AUGUST, 2019
REPORT # AO-19-000015
AIRCRAFT REGISTRATION: N71CF
INVESTIGATION STATUS: COMPLETE

Aircraft details	
Aircraft Type and Registration:	PA-23-250, N71CF
Year of Manufacture & Serial #:	27-7954092
Number and Type of Engine(s)	2, IO-540 SER
Type of operation:	Private
Information Source:	AAID Field Investigation
Nature of Damage:	Left landing gear, undercarriage and propellers

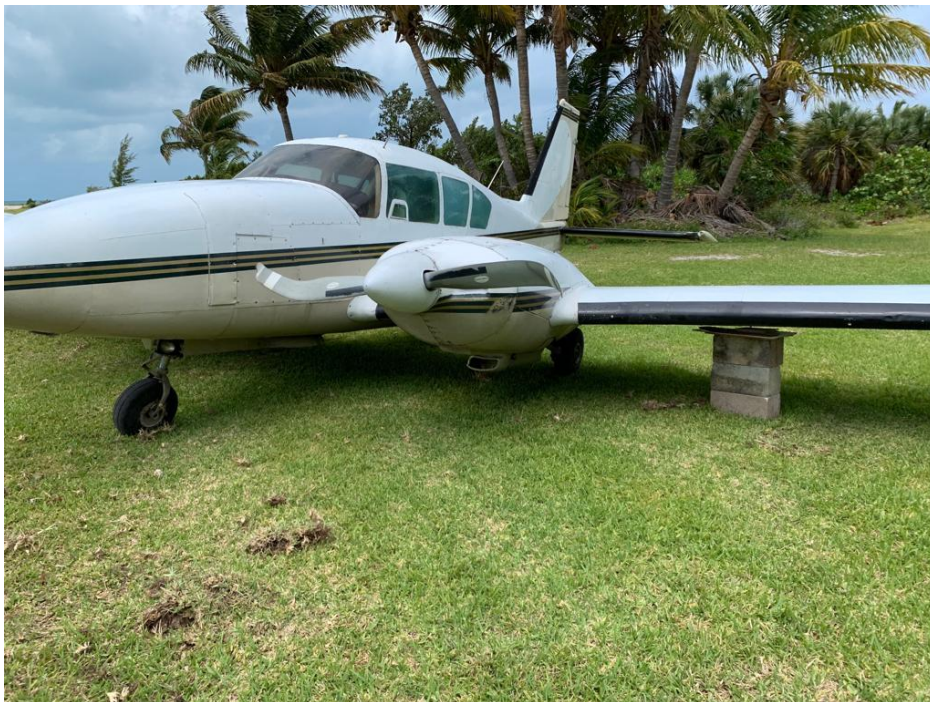
On the 19th April 2019, at approximately 9:00 AM LCL, Piper Aztec N71CF was involved in a runway excursion, while landing on runway 09 at Walkers Cay Abaco, Bahamas. The pilot reported that there was a strong gust of wind causing the aircraft to veer off the runway to the left which resulted in the collapse of the left main landing gear. Other damage sustained in the excursion includes; the left flap and left propeller.
