AIRCRAFT ACCIDENT REPORT

CATASTROPHIC ENGINE FAILURE

CESSNA C-182L

N42011

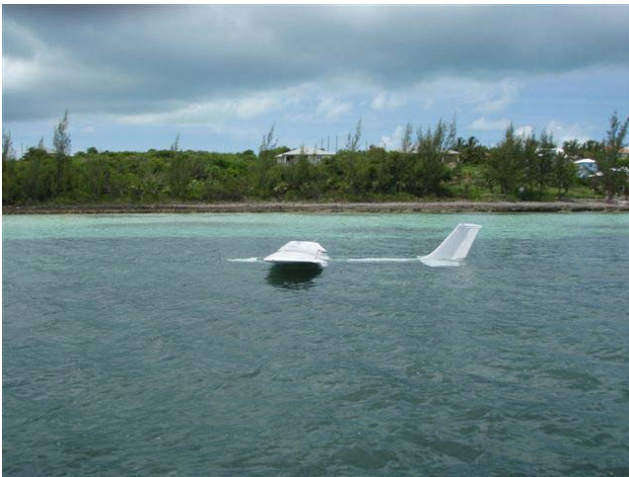
At 8:55am local Nassau control tower was informed that the aircraft did land in water approximately 6ft deep and 100 yards from the shore line of Russell Island. The pilot was said to be in good health. The aircraft was partially submerged in water.

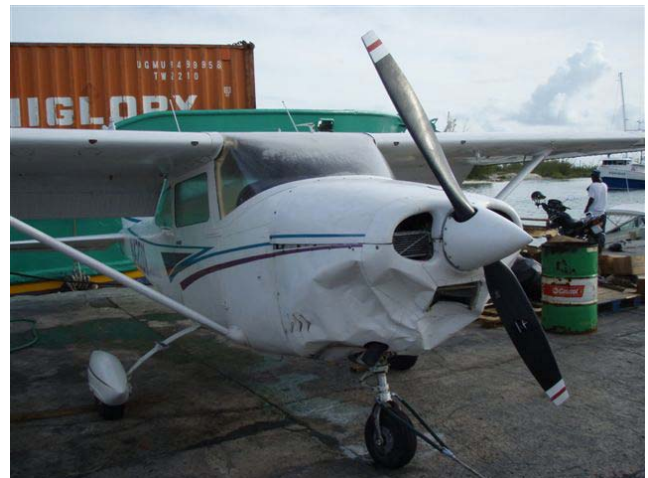
The aircraft sustained minor damages from impact. Further damage was noted as a result of water submersion. It was later recovered from the crash site and taken to the dock at Spanish Wells, Eleuthera.

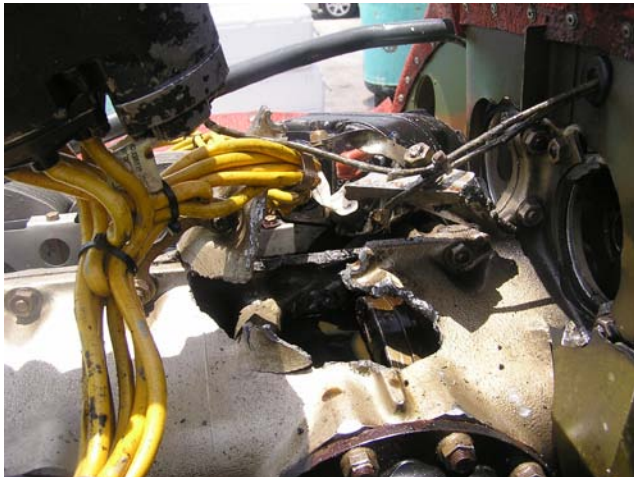
N42011 landed in waters off Russell Island, in approximately 6-8 feet of water approximately 100 yards from the beach at Russell Island. Minor damage was confined mainly to the nose and propeller due to impact with the water. Other damage includes catastrophic damage to the engine which resulted in the aircraft ditching and water damage as a result of the aircraft being submerged in salt water.
