BAHAMAS FLIGHT STANDARDS INSPECTORATE

AIRCRAFT ACCIDENT REPORT

**LANDING GEAR FAILURE
FAIRCHILD SA-227AC, C6-SAR
LYNDEN PINDLING INT'L AIRPORT
FEBRUARY 02, 2008**

AIRCRAFT ACCIDENT
REPORT No. A0826450

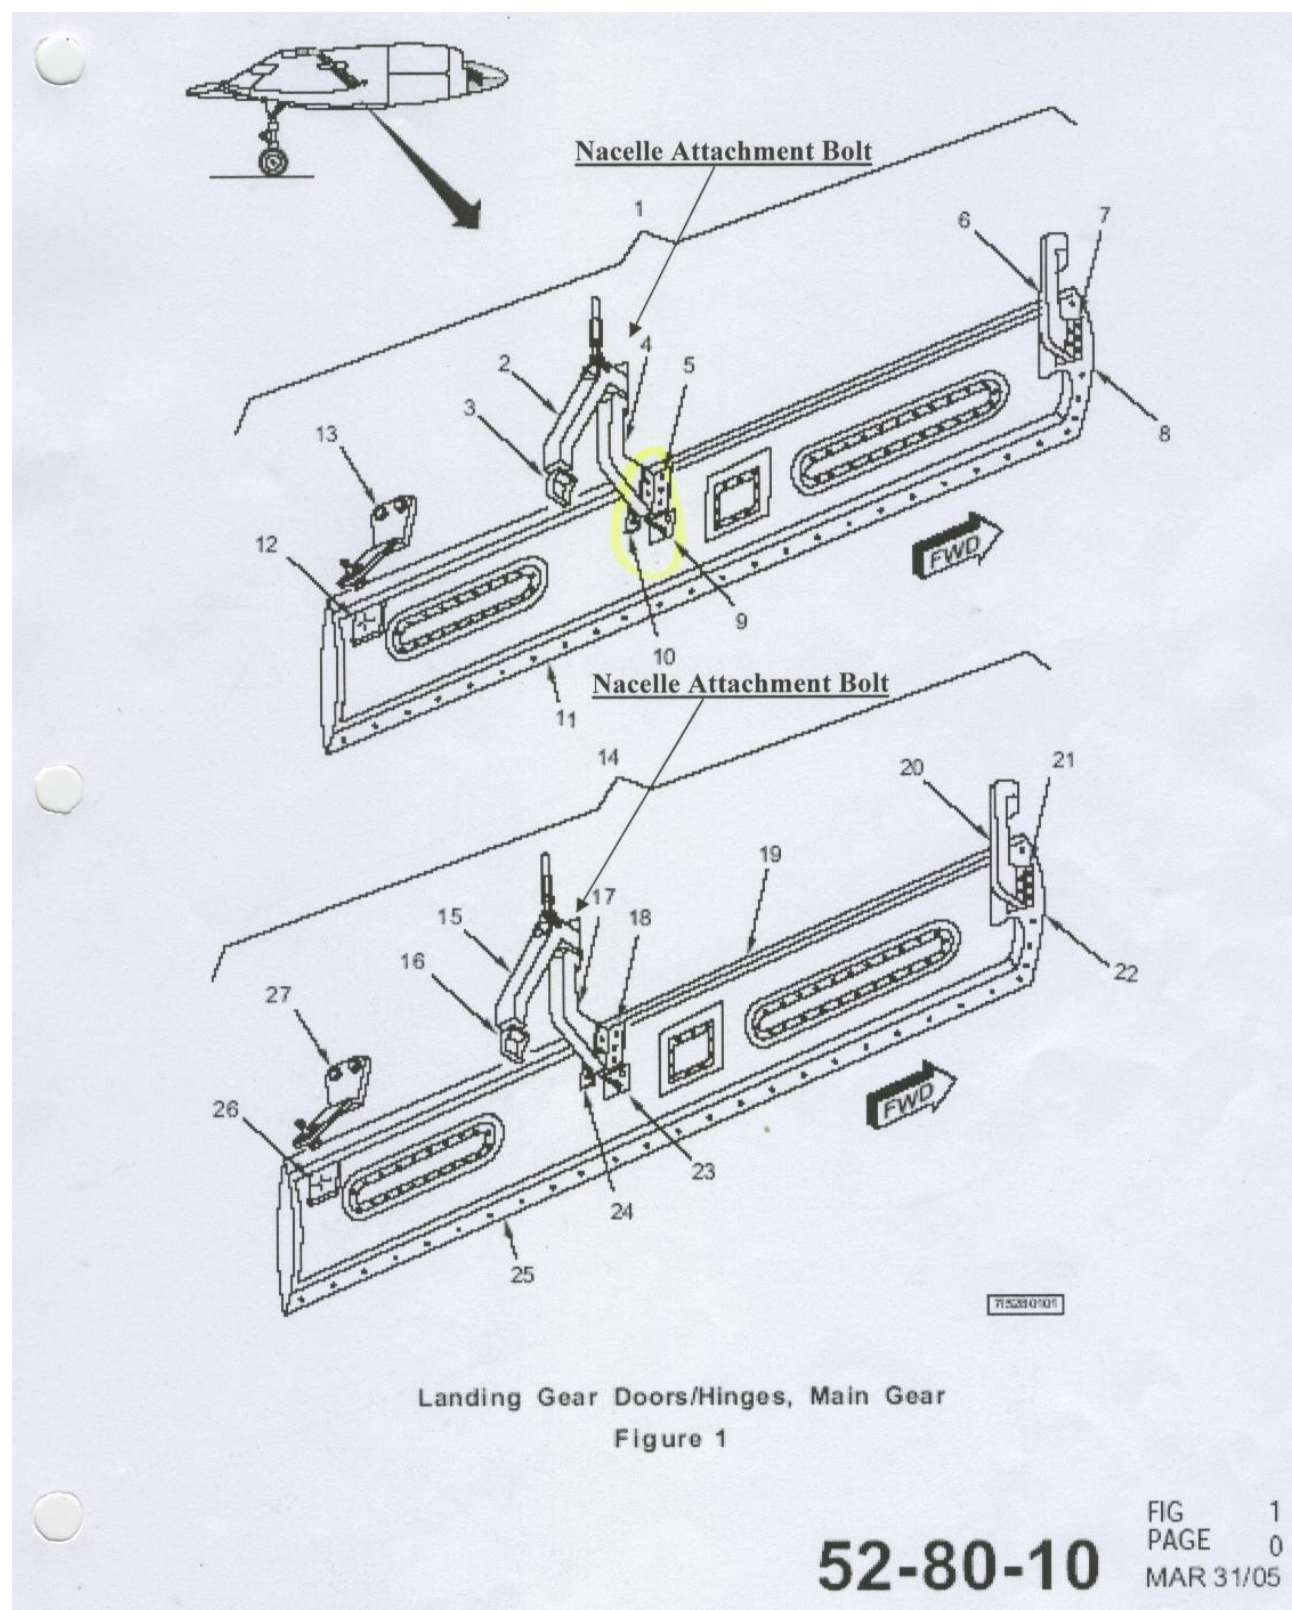
APPENDIX 05 – GEAR DOOR HINGE SHOWING ATTACHEMENT POINT

1. Right main landing gear door aft hinge attachment failure resulting in door not opening when gear selected to the down position. See appendix 05.
2. Captain Devon Robinson elected to fly C6-SAR in an un-airworthy condition in violation of BASR Schedule 10.245(b).
(On the ground at Clarence Bain Airport, Mangrove Cay, Andros it was reported that the Gear Door Position light was illuminated on the annunciator panel. It was further reported that the pilot acknowledged the annunciator and went outside and closed the door prior to departure for Nassau. This was the leg which ended with the emergency landing. The pilot late entered into the Technical & Journey Log the right main landing gear failure). See log page 12649 in Appendix 08.

Probable cause has been determined as detachment of the right main landing gear door aft hinge attachment.

(The locking wire which secures the gear door attachment bolt in place was found broken which allowed the attachment bolt to disengage. Once the bolt disengaged the aft door hinge detached from its secure position resulting in the movement of the hinge. This may have resulted in the hinge jamming the gear door resulting in the right main landing gear failure).

1. Safety Alert 004 was issued to have all operators of this type of aircraft immediately inspect all aircraft in fleet prior to next flight to ensure the security of this locking wire and replace as necessary.
