AVIATION OCCURRENCE BULLETIN

DATE: 20TH AUGUST, 2019
REPORT # AO-19-0000
AIRCRAFT REGISTRATION: N6102R
INVESTIGATION STATUS: COMPLETE

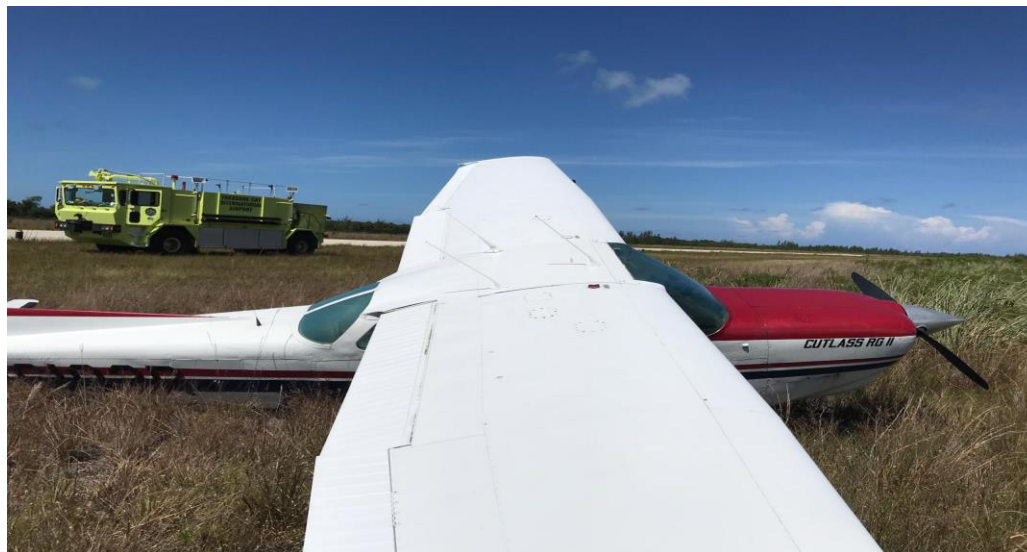
On the 13th June 2019, at approximately 10:49 AM LCL, a Cessna 172RG aircraft, registration N6102R both main gears collapsed on landing which resulted in Runway Excursion at South Bimini International Airport, Bahamas.

No injuries were reported. Damage assessment was made to the rear under lying skin, stabilizers and gears. A limited scope investigation was conducted, no safety message(s) or recommendations were issued.
