BAAID# A16-002290

## AIRCRAFT ACCIDENT REPORT

LOSS OF CONTROL  
PA 23-250 N63ZZ  
SOUTH BIMINI  
BAHAMAS  
June 19, 2016

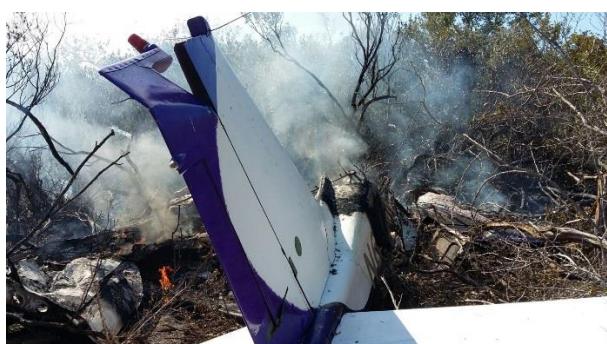
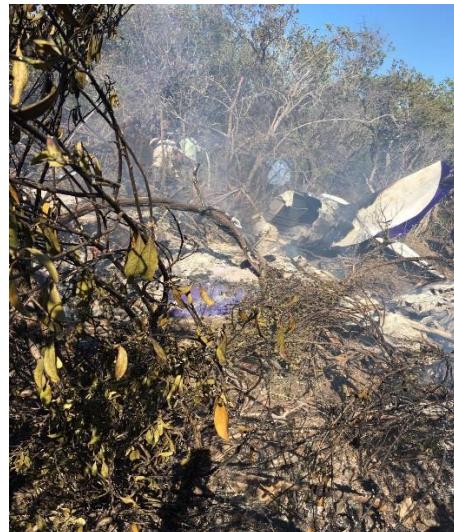
The extent of the destruction to the aircraft due to post-crash fire prevented any further follow up analysis. The fuselage, cockpit, all dashboard instrumentation, wings and nose area of the aircraft were completely destroyed by fire. Both engines were burnt to such an extent that any recoverable part for further analysis was not possible.

A fire ensued as a result of the aircraft crash. Due to the topography of the crash site, access to the site was difficult. A road had to be constructed to gain access. No firefighting equipment was able to access the site until a road was constructed to the site. The aircraft was destroyed by the post-crash fire.
