AVIATION OCCURRENCE BULLETIN

DATE: 20 JUNE, 2018
REPORT # AO-18-000010
AIRCRAFT REGISTRATION: N87175
INVESTIGATION STATUS: COMPLETED

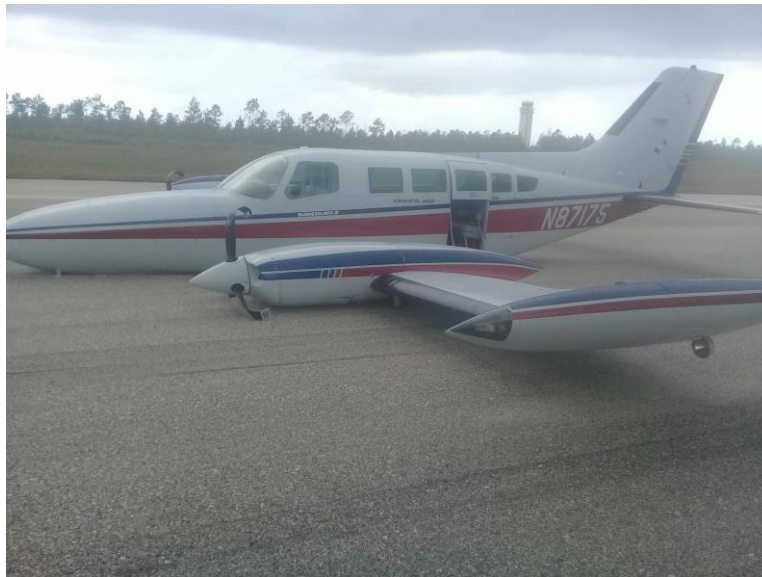
The pilot stated that upon receiving clearance to land, pre-landing checklist was completed and indication of gear down (three green) was confirmed. However, upon landing, the nose gear collapsed followed by the left and right main landing gears. The aircraft sustained extensive damages as a result.
