AVIATION OCCURRENCE BULLETIN

DATE: 21ST OCTOBER, 2019
REPORT # AO-19-000058
AIRCRAFT REGISTRATION: N217PG
INVESTIGATION STATUS: COMPLETED

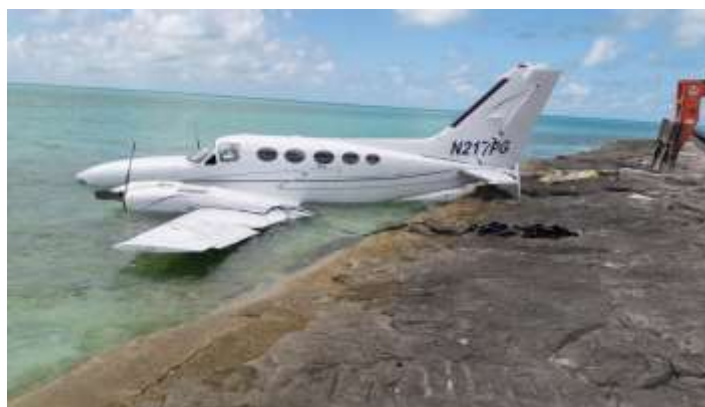
The pilot reported that after landing runway 21 at MYEN, during roll-out, he applied brakes but there was no braking action. The aircraft subsequently exited the useable surface of the runway, impacting the perimeter fencing, and then travelled down an embankment and into the ocean approximately 200 ft. from the end of the runway.

The aircraft received damages to nose cone, nose gear, both wings, left elevator, and main landing gears. There were no injuries reported in relation to this occurrence.
