Short Investigation Bulletin

DATE: 1st April, 2020
REPORT # AO-20-000011
AIRCRAFT REGISTRATION: N271SE
INVESTIGATION STATUS: Complete

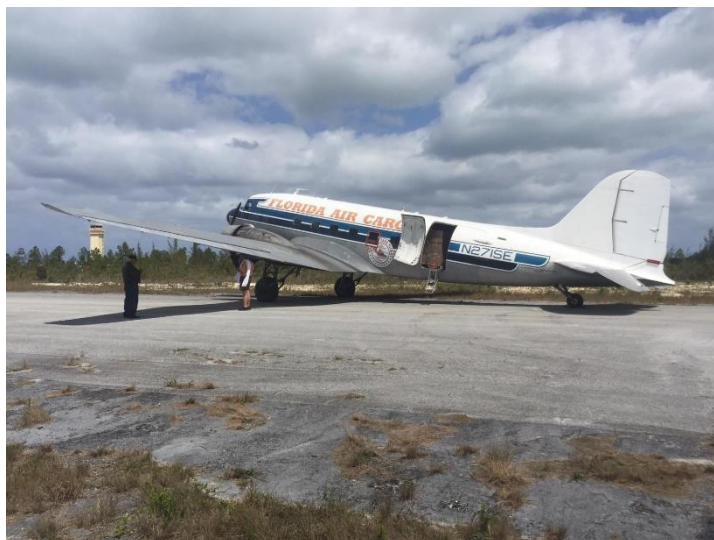
On the 7th March, 2020 at approximately 11:30 AM, a DC3 aircraft with United States registration N271SE, operated by Florida Air Cargo experienced a right engine failure while enroute to the Lynden Pindling International Airport (MYNN).

The aircraft previously departed the Chub Cay Airport (MYBC), Berry Islands, Bahamas with three (3) souls on board. According to the pilot, while at a distance of approximately 8 NM from the airfield at MYNN, a loss of power in the right engine was experienced. Emergency procedures for the aircraft was utilized, resulting in the engine being shut-off and secured. An emergency with Nassau air traffic control was subsequently declared.

The aircraft landed safely without incident on runway 14 at MYNN. There were no injuries reported and no damage to the aircraft. The weather at the time of the occurrence was visual meteorological conditions and deemed not a factor. A limited scope investigation was conducted, no safety message or recommendations were issued.
