BAHAMAS FLIGHT STANDARDS INSPECTORATE

AIRCRAFT ACCIDENT REPORT

**Propulsion System Malfunction
Inappropriate Crew Response
PIPER AZTEC, PA 23-250, C6-LEE
NASSAU, BAHAMAS
31 JULY, 2007**

AIRCRAFT ACCIDENT
REPORT No. A0825088

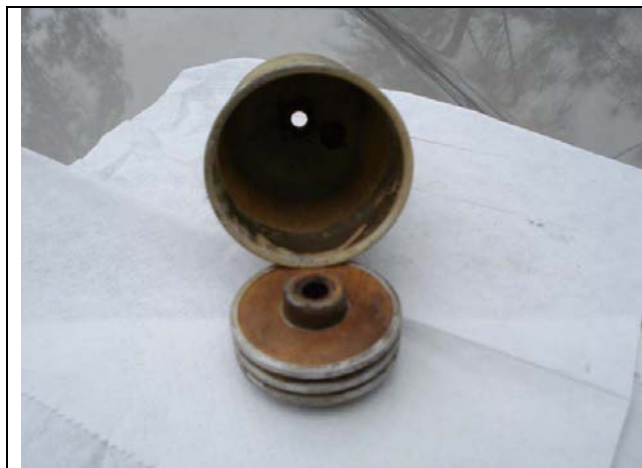
Left fuel strainer bowl found rusted, corroded and stained with sediments.

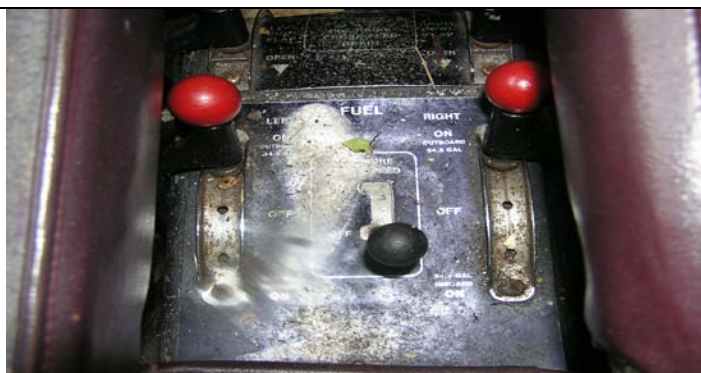
Fuel Selector set to Left and Right Outboard Tanks

Note: Both left and right outboard tanks were found empty however, both fuel tank selectors were found in the respective outboard position.

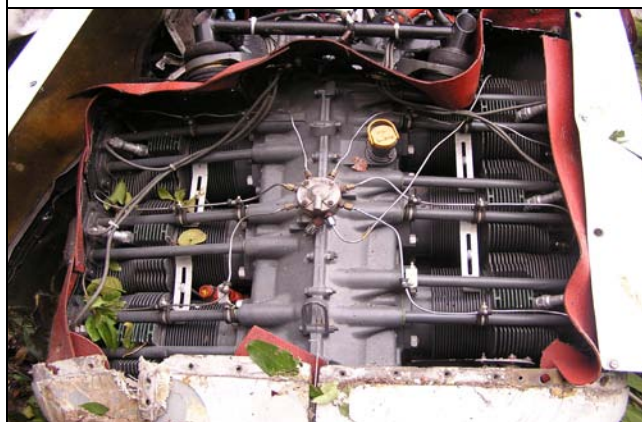
Fuel Manifold and Fuel Supply lines that were found contaminated with water and sediments. (Photo shows left engine only, however, both engines, and its associated fuel supply lines and flow dividers were found contaminated with water)

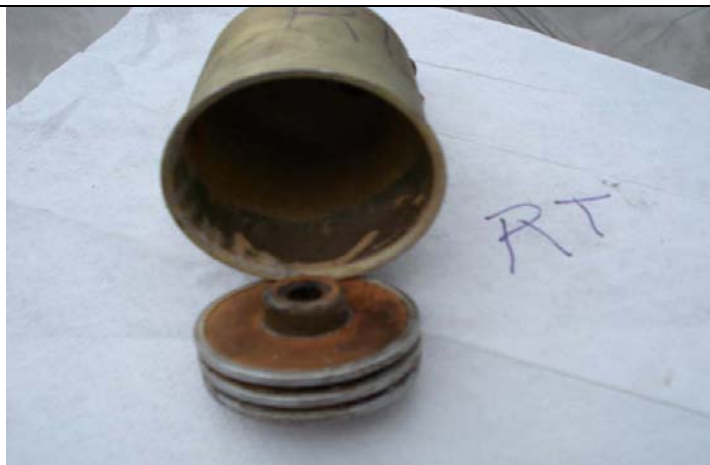
Right fuel strainer bowl found in the same sediment stained and corroded condition.

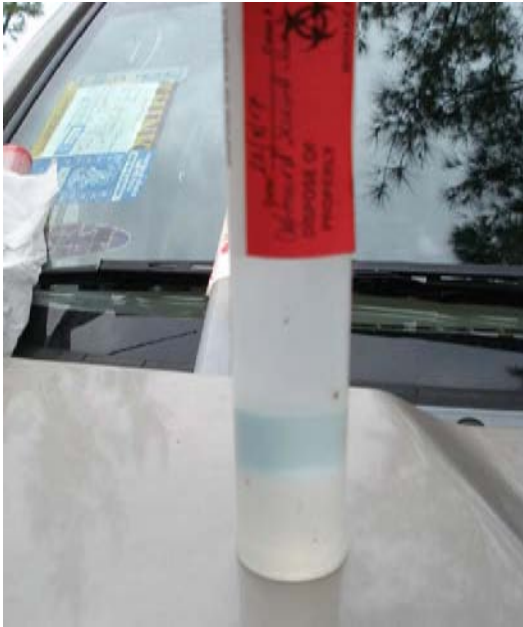
Water and fuel sample taken from right engine gaskolator. Taken on August 23, 2007. C6-LEE

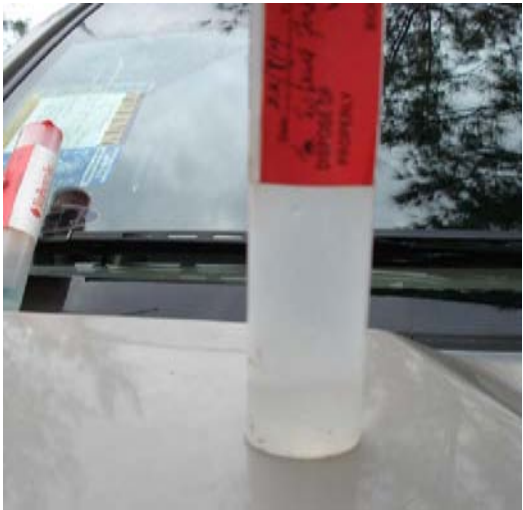
Fuel taken from fuel line between servo and spider valve. August 23, 2007

9. The fuel line between the servo and the spider valve was removed and water was removed from the lines.
10. The fuel line between the engine driven fuel pump and the servo was removed and water was also found in the lines.

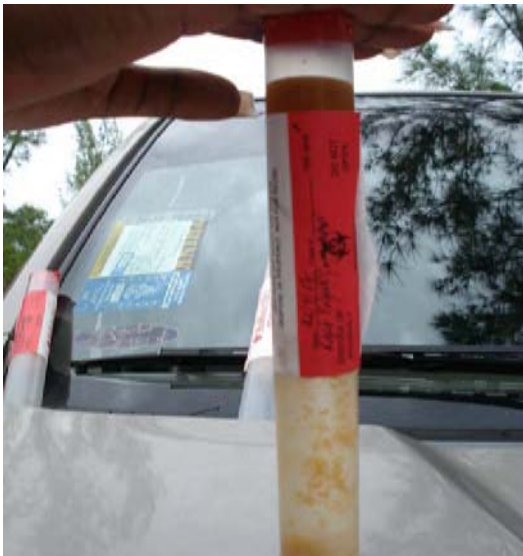
Sediments and water filled tube taken from mechanical fuel pump to servo. August 23, 2007

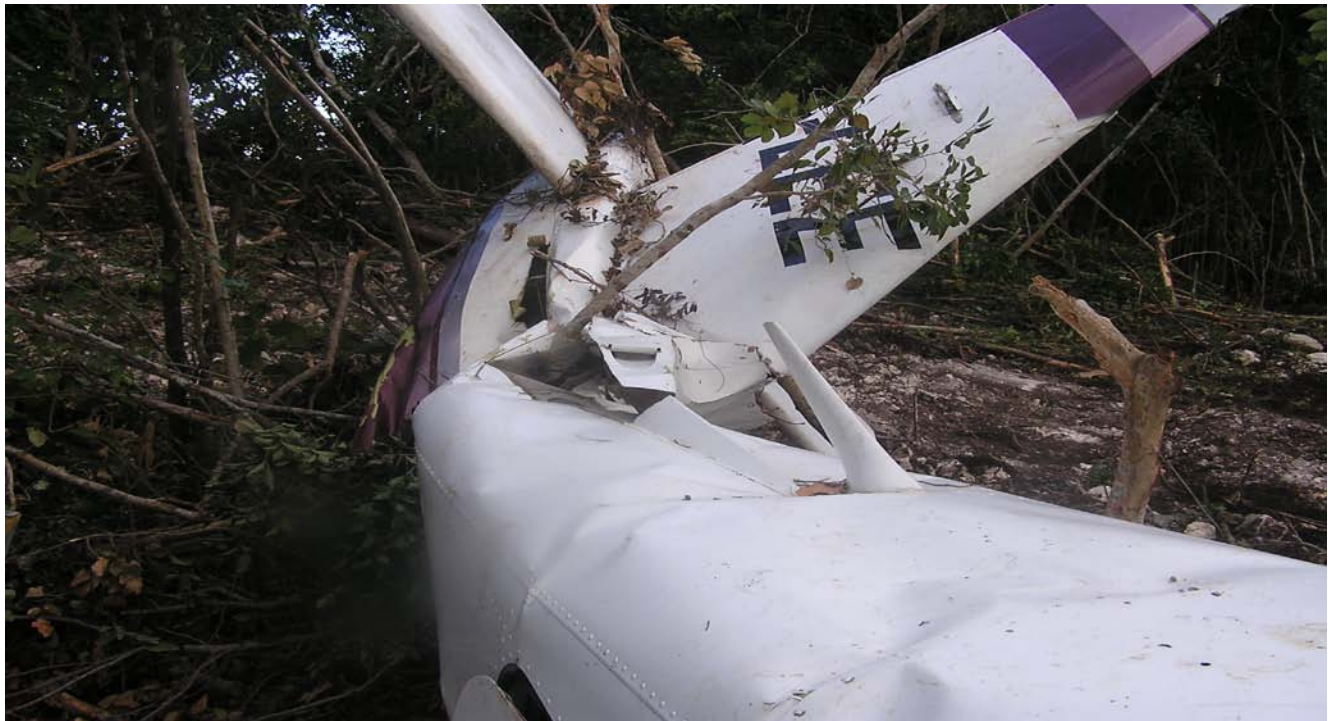
The tail cone was bent forward and to the left approximately 45 degrees. The bending started forward of the vertical fin, near the dorsal fin. The vertical fin and rudder assembly were crushed inboard on the right side. Continuity was established between the rudder and the rudder pedals in the cockpit. The horizontal stabilizer was attached to the rear bulkhead. Trees had damaged the left tip leading edge. The left elevators trailing edge was deformed at its inboard edge, next to the anti servo trim tab. The anti servo trim tab was attached to the horizontal stabilizer and no visible damage was documented. The right side of the stabilizer had outboard leading edge damage starting inboard of the tip and continued inboard approximately two feet. All balance weights were intact. Continuity was established from the elevator to the aft cabin area.

Photo show tail section nearly separated from fuselage after the impact.

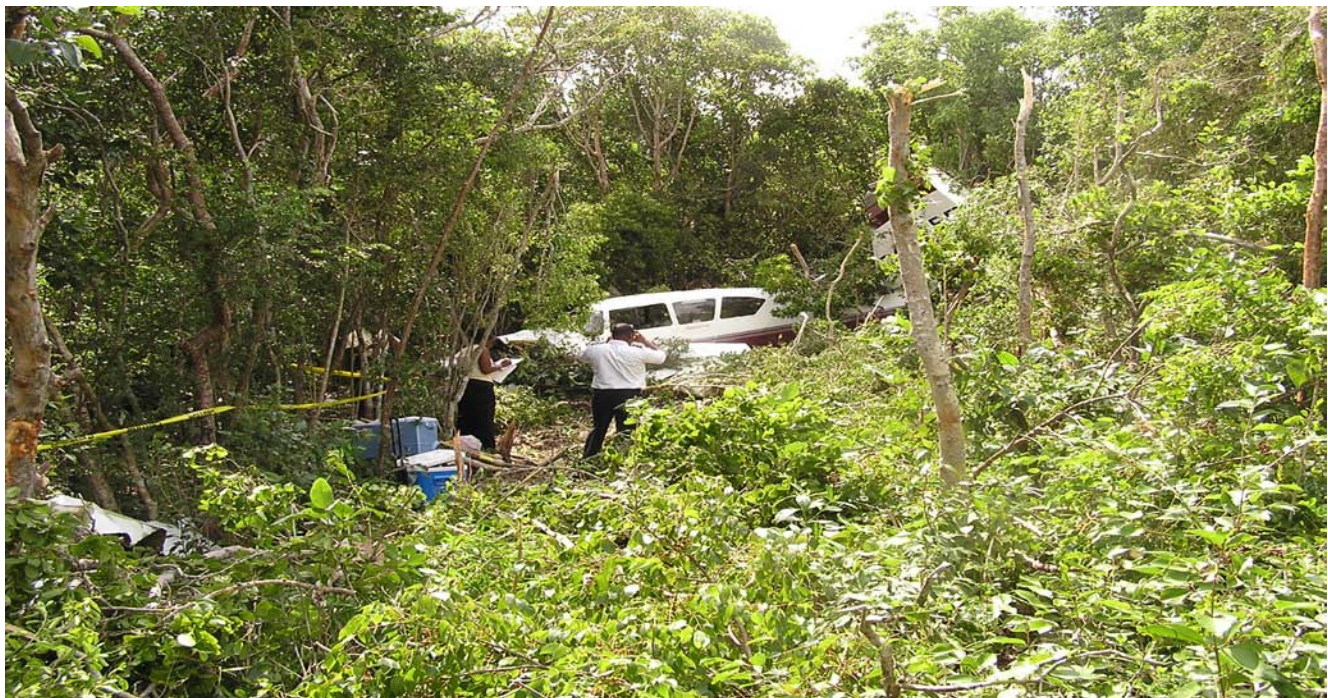
Path made by aircraft during the crash. Photo show trees cut during the descent to the terrain.

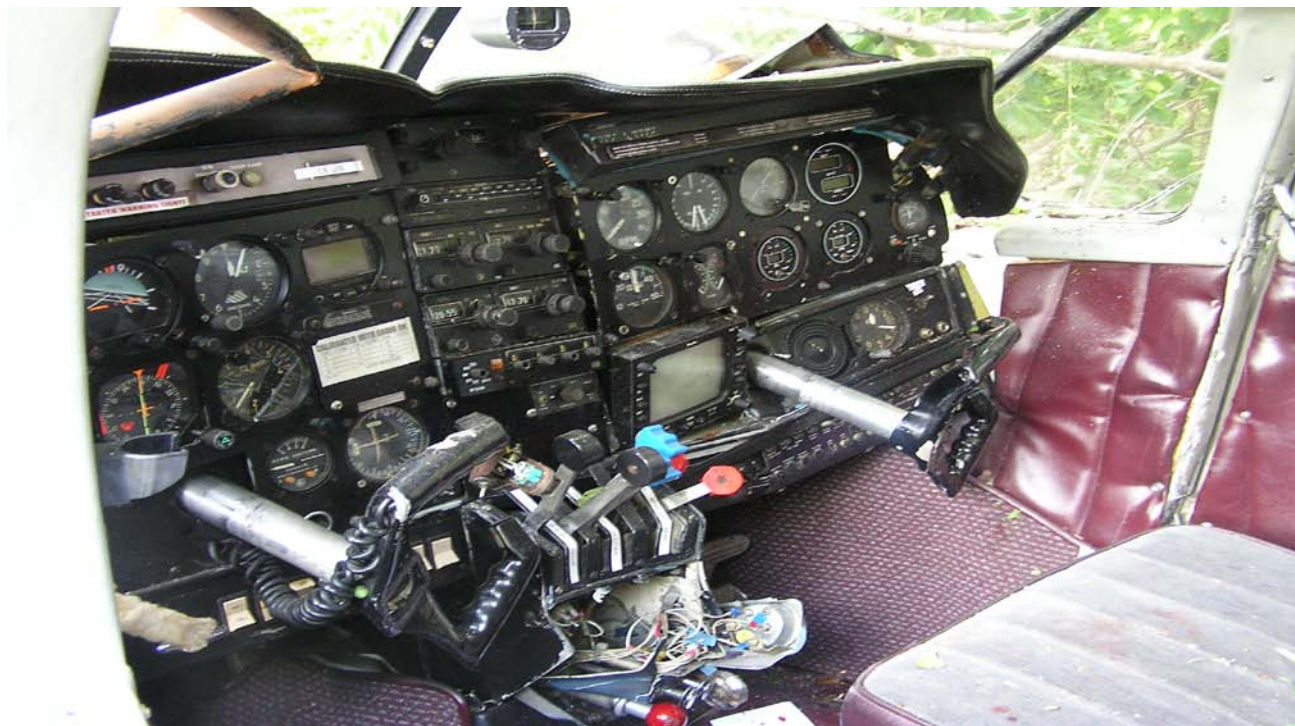
Photo shows intrusion into rudder area of the cockpit.

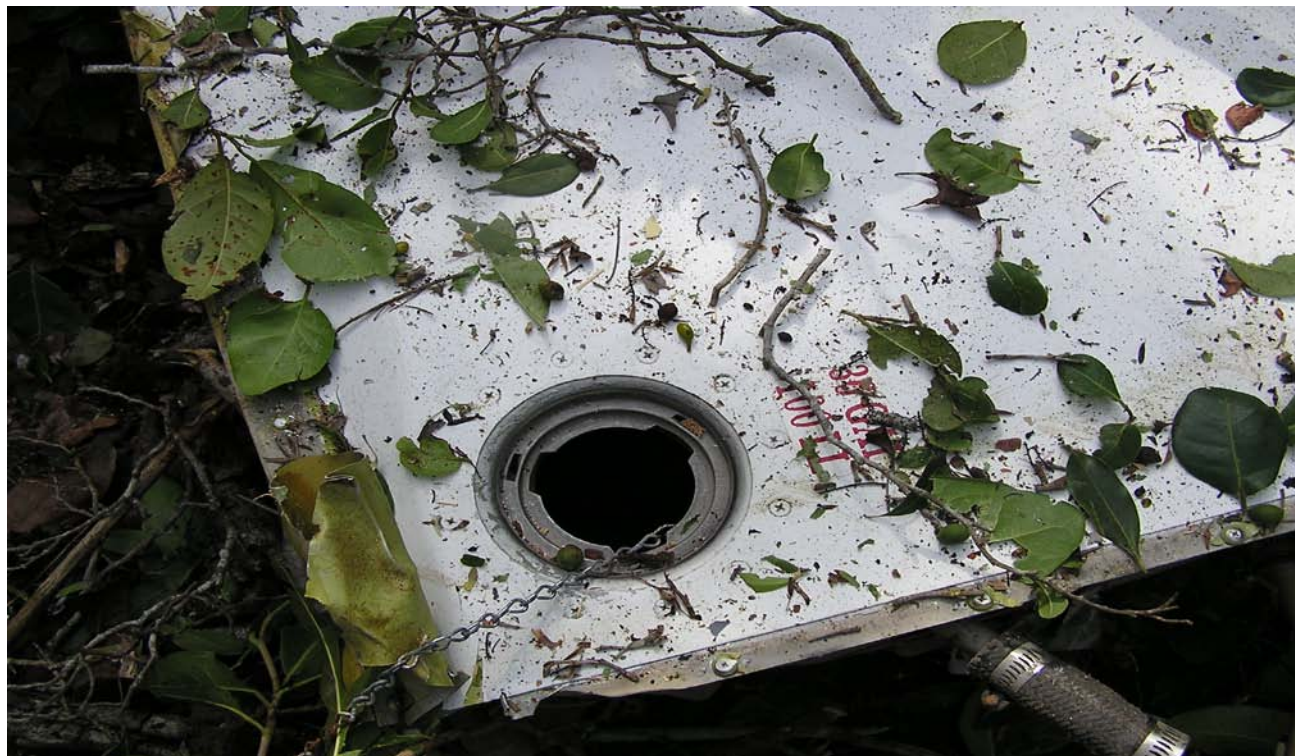
- Both fuel tank selectors, located between the pilot and copilot seat were found selected to the outboard fuel tank positions.
- Upon further visual inspection, both outboard fuel tanks were found empty.

Photo of right outboard tank showing no fuel in tank.

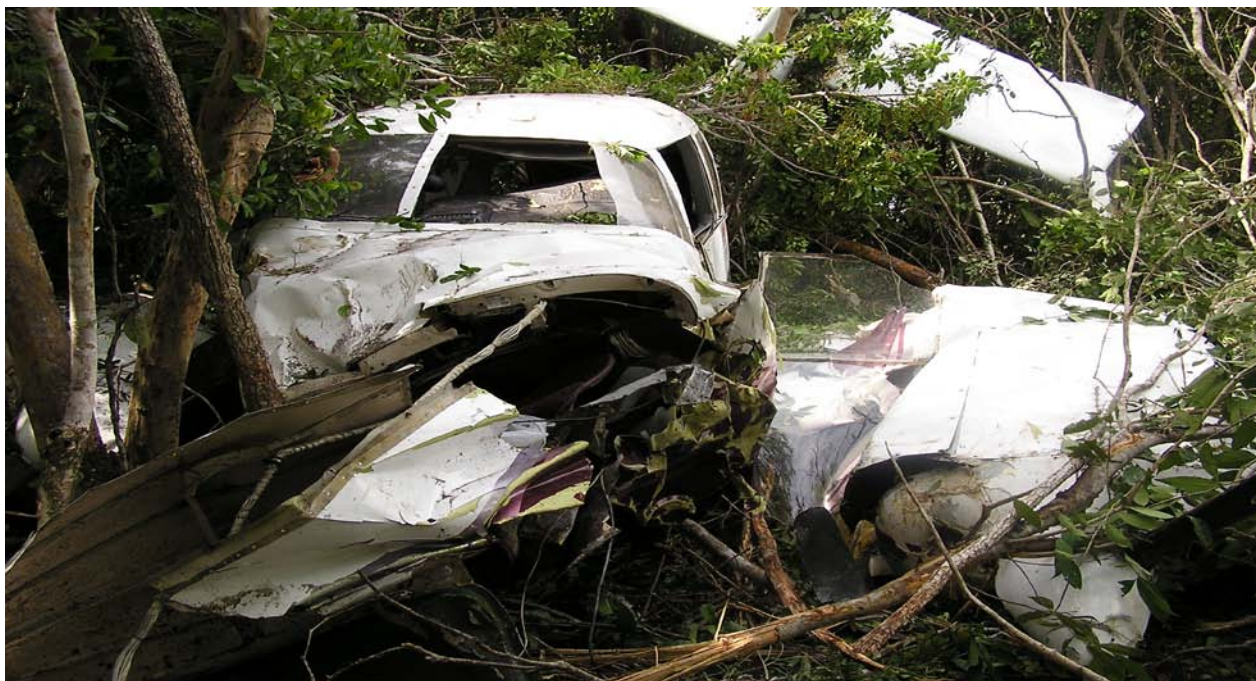
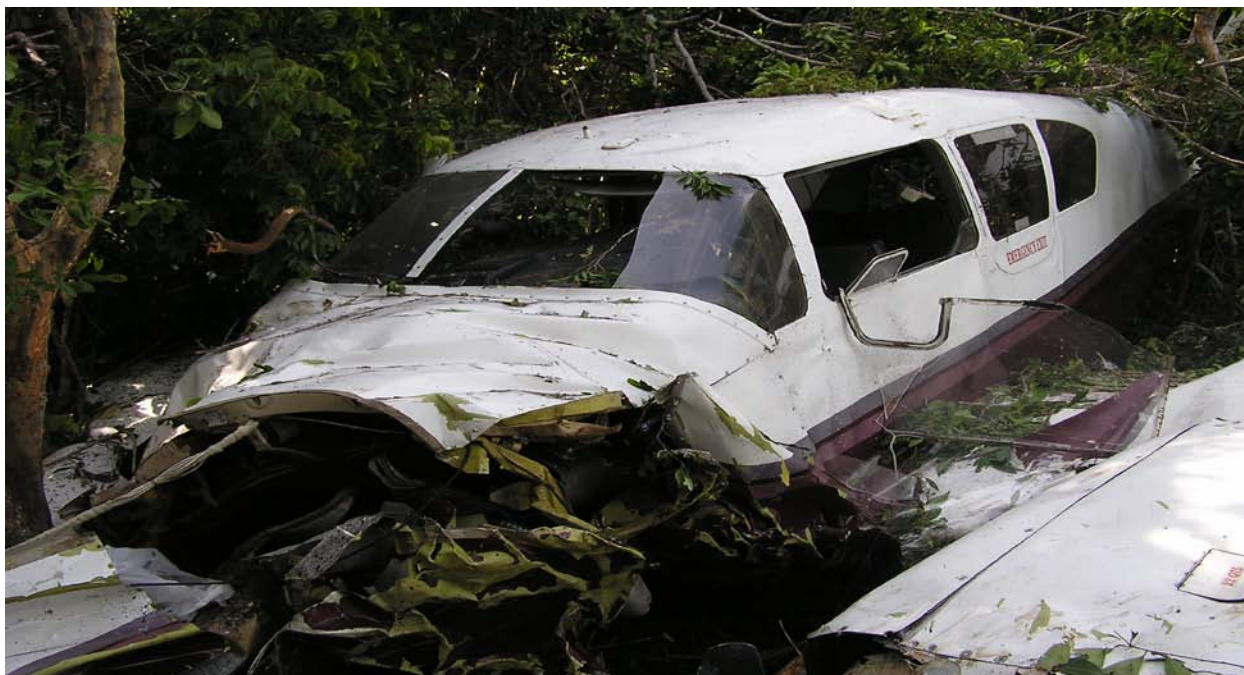
Photo showing extent of damage sustained by aircraft.
