# Aviation Short Investigation Final Report

Aircraft Ditching

Cessna 210L – N727TJ

**AAID Aviation Occurrence Investigation  
AO-17-002176**

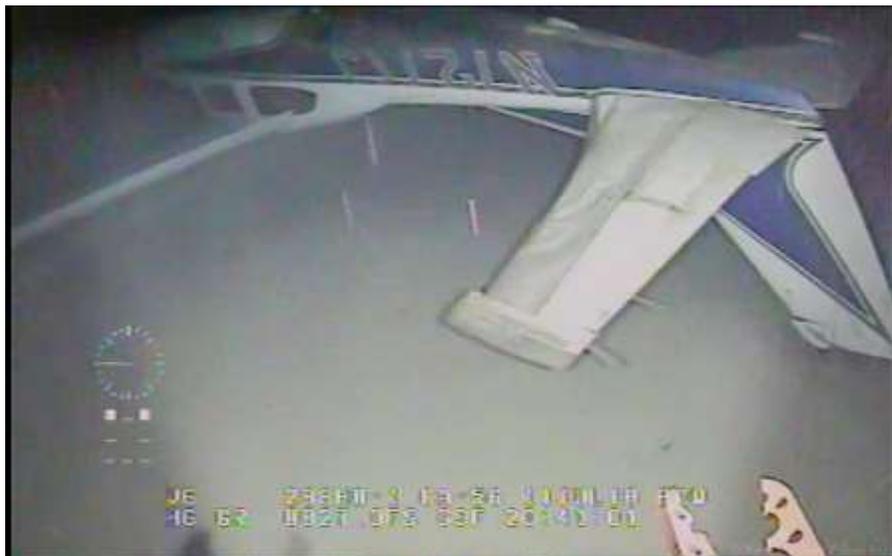
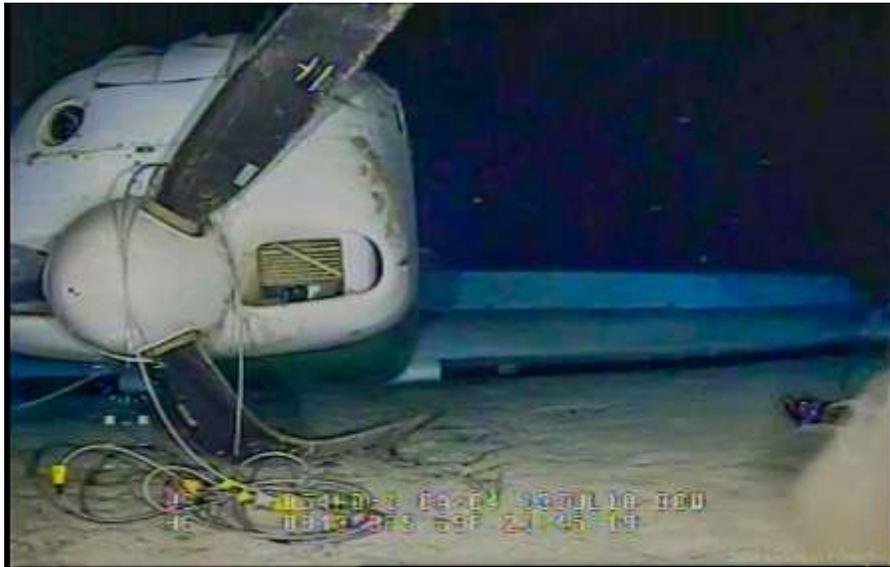
In the aftermath of the unsuccessful attempt to locate Cessna N727TJ, a private salvage and recovery mission was organized and launched between the 7<sup>th</sup>-10<sup>th</sup> July, 2018. With the aid of a submersible ROV (remote operated vehicle), the aircraft was located and positively identified on the 10<sup>th</sup> July, 2018 (see photos below). However, compounding factors made it unfeasible for the aircraft to be brought to the surface.
