AVIATION OCCURRENCE BULLETIN

DATE: 20TH MAY 2019
REPORT # AO-18-000026
AIRCRAFT REGISTRATION: N886TS
INVESTIGATION STATUS: COMPLETED

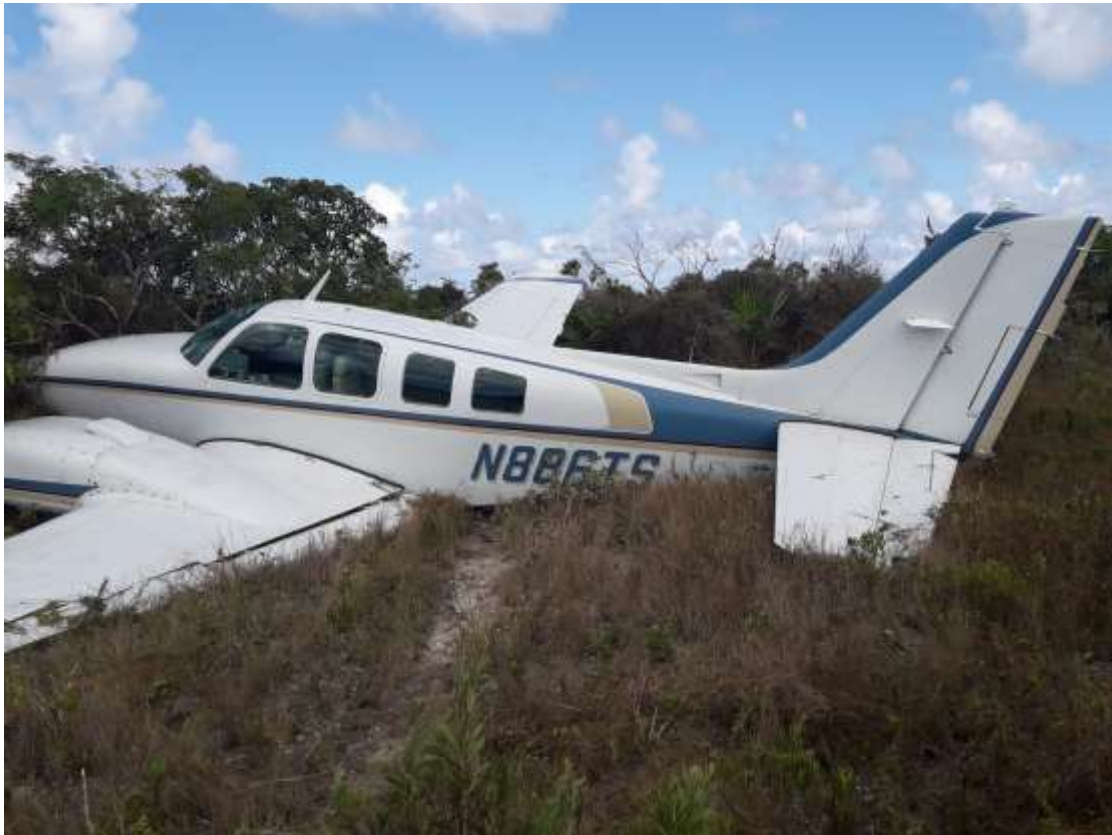
The pilot stated that he observed his landing gear indication lights all confirming gears down and locked. However, upon touchdown and during rolling out, the left main gear collapsed, leading to a loss of directional control. As a result of the gear collapse a runway excursion occurred with the aircraft coming to rest in bushes approximately 94 ft. from the runway's edge.

Significant damages to the left wing, both propellers and possibly engines, the nose and main gear, and lower fuselage of the aircraft were reported. No injuries were reported. The weather at the time of the accident was visual meteorological conditions and not a factor in this accident.
