## AIRCRAFT ACCIDENT REPORT

LOSS OF CONTROL DUE TO FUEL STARVATION

PIPER PA-23-250

**N20373**

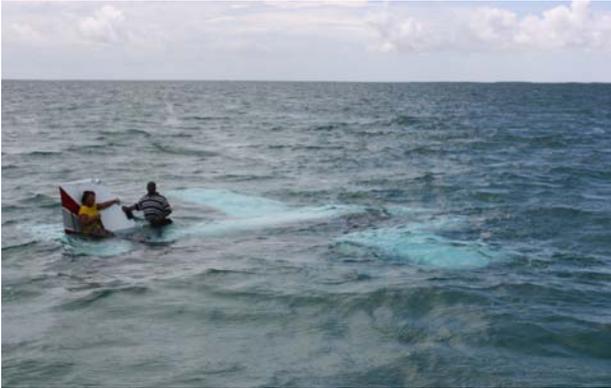
According to the pilot damage to the aircraft was minor. Extent of damage to the aircraft was not verified by the investigation team as the aircraft was inaccessible. Aircraft still remains submerged in waters where the accident occurred.

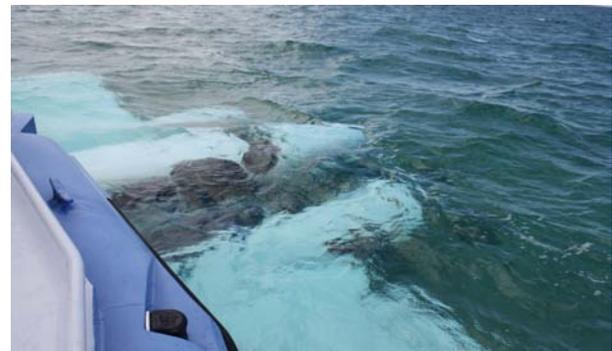
The airplane appeared to be intact post impact. The exact extent of damage is unknown as the investigation team did not visit the site due to the inaccessibility of the site

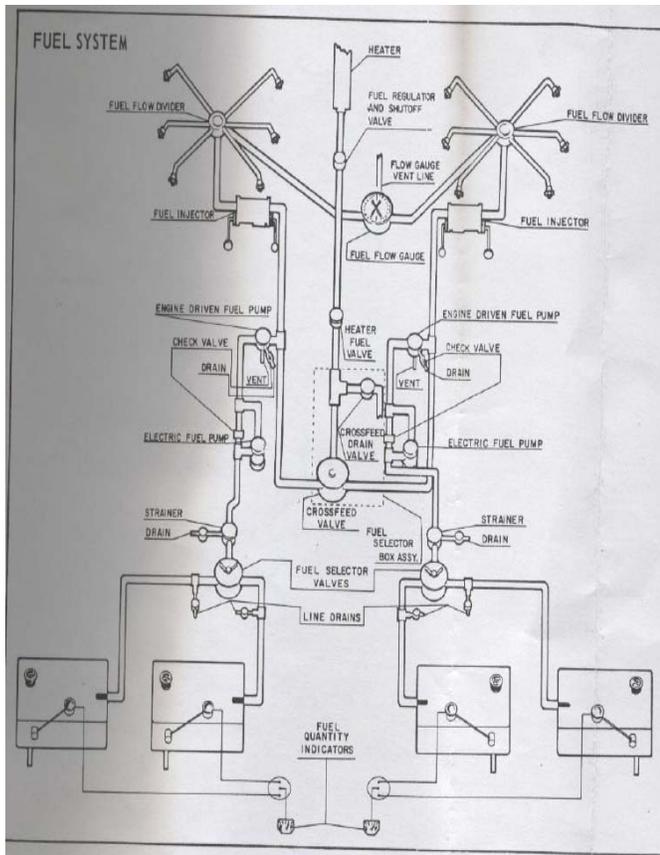
Based on the diagram, failure of the engine driven fuel pump on the left engine should not cause a complete failure of the left engine. The timely actions of the pilot could have prevented the failure had it been the fuel pump that failed.

The options available to the pilot was to turn on the electric fuel pump and should that not work, as a last resort, cross feed from the fuel tanks on the right side.

The cross feed procedure was not done by the pilot according to his admission during the interview. He stated that he turned on the electric pump and still the engine failed.

According to the Mr. Cambridge, his engine failure was as a result of failure of the electric pump. See information on the fuel system which follows.
