## **AIRCRAFT ACCIDENT REPORT AAID# AO-18-000027**

**Loss of Control Inflight and  
Uncontrolled Collision with Terrain (Ocean)**

**Piper Aztec PA-23-250  
N8383C**

**8<sup>th</sup> November, 2018**

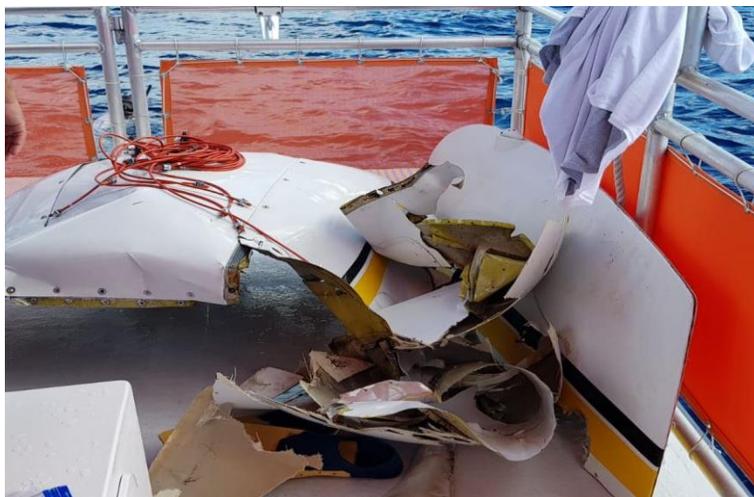
The extent of damage to the aircraft is unknown, as the aircraft was never recovered from the ocean for further analysis. However, parts of the left and right wingtips, engine cowlings and smaller miscellaneous pieces of the aircraft were recovered which confirmed the identity of the missing aircraft.

Damages to the recovered right wingtip appeared more substantial than that sustained by the left wingtip which would account for the right side of the aircraft sustaining the brunt / greater force of the initial impact during the crash sequence.

Both wingtips of the aircraft, and the left upper engine covering (cowling), and miscellaneous pieces that were detached during the crash sequence, were recovered. The right wingtip appeared heavily damaged, whilst the left wing tip appeared to have sustained minimal damage.

All of the damage noted to the recovered parts and components appeared to be attributable to impact forces. None of the flight control surfaces and major structural components was recovered.
