Short Investigation Bulletin

DATE: February 28, 2020
REPORT # AO-19-000062
AIRCRAFT REGISTRATION: C6-FER
INVESTIGATION STATUS: Completed

On the 1st December 2019 at approximately 8:45 AM, a Beechcraft 99 aircraft, registration C6-FER, operated by AOC holder Flamingo Air Ltd., while landing, the right main wheels of the aircraft made contact with an unusable portion of runway 11 at Black Point Airport (MYEB), Exuma, Bahamas that led to the collapse of the right main gear and subsequent runway excursion.

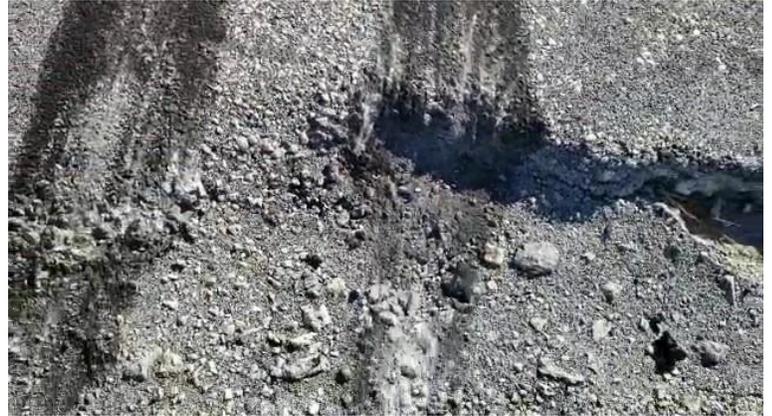
On touchdown on the area preceding the usable portion of runway 11 at MYEB, the right main gear entered an area with depth approximately 1-3 inches in depth subsequently striking an exposed section of asphalt (46 mm thick) on the unusable portion of the beginning of the runway.

Given the speed of the aircraft at the time of the touch down the right main landing gear collapsed after striking the exposed surface. The disabled aircraft traveled an additional distance of approximately 1,527 ft down the runway before exiting the runway and coming to a stop approximately 20 feet in bushes lining the side of the runway.

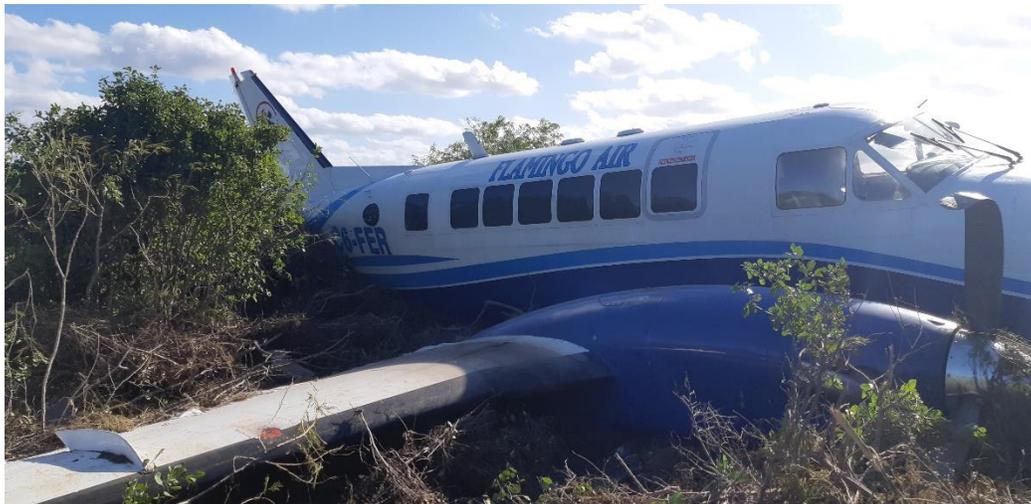
The aircraft sustained damages to the right wing, trailing and leading edges, right propeller, right main gear and fuselage. There were no injuries reported. The weather at the time of the accident was visual meteorological conditions and not a factor in this occurrence.

In the aftermath of this accident, the Bahamas Civil Aviation Authority (BCAA) took immediate action by suspending both crew members until an evaluation of airmen competency could be completed. Both crew members were assessed by the BCAA in commercial flight procedures with an emphasis on standard operating procedures for landing and after demonstrating proficiency were allowed to resume flight duties.
