AVIATION OCCURRENCE BULLETIN

DATE: 20TH AUGUST 2019
REPORT # AO-19-000056
AIRCRAFT REGISTRATION: C6-EDH
INVESTIGATION STATUS: COMPLETED

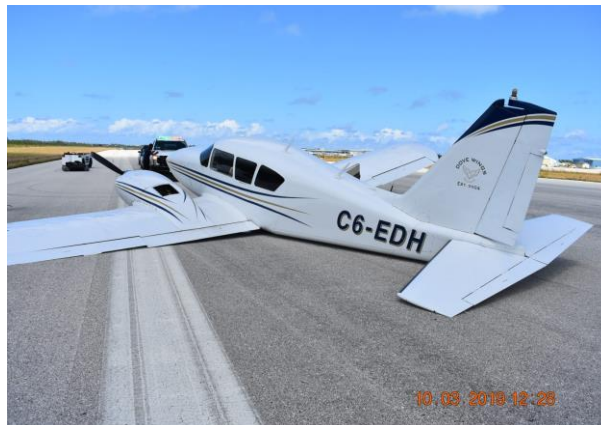
After landing on runway 32, despite use of the emergency blown down bottle system the left landing gear still collapsed. The aircraft slid and veered left of the center line coming to rest near the edge of the runway. Damages documented as a result of the gear collapse includes (left upper and lower wing damages, left gear doors and wheel wells).

The weather at the time of the accident was visual meteorological conditions and not a factor in this accident. A limited scope investigation was conducted, no safety message or recommendations were issued. It is worthy to note that during the preparation of removal of the aircraft from the runway, the right gear also collapsed resulting in additional damages to the right side of the aircraft.
