AIRCRAFT ACCIDENT REPORT

LOSS OF CONTROL

HUBER HARTMUT EXPRESS

N93HE

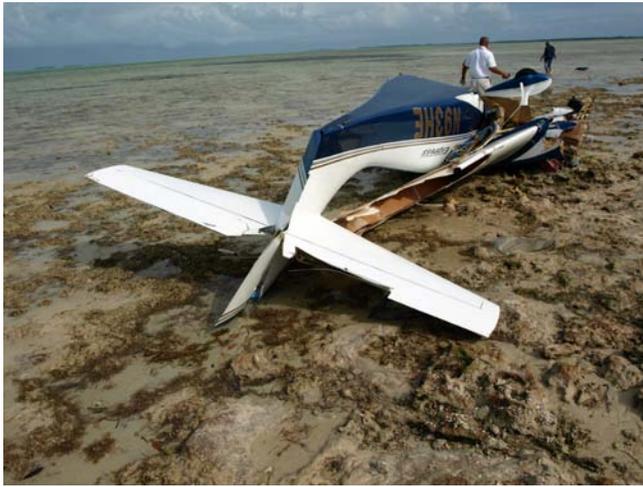
The fuselage was found upside down approximately 40 yards to the left of the location of the engine. The fuselage was partially separated in two pieces between the two forward and two rear rows of seats of the aircraft. The rear fuselage with empennage still attached was bent and twisted and came to rest on top of the left wing upside down. The left wing of the aircraft sustained significantly more damage than the right wing which is consistent with the left wing of the aircraft making first contact with the terrain.

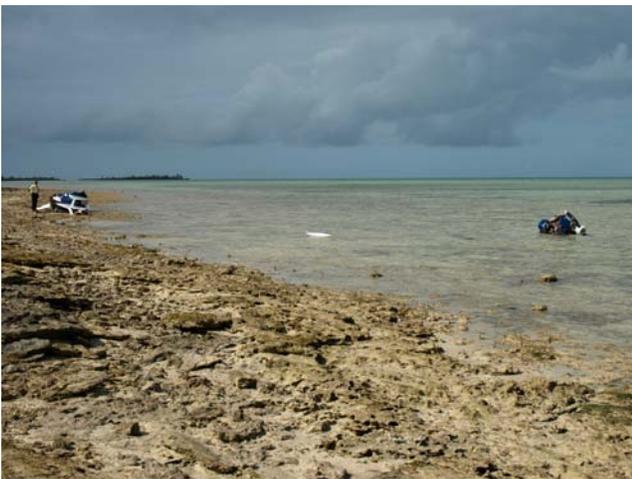
The fuselage was breached and segmented into three sections that consisted of the *forward cabin area, the engine and the rear fuselage.*

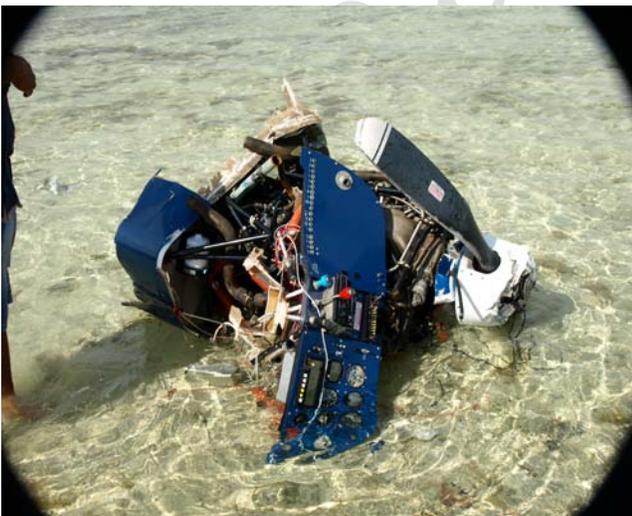
The engine was located with some firewall sections with portions of the engine mount attached; the nose gear was separated from the engine mount and displaced near the point of impact with the ground.

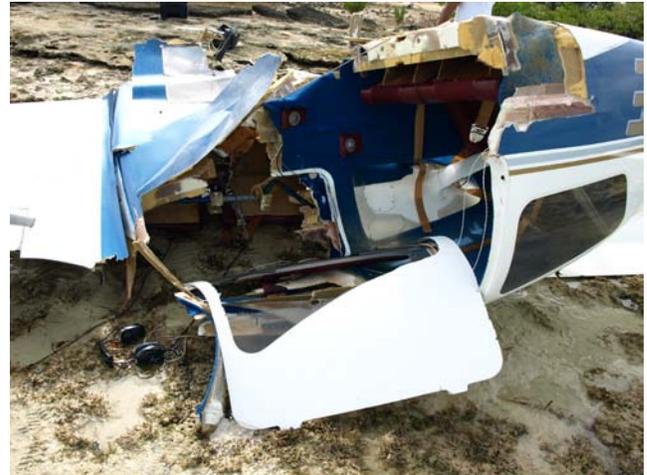
The forward section consisting of the instrument panel was still attached to the engine.

The center section and the aft tail cone section. The roof and side wall sections were breached upon impact.

Both sets of rudder pedals were viewable with impact damage noticeable.

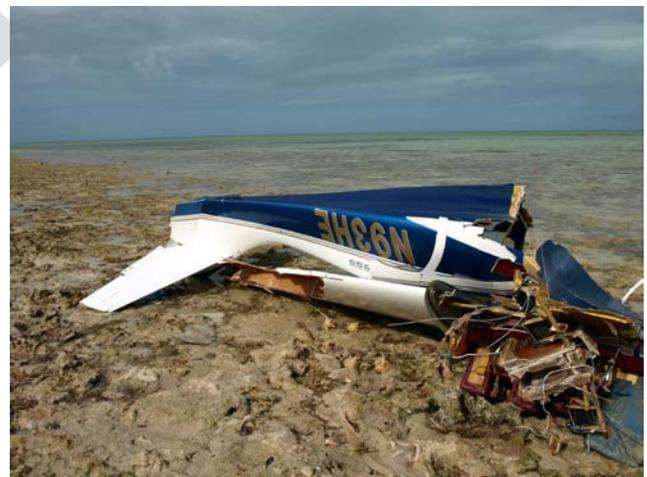
Crumpling of the fuselage, wing, vertical and horizontal stabilizer indicative of the aircraft making contact with the water, cart-wheeling and coming to rest in an inverted position.

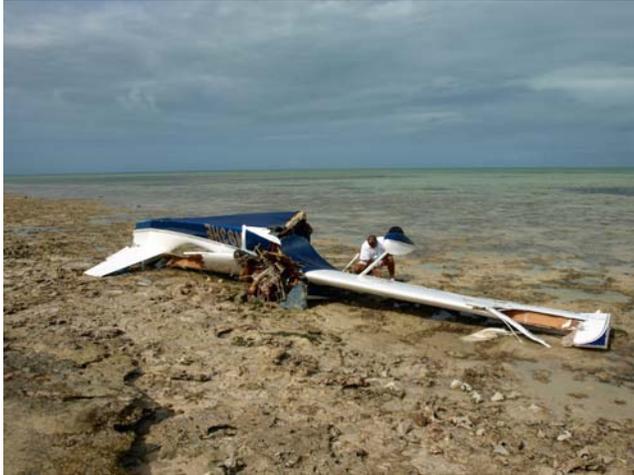
LEFT WING:

The left wing was separated from the fuselage wreckage at the root. It was separated from the wing structure and was breached. The wing leading edge was breached along the entire wing span.

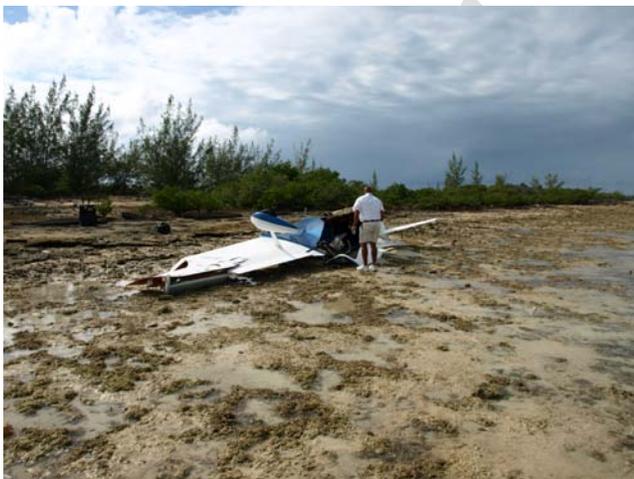
RIGHT WING:

The right wing was attached to the fuselage. The right aileron was accounted for. The outboard wing was breached.
