Aviation Short Investigation Final Report

Missing Aircraft

Cessna 150G, N3214X

AO-17-002172

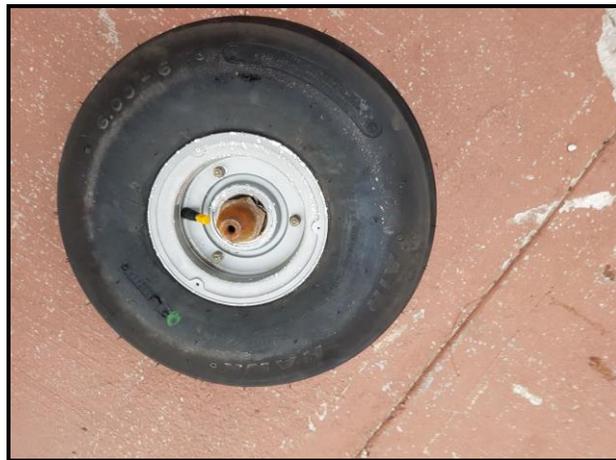
Photo 1 – N3214X Tire

On 29th November, 2017, a tire wheel assembly (**Photo 1**) that was later determined to belong to the aircraft was handed over to authorities after having being found by a local fisherman on the island of Grand Bahama. This tire was the only piece of the aircraft that has been identified to date.

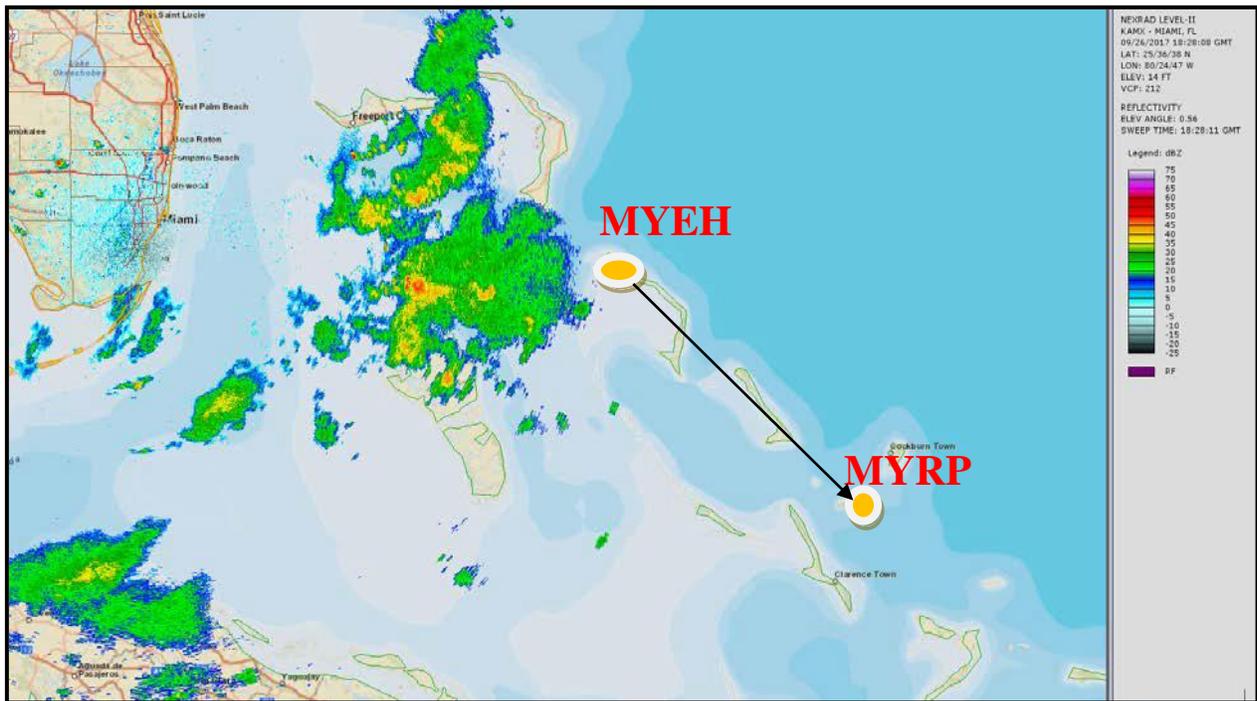
Figure 2 - KAMXWSR-88D reflectivity scan initiated at 1828 UTC

The observations from MYNN surrounding the accident time indicated MVFR to VFR conditions with thunderstorm activity.

The closest NWS Weather Surveillance Radar-1988, Doppler (WSR-88D) to the departure location was the Miami, Florida, radar (KAMX), located 202 miles west-northwest of the accident area at 13 ft.

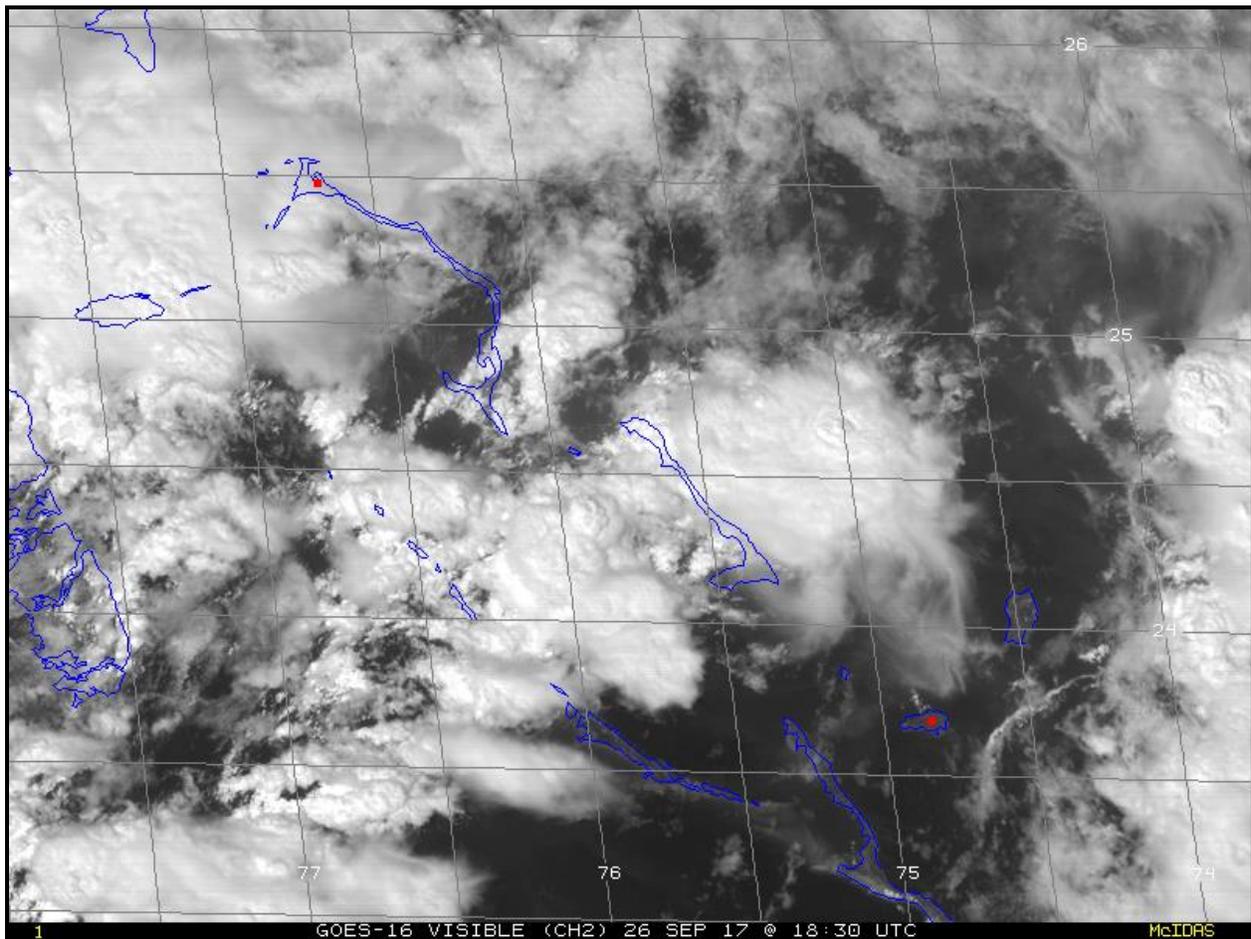
Figure 3 - GOES-16 visible image at 1830 UTC

Figure 3 below presents the GOES-16 visible imagery from 1830 at 2X magnification with MYEH (departure location) and MYRP (intended destination) highlighted with red squares. Inspection of the visible imagery indicated abundant cloud cover along the intended route of flight with several areas of cumulonimbus clouds in between MYEH and MYRP. The cumulonimbus clouds and thunderstorm activity were moving from southwest to northeast.
