AIRCRAFT ACCIDENT REPORT

GEAR UP LANDING

AERO COMMANDER

N504AP

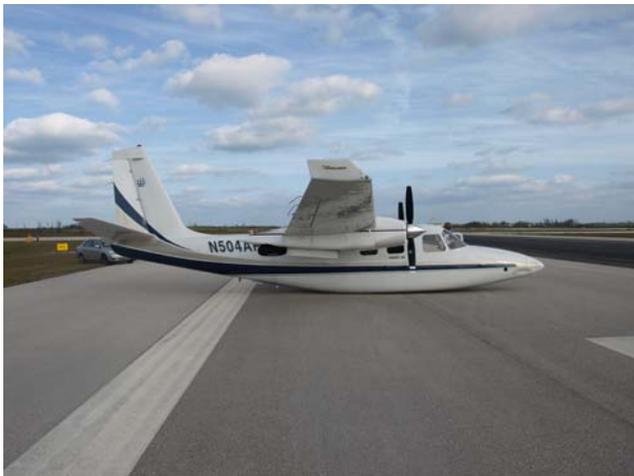
Major damages were limited to the left propeller, left engine and the underside of the fuselage aft of the cockpit, extending to the aft cabin bulkhead.

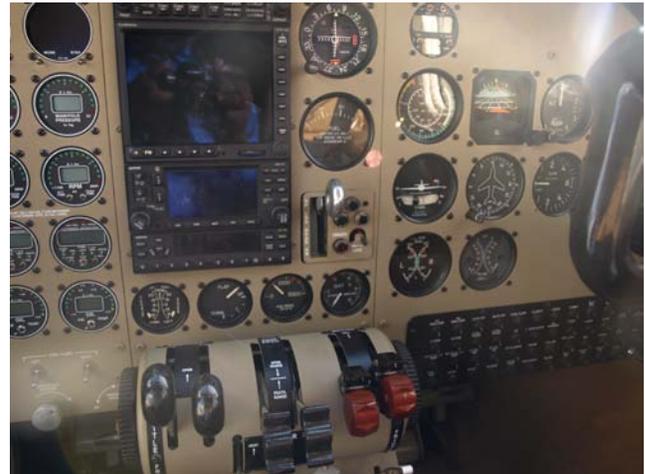
The aircraft sustained damages from impact. The left engine and propeller sustained impact damages from the propeller contact with the runway.

Indication in the cockpit showed the gear handle was not placed in the down position required for landing.

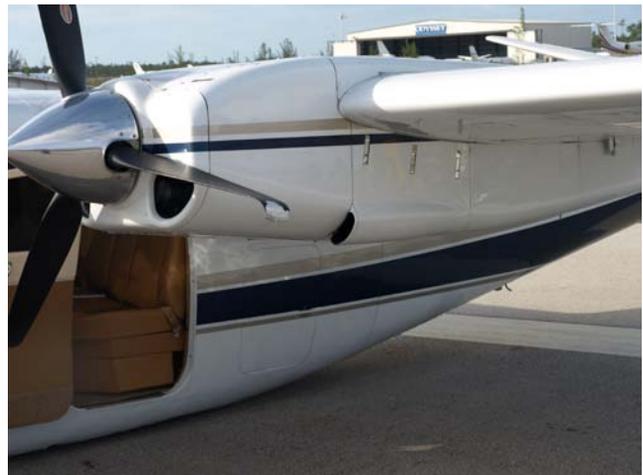
The aircraft sustained damages from impact. The left engine and propeller sustained impact damages from the propeller contact with the runway.

Damages were also sustained to the underside of the fuselage aft of the cockpit extending to the aft cabin bulkhead.

The probable cause of this accident has been determined as pilot distraction resulting in failure to extend landing gear.
