# **AIRCRAFT ACCIDENT REPORT**

**RUNWAY EXCURSION**

**SAAB 340B**

**C6-SBJ**

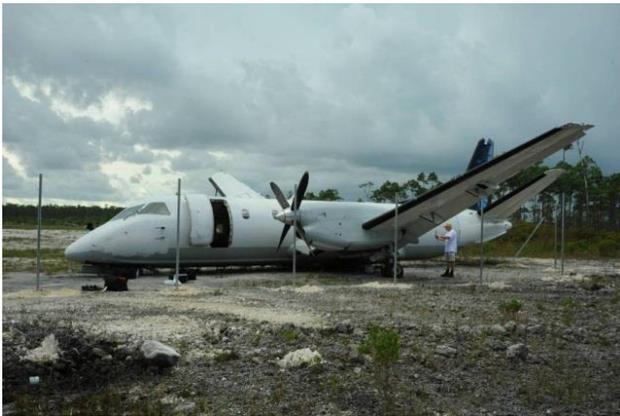
1. The nose landing gear (Cylinder, Rims/Wheel Steering mechanism devices) had collapsed and separated from the upper portion of the piston. The impact created a large deformed and punctured/torn area aft of the nose gear bay area. Nose gear well walls (L/H and R/H side) have been shear buckled and found to have numerous ripples.
2. Longitudinal beams located inside of the electrical compartment on both (L/H and R/H at BL 18.3) sides were locally cracked and deformed.
3. NLG landing doors severely damaged - distorted and deformed. The associated fittings were ruptured.
4. The attachments of the weather radar (inside the nose radome) were found to be broken (the lugs of the component).

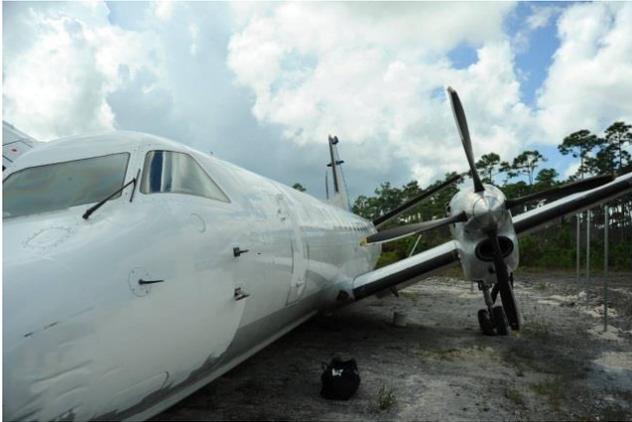
1. This wing was severely damaged, kinked and twisted. The main spars (forward and rear) were both completely broken at WS 42. However, the attachment fittings between the fuselage/wing were deemed to be intact.

2. The lower wing panel (between WS 42 and WS 120), area from attachment fittings to nacelle including stringers, were distorted, cracked and afflicted with large permanent settings.

5. The upper wing panels including the internal stringers sustained severe deformations and distortions at inboard part.
6. Some extensive tear in span wise direction was also noticed.

7. The inboard leading edge portion was ruptured and deformed at the inboard section as a result of the ground contact.
8. The lower trailing edge panel had some indications of high temperature, the paint was locally discolored and blistering paint was noticeable.
