AVIATION SHORT INVESTIGATION BULLETIN

REPORT # AO-17-002062

INVESTIGATION TITLE: C6-CAM INCIDENT

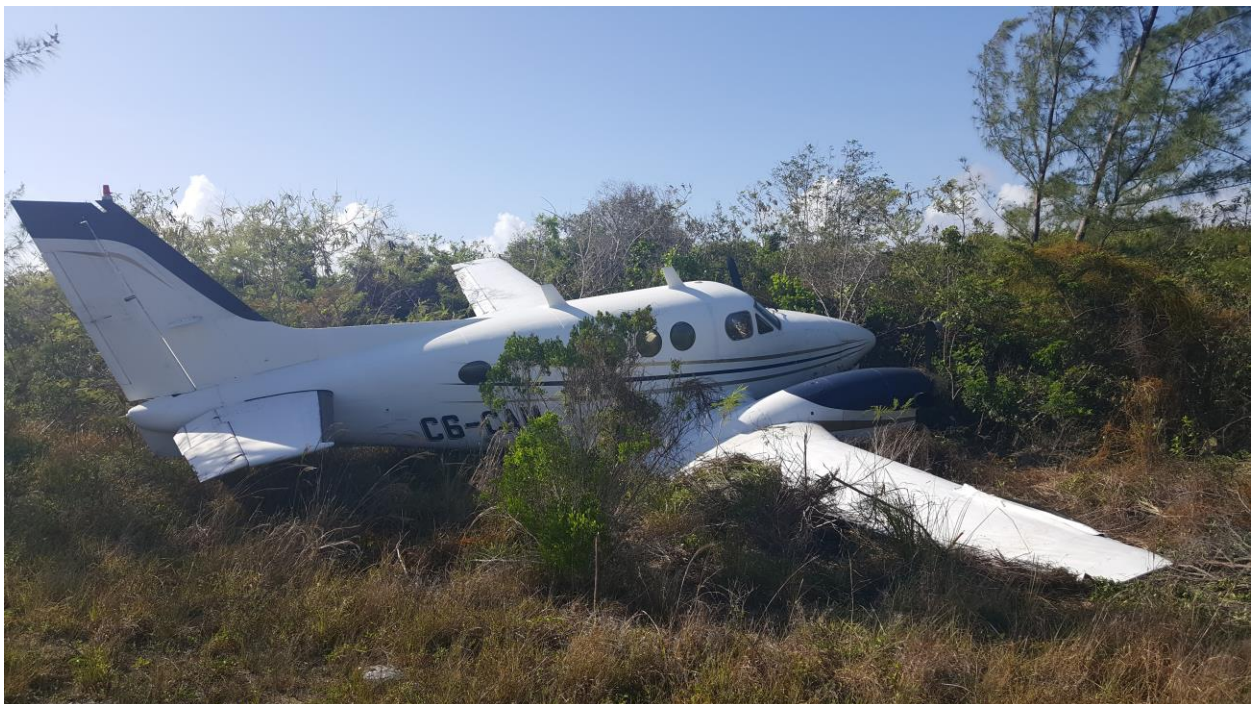
Upon landing at MYAB, the pilot loss control of the aircraft after the right wing dropped while on landing roll-out. Brakes and full left rudder was applied as an attempt to regain control but was unsuccessful. Subsequently the pilot executed emergency procedures shutting down both engines as well as fuel and electrical items. The aircraft veered to the right of RWY 09 and came to rest in bushes some 101 ft. from the side of the runway.

The two pilots, who were the only souls on board, immediately evacuated the aircraft. Upon further analysis, the right main gear (still attached to strut) was discovered on RWY 09 some 451 ft. from where the aircraft came to rest.

There were no injuries to the two souls on board, the aircraft did however receive damages.
