FINAL REPORT DRAG LINK BRACE FAILURE

**Western Air Limited
Fairchild Aircraft (SA-227)
C6-REX
Nassau New Providence Bahamas
May 6, 2005**

Report A0516317

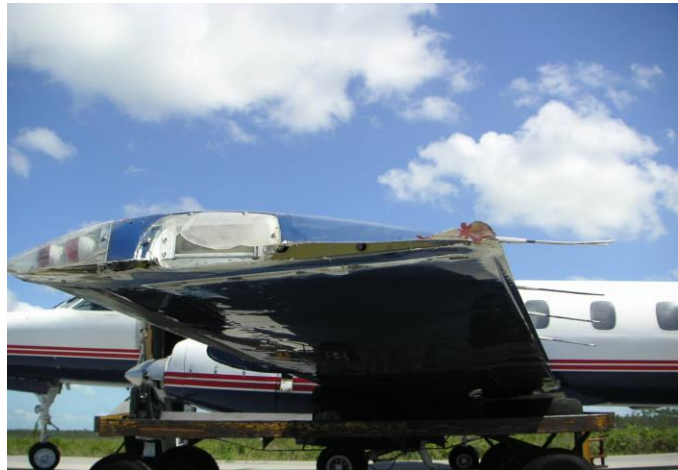
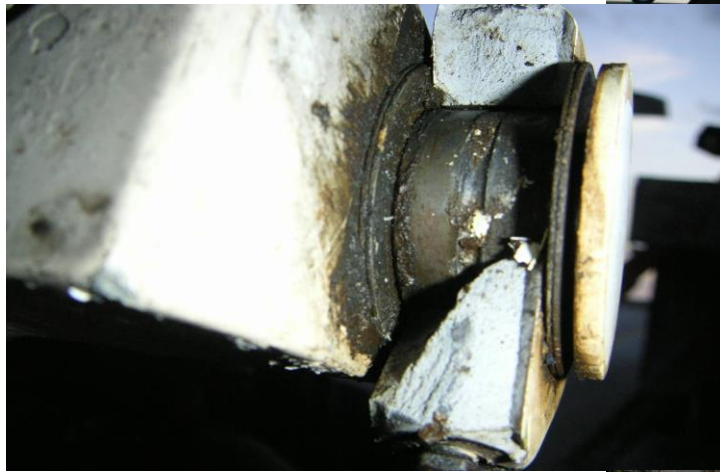
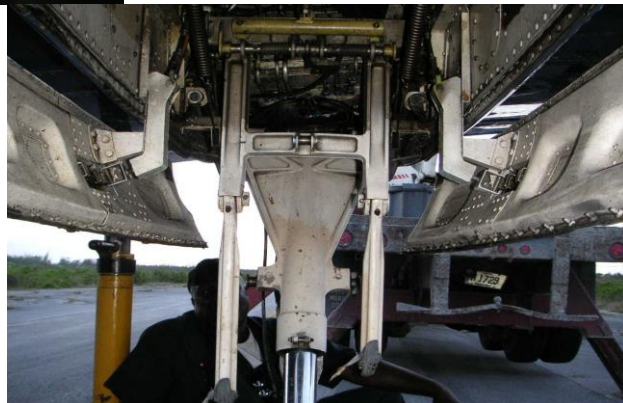
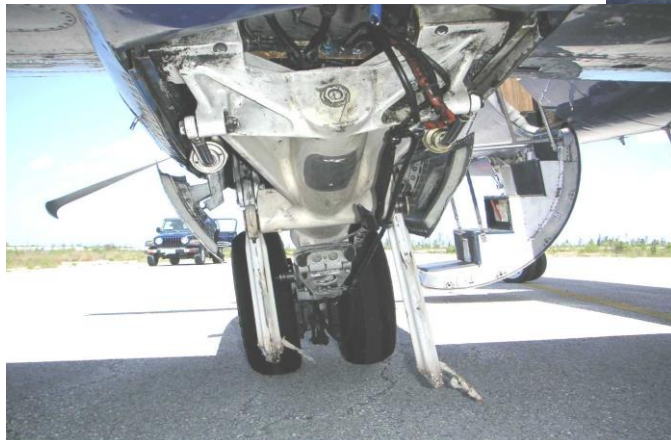
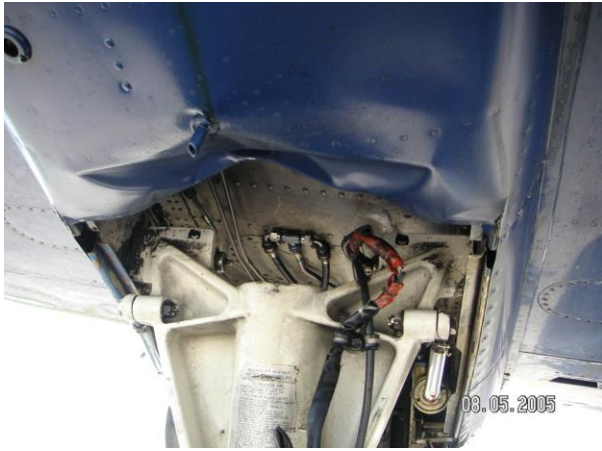
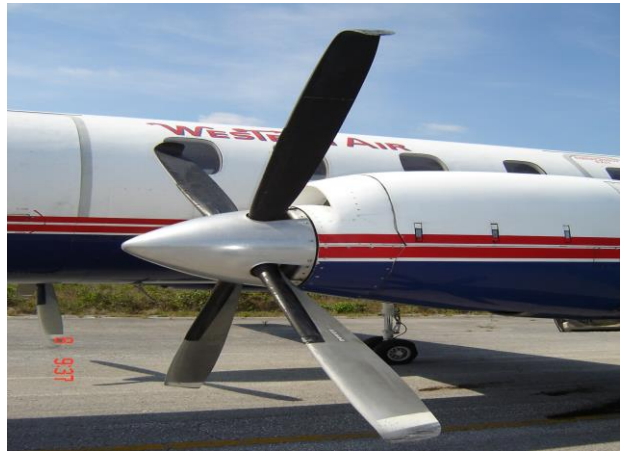
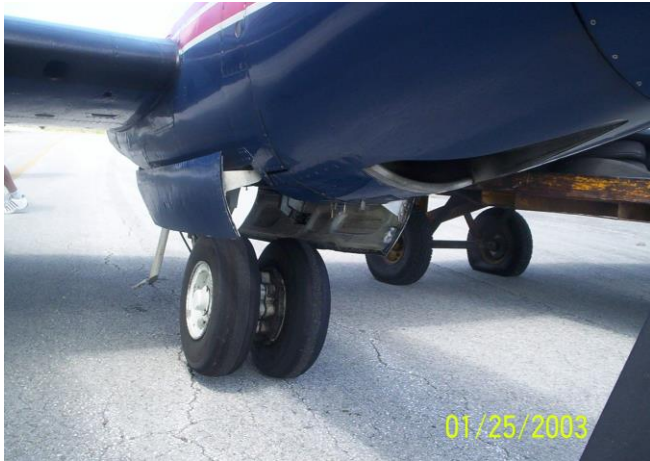
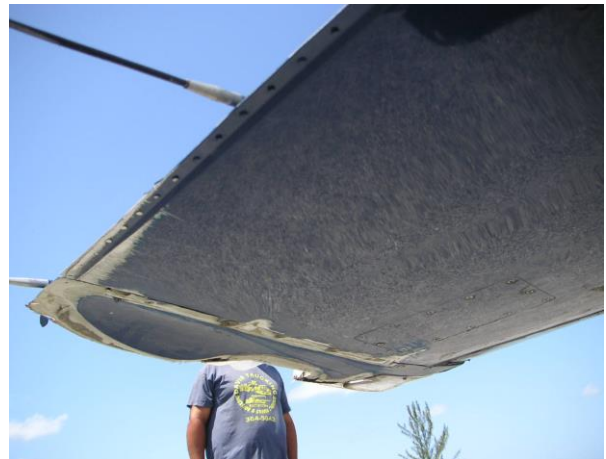
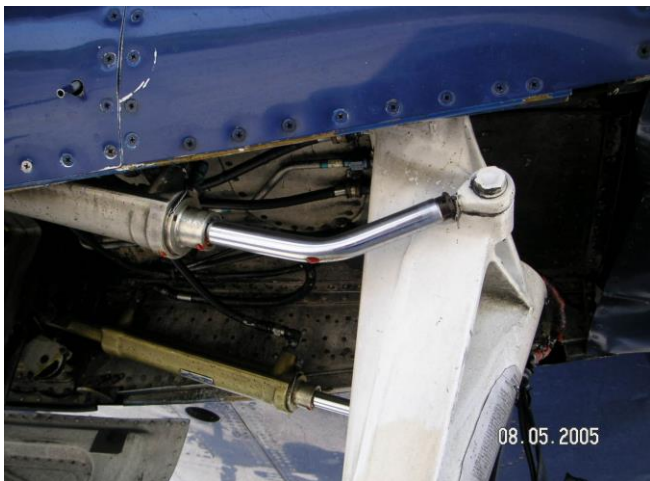
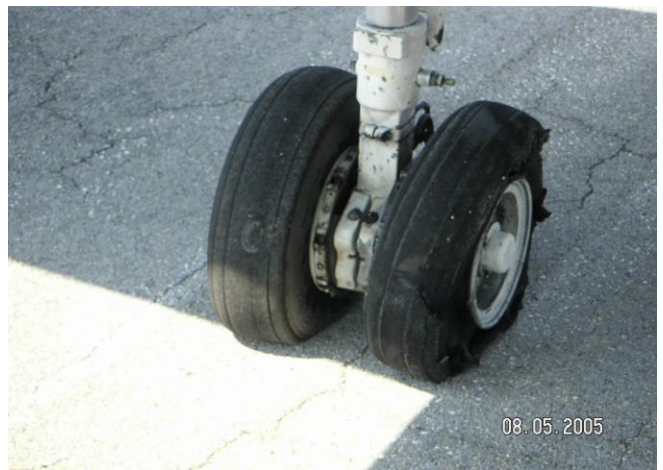
The aircraft came to rest upright. The underside of the left wingtip, the left propeller, the bottom of the left aft engine nacelle, and the left main gear, bore the main impact of the collapse. The right main gear tires also sustain damage. The fuselage remained intact. The cockpit and empennage were intact. The horizontal stabilizer and elevators had no visible impact or post impact damage. The vertical fin and rudder had no visible impact or post impact damage. There was no post impact fire.

8. Left gear drag brace failure occurred at San Andros International Airport. This fact evident by the recovery of portions of the left landing gear drags brace at San Andros.

Failure of the left main drag brace.

1. Random inspection of Western Air Limited Flight Preparation Records.
2. Fleet wide maintenance inspection of the gear link drag brace instituted immediately at Western Air Limited.
*(Western Air Limited has been proactive and has already inspected the fleet to determine if there was any other cracked MLG link drag brace. Further, Western Air Limited has replaced any cracked components discovered as a result of their investigations.) See Exhibit – FSI2.
The Flight Standard Inspectorate has on record the aircrafts that were affected and the repairs that were carried out.*

4. Due to the high number of cycles verses the number of flight hours flown, the times interval between inspections of main landing gear drag brace shall be reduced from 1,000hours to 500hours.
