AIRCRAFT ACCIDENT REPORT

LOSS OF CONTROL

DASSAULT SUD FAN JET FALCON
N28RK

MATTHEW TOWN, INAGUA, BAHAMAS
DECEMBER 17, 2009

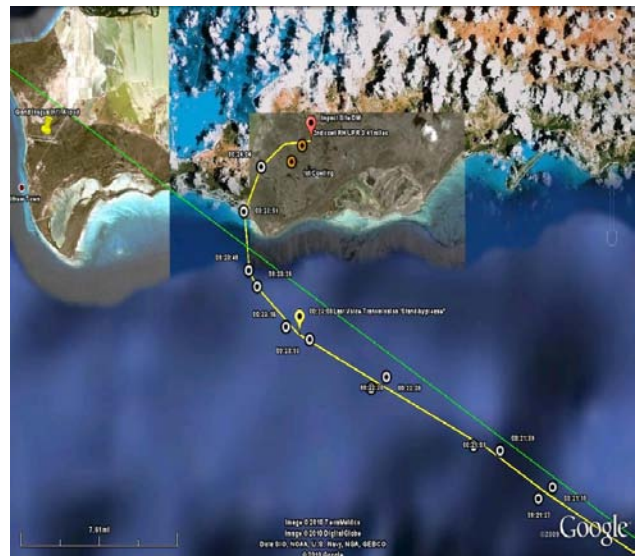
The accident occurred approximately 6 mile off the filed flight path.

Figure 3 Aircraft Tracking based on radio communication

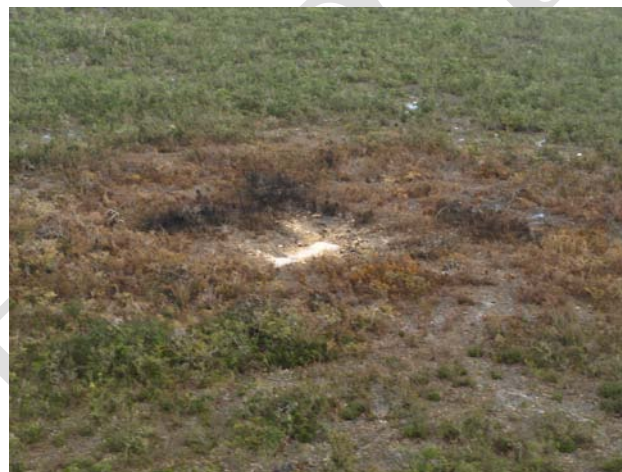
Figure 6 Post impact fire in National Park

Post impact fire destroyed approximately 5 acre section of the National Park. No other damage was reported.

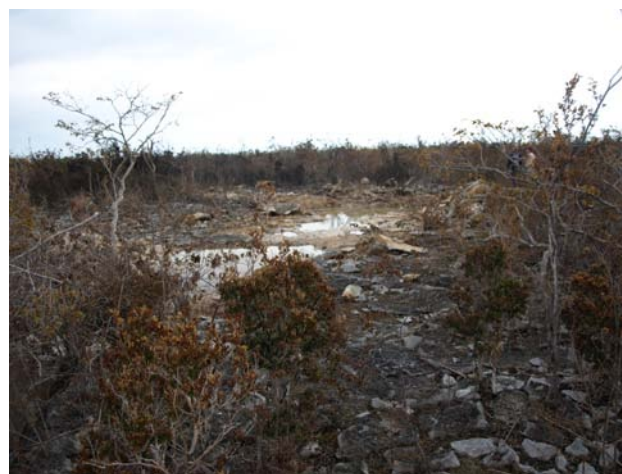
Figure 7 - Point of Impact, heading determined to be approximately 105 degrees at point of contact with terrain.

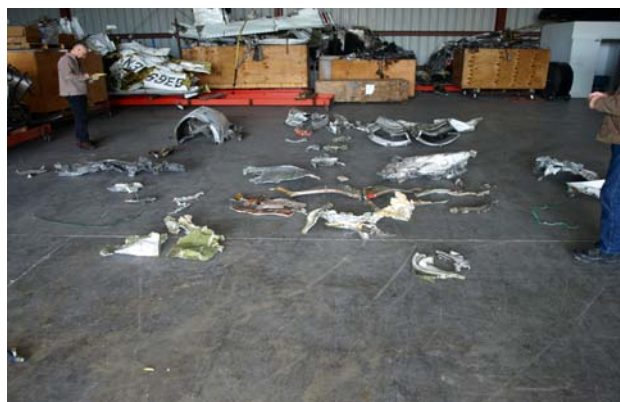
condition prior to ground impact. Less than 10% of the aircraft was recovered.

Figure 8 - Parts on the hanger floor represents the total recovered parts of the aircraft.

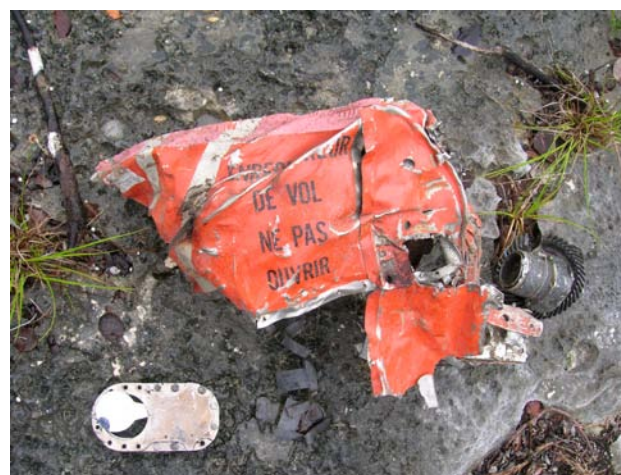
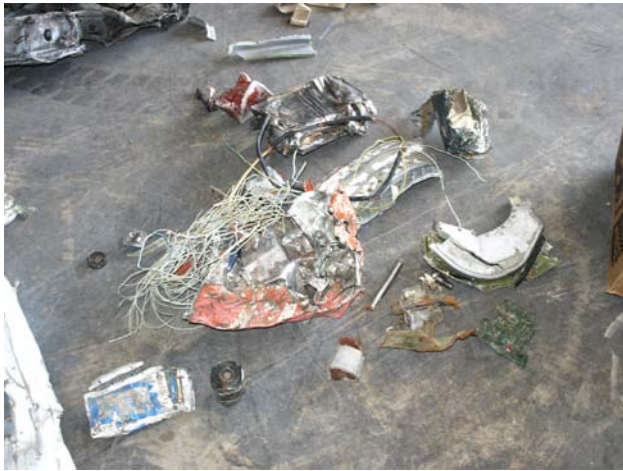
Successive searches of the area did not locate the internal parts of the CVR. The housing of the CVR was recovered; however the internal components were never recovered. Photo following showed the extent of damage sustained by the CVR.

Figure 9 and 10. Actual CVR case recovered from N28RK. Case was destroyed internal parts and recorder never recovered.

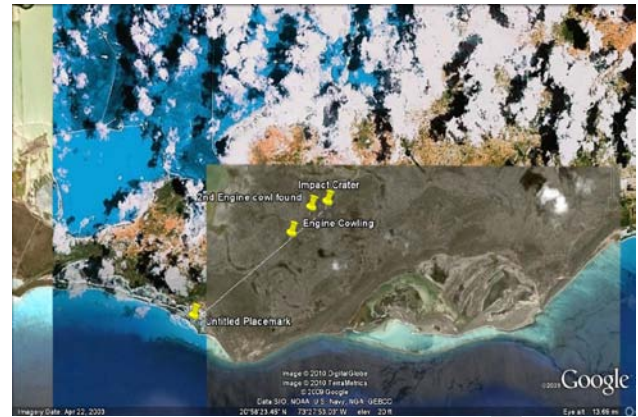
Three engine nacelle cowlings were found before the main impact site, below the flight path of the airplane from radar tracking. One was the upper cowling from the right nacelle, found .4 miles west of the crash site. The other two were lower cowlings from the left nacelle which were found 1.2 miles west southwest of the crash site.

Figure 11 view showing aircraft break up and parts found from the ocean to the crash site.

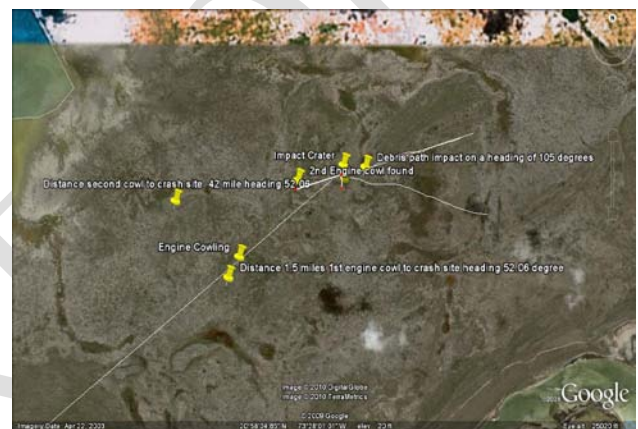
Figure 12 view showing location of 1st and 2nd cowling found in relations to the impact and debris field

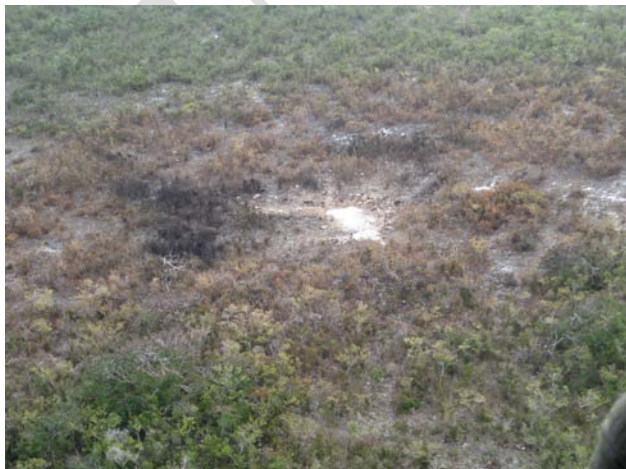
Approximately 5 acres of the national park was destroyed by the fire. Parts of the aircraft including personal effect, aircraft parts and furnishing, seat and seat cushions were also destroyed in the post impact fire.

Figure 13 show results of fire from explosion and burning that followed.
