AVIATION OCCURRENCE BULLETIN

DATE: 28 JUNE, 2019
REPORT # AO-18-000008
AIRCRAFT REGISTRATION: N802CS
INVESTIGATION STATUS: COMPLETED

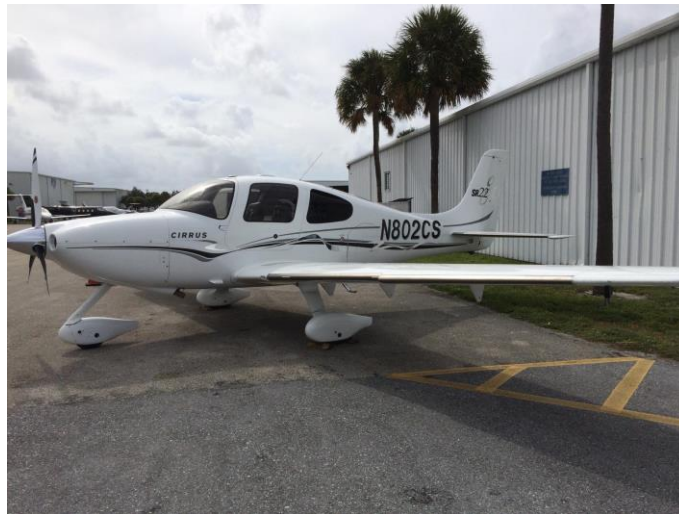
The pilot stated that upon landing, there was a blow out of the left main tire which resulted in a loss of directional control and the subsequent runway excursion.
