AIRCRAFT ACCIDENT REPORT

SUDDEN ENGINE STOPPAGE

PIPER WARRIOR PA-28-151

N444HA

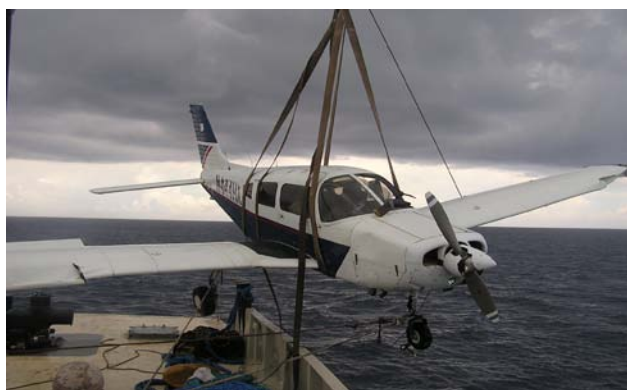
Damage to Wing tips

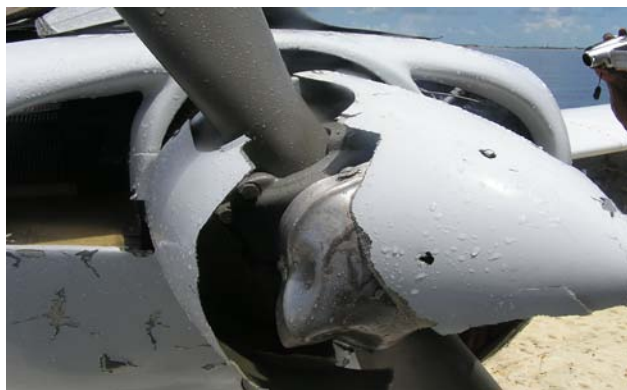
Damage sustained by the propeller dome.

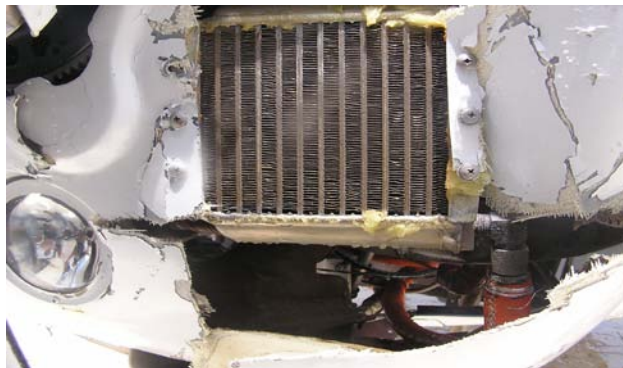
Damage sustained by the lower engine cowling

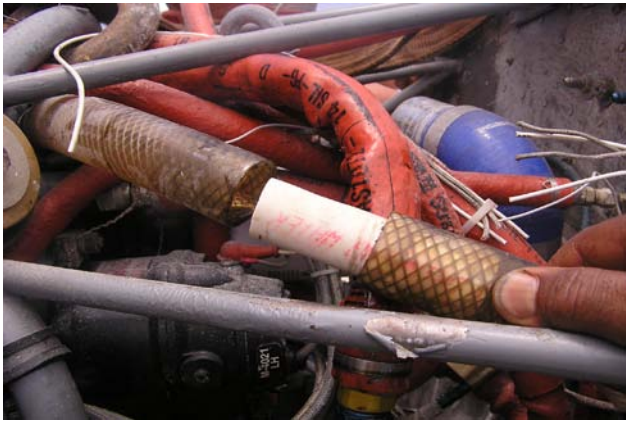
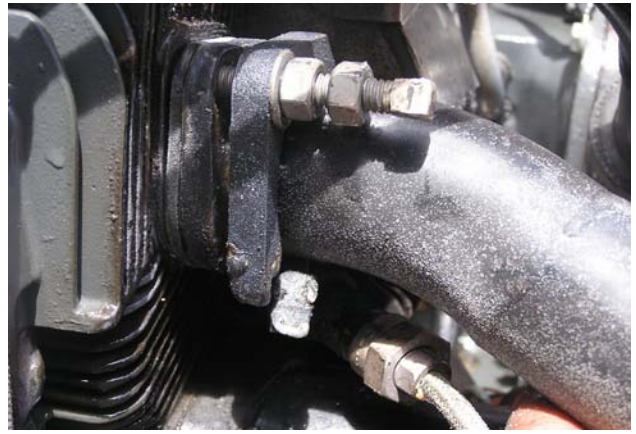
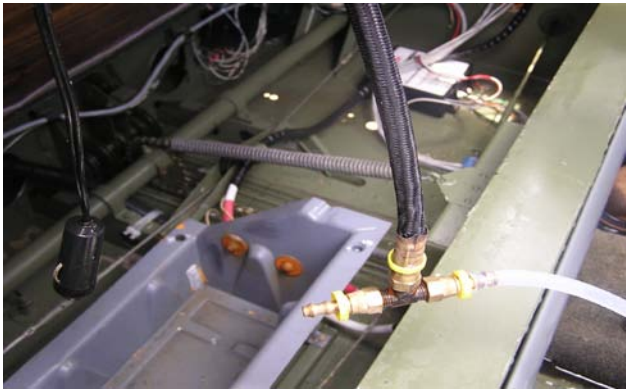
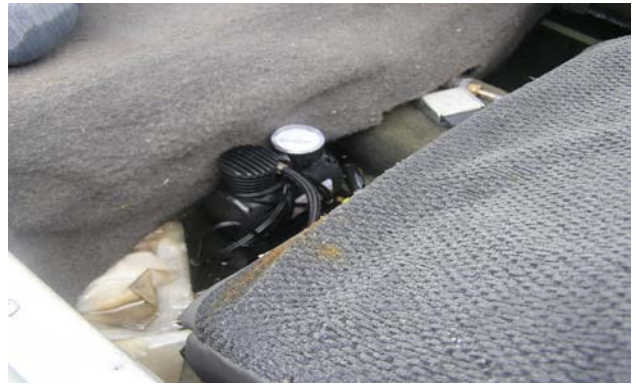
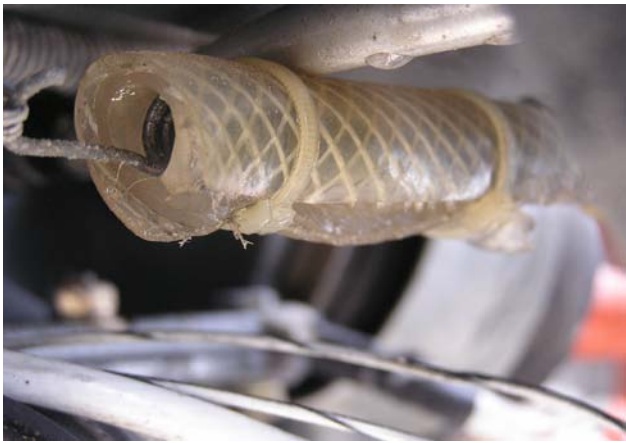
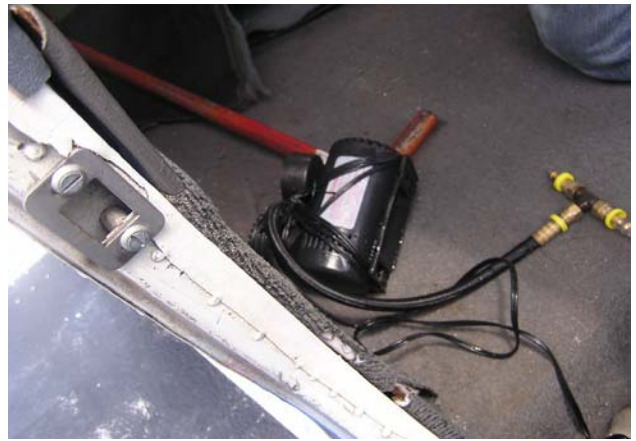
Closer inspections of the aircraft by the Investigation authority revealed several modifications were made to the aircraft fuel systems and wrong hardware used on the exhaust system without the proper paperwork being supplied to justify the modifications. The unapproved modifications were reported to the Federal Aviation Administration for further investigation.
