Short Investigation Bulletin

DATE: February 28, 2020
REPORT # AO-20-000007
AIRCRAFT REGISTRATION: C6-FLA
INVESTIGATION STATUS: COMPLETED

| Aircraft Type and Registration: | Cessna 402-C; C6-FLA |

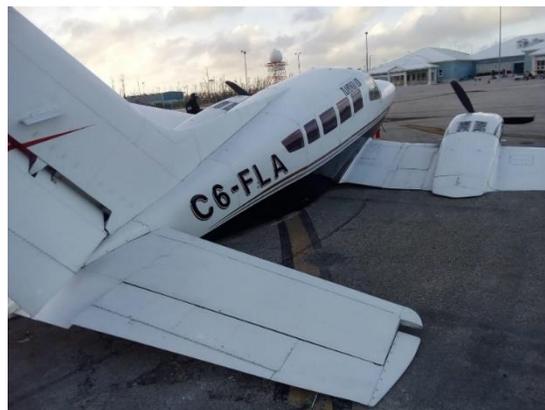
According to the pilot, the flight enroute was uneventful and after a successful landing, and while taxiing on Taxiway Bravo enroute to the ramp area, the aircraft fell into one of several ‘potholes’ that littered the movement area resulting in the main gear collapsing.

As a result of the gear collapse, the aircraft received damages to its right trailing edge, right propeller and engine, right landing gear door and underneath right side of the fuselage. No injuries were reported. The weather at the time of the accident was visual meteorological conditions and not a factor in this occurrence.

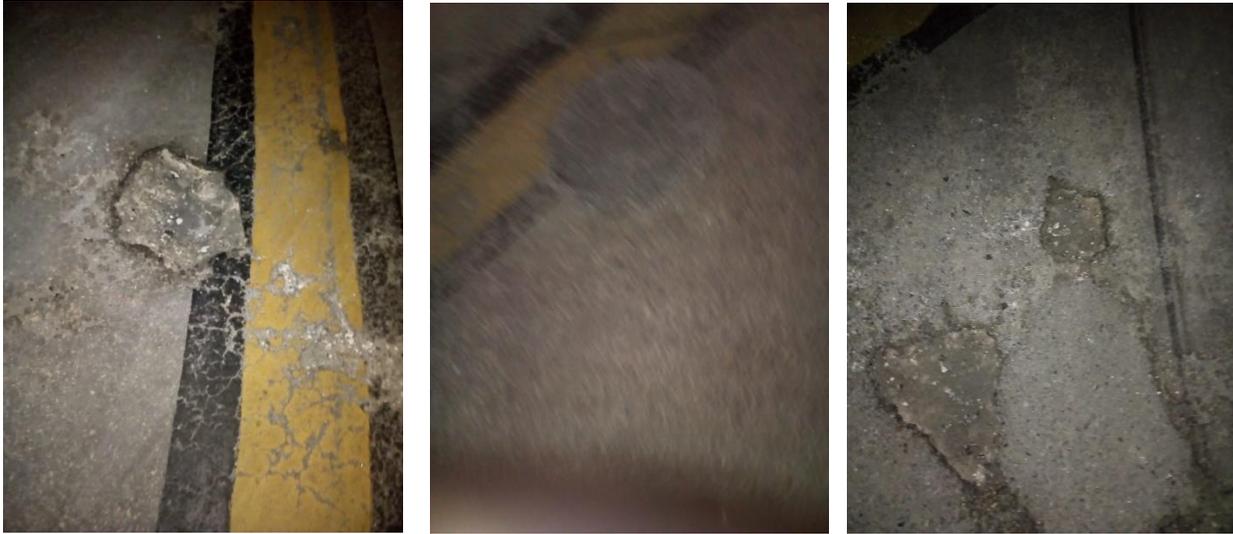
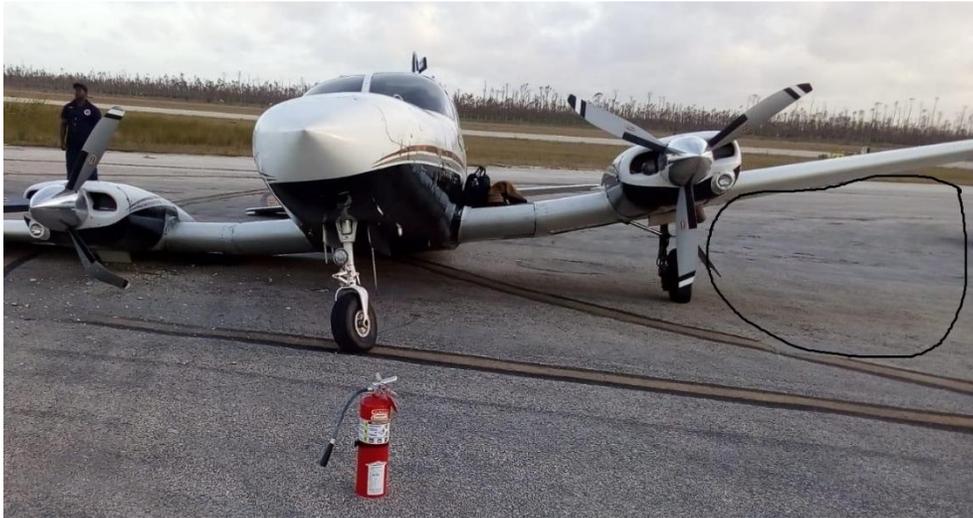
As a result of the investigation into this occurrence, the AAIA identified the state of the taxiway as a serious safety hazard because of the various potholes of varying size and depth that poses a potential danger to any aircraft unfortunate to fall in any.

Area in circle and under left wing shows series of pothole on taxiway

- The BCAA have advised they were liaising with FIAD on status of works to correct the hazards.
- FIAD also advised they were coordinating efforts with the Ministry of Works for resurfacing of the area.
- No immediate action to address the hazards were provided by the BCAA nor the FIAD.
