## AVIATION OCCURRENCE BULLETIN

**DATE:** 6<sup>TH</sup> FEBRUARY, 2020  
**REPORT #** AO-20-000006  
**AIRCRAFT REGISTRATION:** N798JS  
**INVESTIGATION STATUS:** COMPLETED

Aircraft details	
<b>Aircraft Type and Registration:</b>	Cessna 560, N798JS
<b>Year of Manufacture &amp; Serial #:</b>	2008; 500-0796
<b>Number and Type of Engine(s)</b>	Two (2), Pratt & Whitney
<b>Type of operation:</b>	On Demand Charter
<b>Information Source:</b>	AAID Field Investigation
<b>Nature of Damage:</b>	Fire/heat damage to both main gear tires, right main

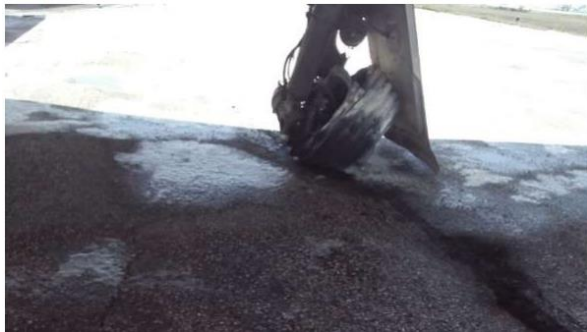
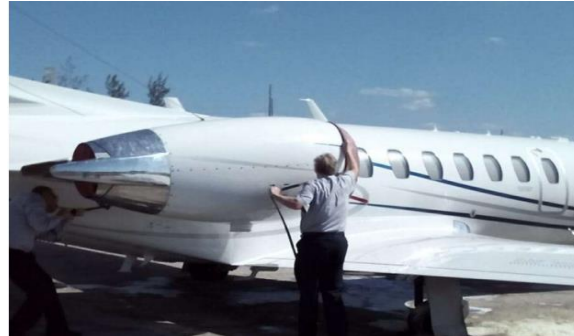
The Captain then called for the evacuation of passengers by the first officer while he shut the engine down. The Eleuthera Airport Fire Rescue services responded and upon arrival met the right main landing gear tire on fire. The fire was suppressed and there were no reported injuries. The aircraft received fire related damages to the right main gear assembly, right main gear door, and underside of the right wing.
