C6-JTJ Preliminary Occurrence Report

Location Lynden Pindling Int'l Airport (MYNN), Nassau, Bahamas	Accident number OCC-2024/0012
Destination Fresh Creek Airport (MYAF), Andros, Bahamas	Registration C6-JTJ
Date & Time 17 th February 2024 4:40 pm local (2140 UTC)	Make/Model Cessna 402C
Flight Conducted Under Visual Flight Rules	Serial Number 402C-0648

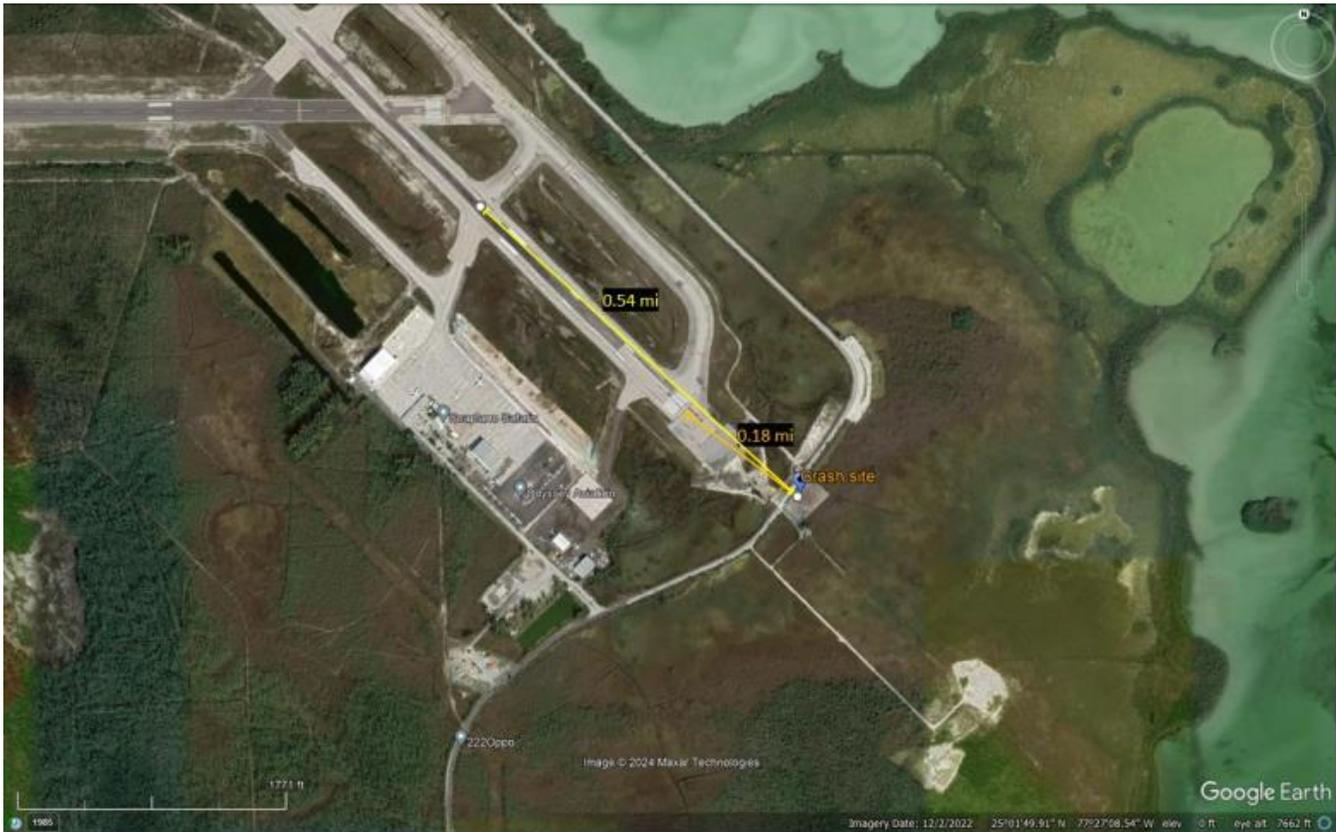
Fig.1: Google Earth imagery of crash site in relation to runway 14 at MYNN

Recognizing that the left engine was malfunctioning, the pilot added more power to the right engine and continued takeoff roll but after achieving some lift, the pilot reported to observe the aircraft “stall” and it was unable to clear the inner layer of perimeter fencing (height of approximately 12 feet), at a distance of approximately 820 feet from the approach end of threshold of runway 32.

The aircraft impacted the first inner layer of perimeter fencing, hitting the surface and travelling for some 57 feet on a heading of approximately 123° before impacting the second outer layer of perimeter fencing. The aircraft’s trajectory continued in that general direction travelling for an additional 73 feet, sliding across the Coral Harbour Road before come to rest in a swampy area.

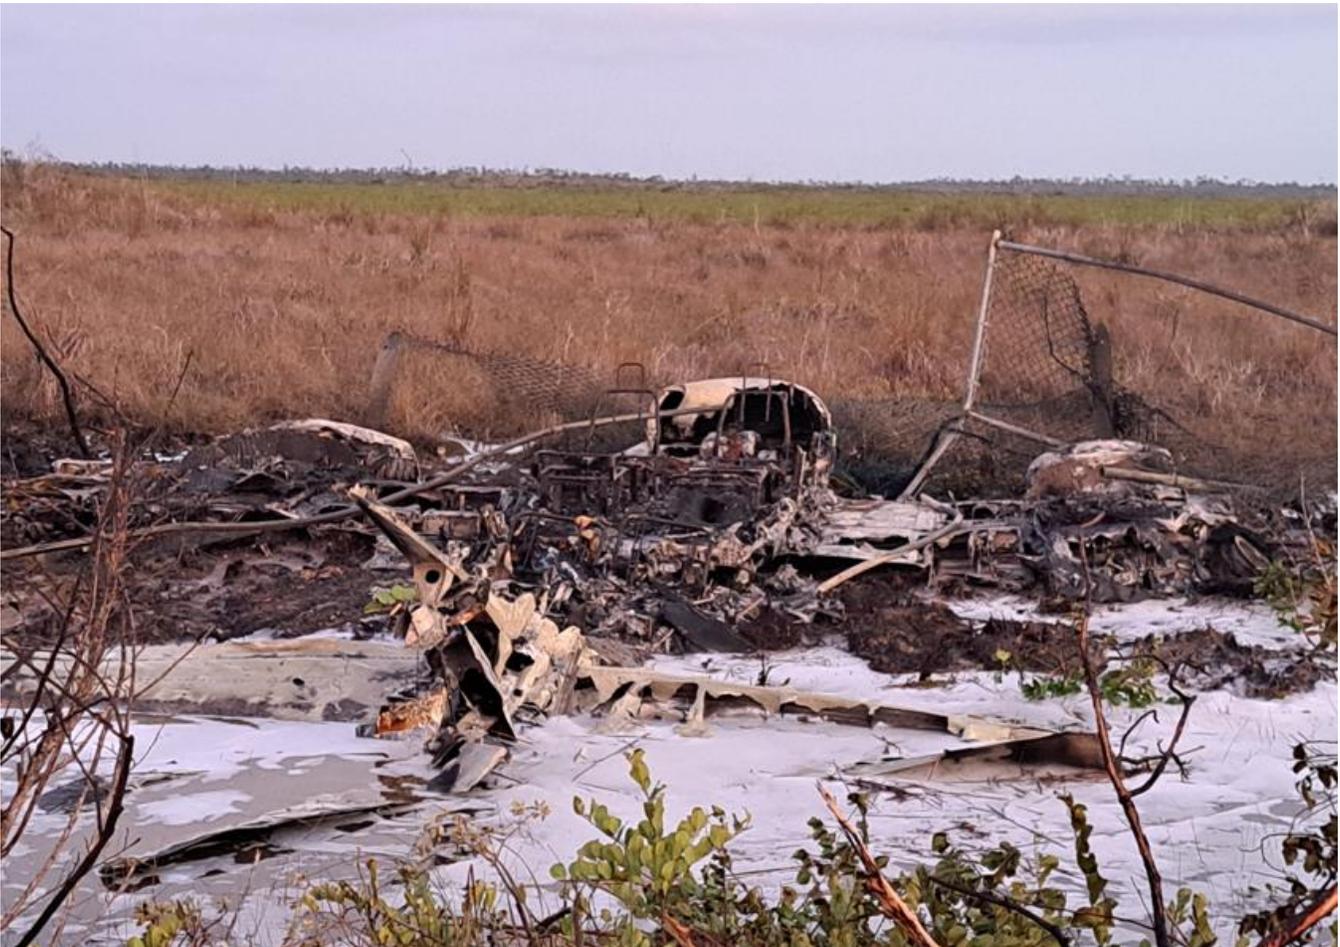
Fig.2: Photo of burnt remnants of C6-JTJ

The ARFF team were able to suppress and ultimately extinguish the flames that had engulfed the aircraft and some of the foliage in the immediate vicinity. The pilot was taken by ambulance to receive medical attention for some burns received to the face. The aircraft was ultimately destroyed by fire.

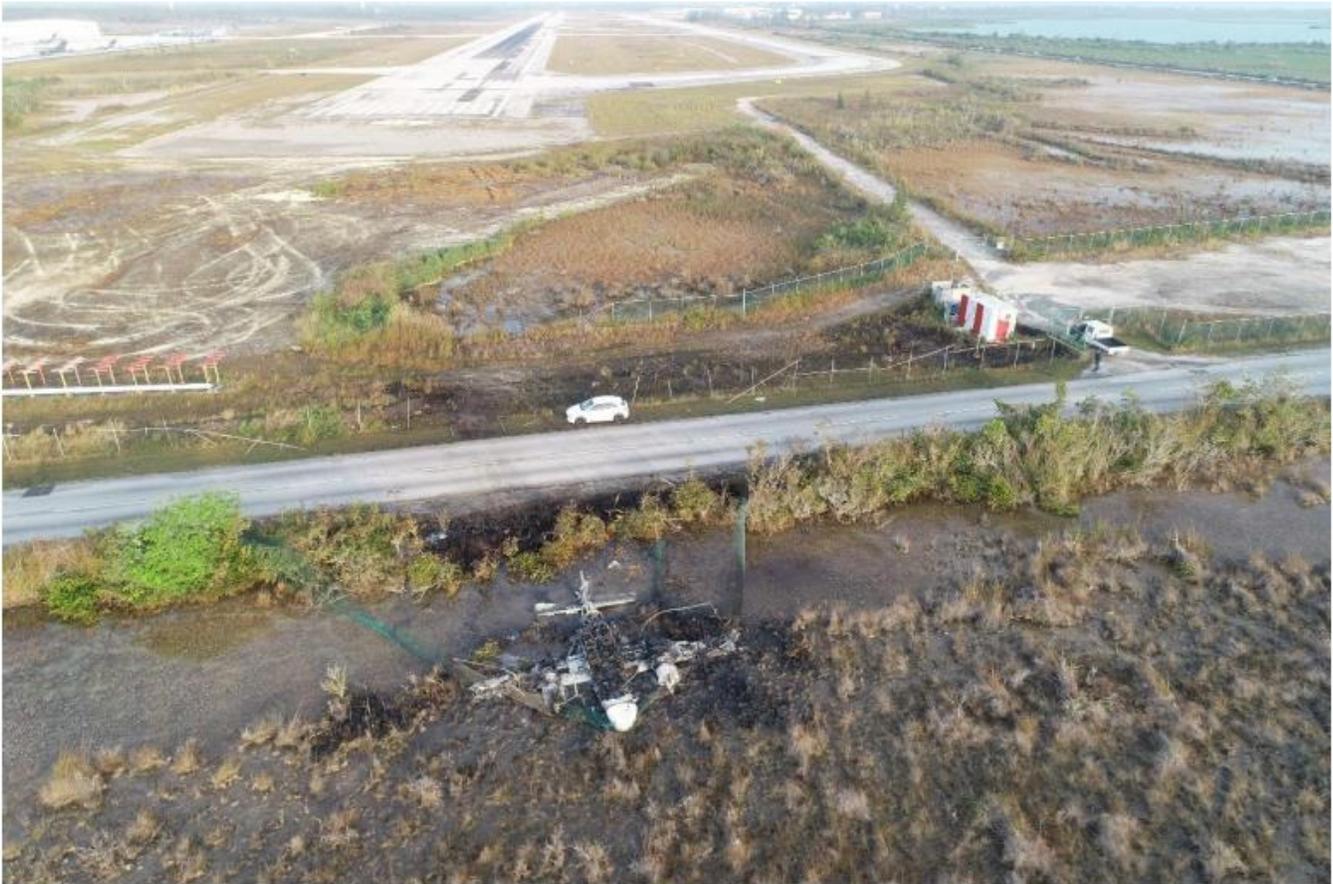
Fig.3: Drone photo of C6-JTJ from approach end of runway 32 at MYNN
