Aviation Short Investigation Final Report

Occurrence involving
Israeli Aircraft Industries
Westwind – 1124A, Registration N790JR

**Treasure Cay, Abaco, Bahamas
5th July, 2021**

**AAIA Aviation Occurrence Investigation
Controlled Flight into Terrain
AO21-022**

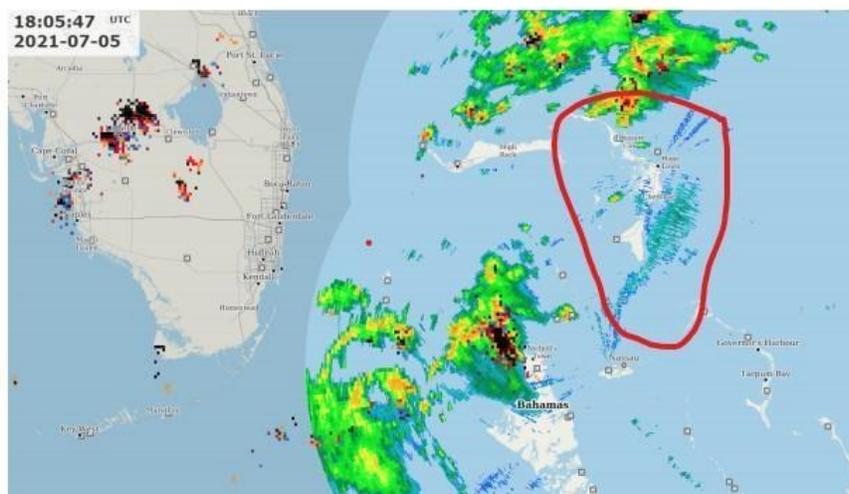
2:05PM 5th July, 2021

At the time of departure, eyewitnesses reported the conditions at the airport as light drizzle, however, shortly thereafter, the conditions deteriorated with a heavy rain downpour which also hampered rescue operations.
