AIRCRAFT ACCIDENT REPORT

AAIA# AO-2022/0018

Piper Navajo PA-31-310

N711JW

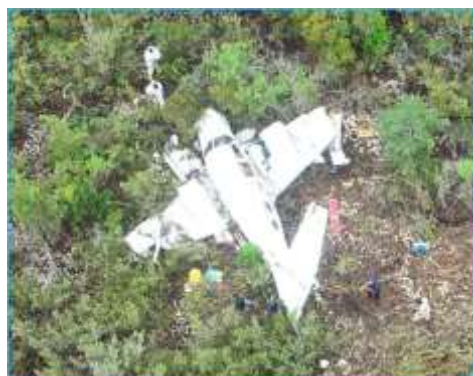
Deadman’s Cay, was flown to Nassau, Bahamas for further medical attention. The female passenger who occupied the rear seat of the aircraft, succumbed to injuries she sustained as a result of the impact and crash sequence. The aircraft came to rest in dense brush approximately 75 feet from the point of initial contact with trees, just 2NM from the Deadman’s Cay Airport at N023° 11’ 44” and W075° 06’ 10”.

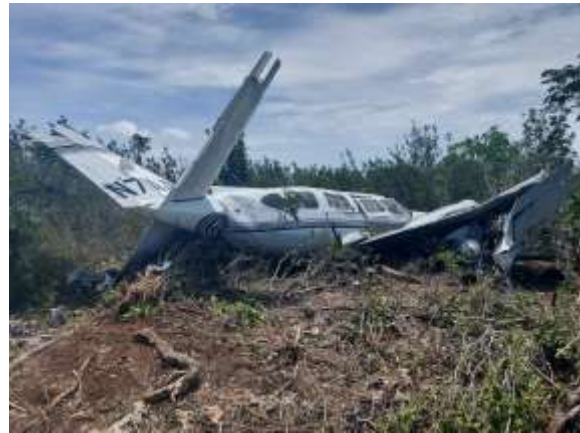
The extent of damage to the aircraft was substantial. Both left and right engines received extensive damages as a result of the initial impact and subsequent crash sequence.

The field of debris was confined to an approximate 100 feet radius from the center of the fuselage. The aircraft came to rest at coordinates N023° 11' 44" and W075° 06' 10".

All critical parts and components of the aircraft were recovered and accounted for during the analysis.

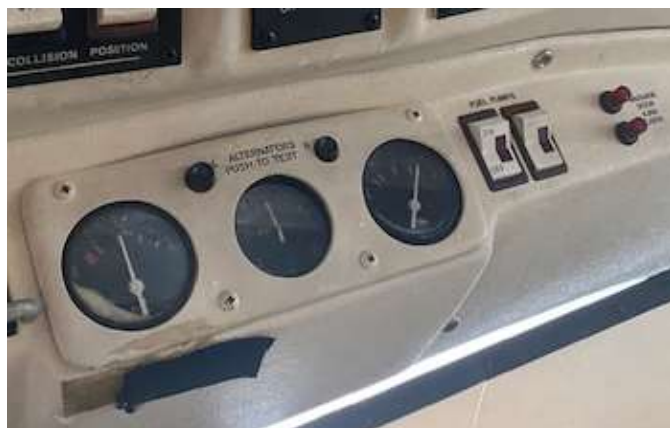
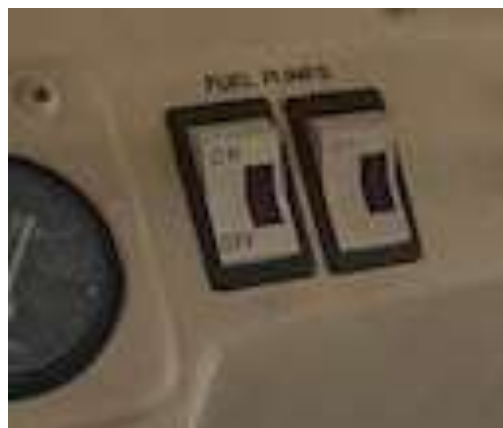
9. All fuel pumps should be on for takeoffs and landings. On airplanes not equipped with fuel boost pumps*, the emergency fuel pumps should be on and operating on the ground for starts and when temperatures are above 75°F. With fuel boost pumps installed, use of the emergency fuel pumps will not normally be required for climbs or cruise at any altitude. However, high power climbs to high altitude under conditions of elevated ambient temperature, high climb rate, and extremely volatile fuel may cause a fuel boost pressure warning light to illuminate and/or the engine fuel pressure gauge to indicate unsteady fuel pressure. The emergency fuel pump should be turned on to provide stable engine operation during the high power operations, but may be turned off after level-out if reduction to cruise power extinguishes the boost pump warning light, and if engine fuel pressure remains steady with the emergency fuel pump off.

During post-crash analysis of the aircraft, the left engine emergency fuel pump was determined to be functional when field tested with a DC power source and there were no anomalies noted during pressure check of the wing-root flexible fuel lines. This suggests, and it would appear that the emergency fuel pump for the left engine was functional prior to the accident.
