AAIPU# A10-01312

# AIR ACCIDENT INVESTIGATION AND PREVENTION UNIT CIVIL AVIATION DEPARTMENT

## AIRCRAFT ACCIDENT REPORT

LOSS OF CONTROL & UNCONTROL FLIGHT INTO TERRAIN  
ACKLINS BLUE AIR CHARTER  
CESSNA 402C

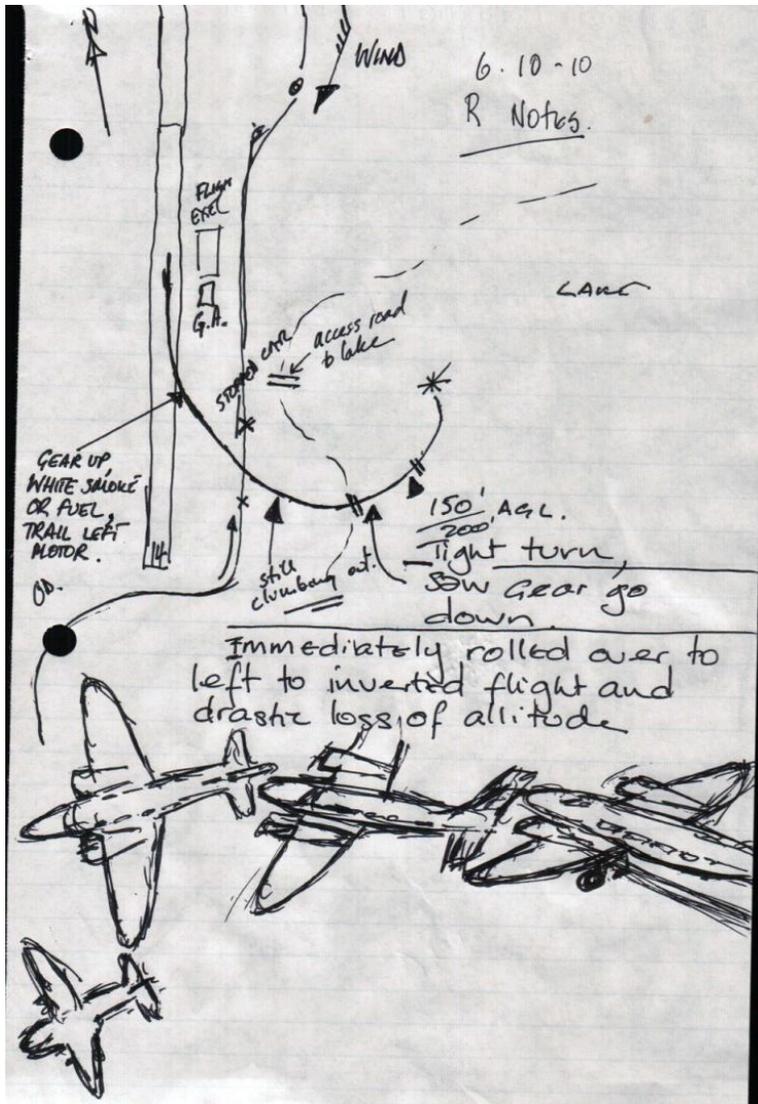
Figure 2 Eyewitness account of the accident

A mechanic who was standing on the ramp near Executive Flight Support (EFS) at the time of the crash, told investigators that he observed the airplane take off from MYNN on runway 14, heading south. He stated that he observed white smoke trailing behind the aircraft. When he “looked at the aircraft again it appeared to be experiencing engine trouble”. He observed the aircraft banking to the left with landing gears in the down position. He stated he believed the airplane was attempting to land on runway 27, but the aircraft was flying abnormal. The witness further stated that he believed the aircraft went into a stall and that is when he believes the pilot lost control of the aircraft. He then saw the aircraft flipped upside down and plunged into the lake. He saw and heard a loud explosion.

Another eyewitness, who is an ATC ground controller, stated “I observed aircraft C6-NLH which departed at 1633, with white smoke trailing behind the left engine. The pilot made a left turn attempting to return to the field. It was then that I noticed that the aircraft began an immediate descent and ditched into waters at the approach end of runway 27.”

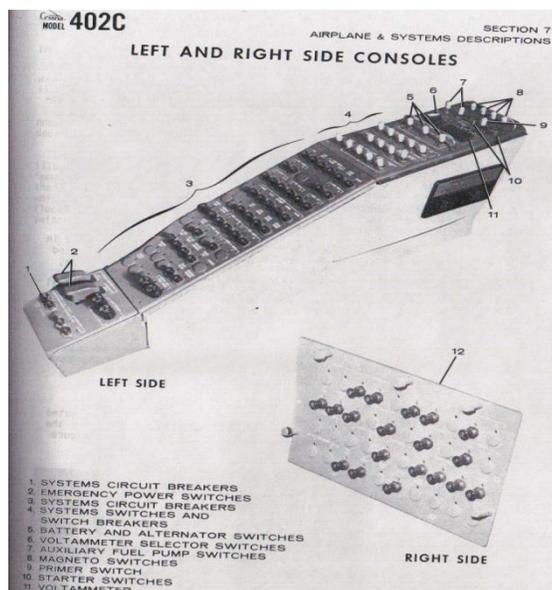
Figure 5 Left Console

Both fuel selector valves were found in the "OFF" position. The fuselage structure below the floor had been crushed and distorted in the crash. This was the area of the fuselage's first impact with the ground and it is likely, therefore, that the cables to the selector valves may have been trapped and moved at first impact.

The possibility that the cable was moved prior to, or during the impact, before being trapped in the "OFF" position cannot be discounted.

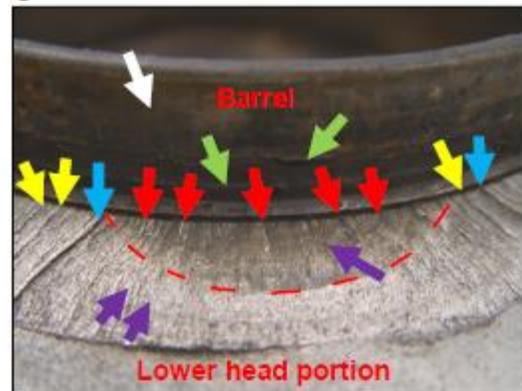
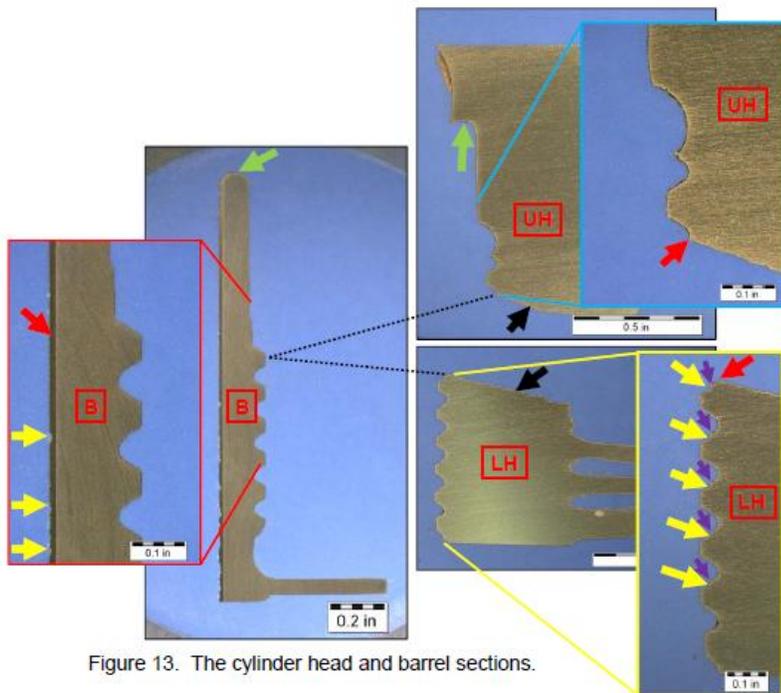
Figure 13. The cylinder head and barrel sections.

Samples were removed from the cylinder head and the barrel for detailed examination and their sectional views are illustrated later in Figure 13. The purple dashed lines in Figure 3 indicate the location of a lower cylinder head sample identified as “LH” and a mating barrel sample identified as “B”. The white dashed line on the opposite side of the cylinder head in Figure 3 indicates a cut that was made in order to separate the lower head portion from the barrel so that sample “H”, indicated by the yellow dashed lines, could be removed. A mating sample of the upper cylinder head, identified as “UH”, was also removed and is indicated by the red dashed line in Figure 2.

The darker arced area indicated by the yellow arrow in Figure 3 displayed a relatively smooth fracture face that abutted the crest of the first thread on the barrel. The fractured face displayed arced crack arrest marks and ratchet marks<sup>15</sup> consistent with fatigue. The darker arced area is illustrated in Figure 4 with the barrel and the lower cylinder head portion identified. The red dashed line indicates a distinct termination of the darker area consistent with the engine not being operated for a significant time resulting in a cessation of crack propagation. The purple arrows indicate crack arrest marks within the darker area and outside of it. The red arrows indicate ratchet marks, within the darker area, that originate in the root of the cylinder head thread engaged with the first thread on the barrel.

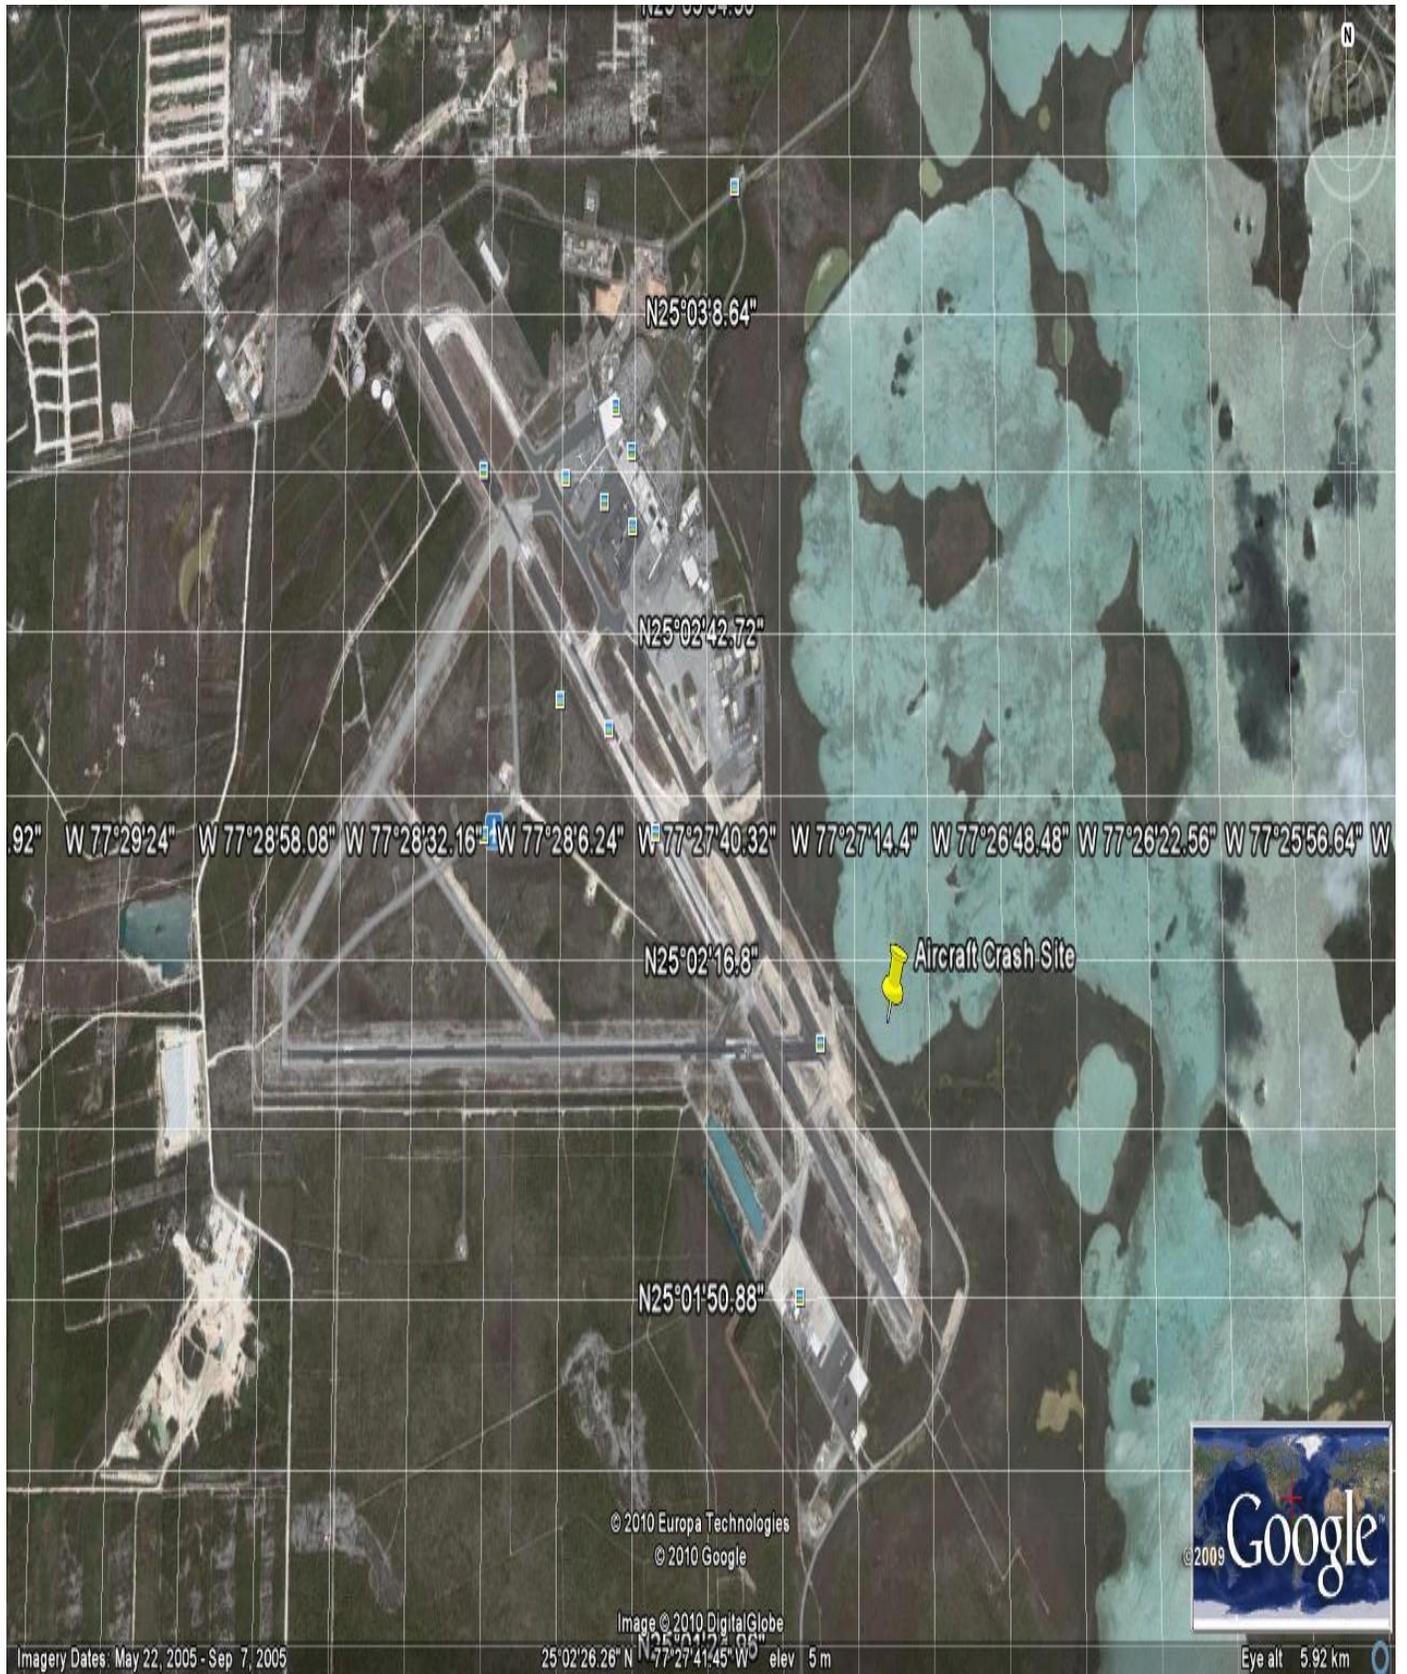
Appendix 5.19 CRASH SITE DIAGRAM

The paucity of 'firm' data, particularly the absence of any flight data or cockpit voice recording, frustrated efforts to reconstruct precisely the flight path and sequence of events which led up to the accident. The tower controller's communication transcription provided significant data to determine the timing of key events to within a few seconds, but apart from the white smoke observed by the tower controller and his alerting the pilot of C6-NLH, the pilot gave no indication of a problem. The aircraft was subsequently given permission to return to the field and accept runway 27 if able. This instruction was acknowledged by the crew and attempts were made to return to a landing by the aircraft on runway 27. There was no radar or navigation system data with which to reconstruct the flight path and so, an approximation was compiled based on the recollection of numerous eyewitness reports. All reports seemed to be consistent with each other. The probable flight path is illustrated on the eyewitness statement on Figure 3 and Appendix 5.19.
