# **AIRCRAFT ACCIDENT REPORT**

**RUNWAY EXCURSION**

**SAAB 340B**

**C6-SBJ**

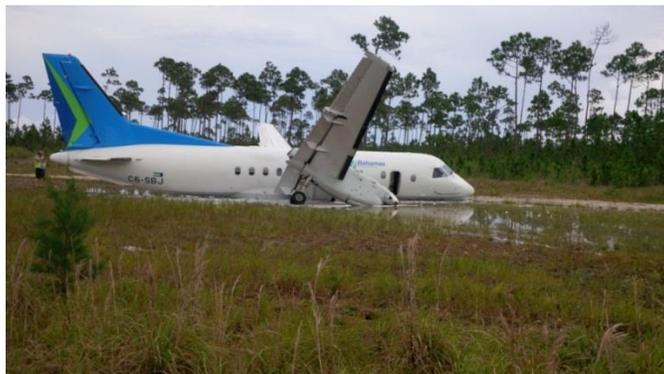
As a result of the excursion, the right underside of the fuselage, right propeller, nose landing gear and right wing were substantially damaged. There was also minor damage to at least one of the Runway 09 edge lights. As a result of the accident the airport was closed briefly. Weather conditions at the time of the accident were reported as instrument meteorological conditions (IMC) with heavy rain and thundershowers in the area of the airfield. There were no reports of serious injuries as a result of this occurrence.

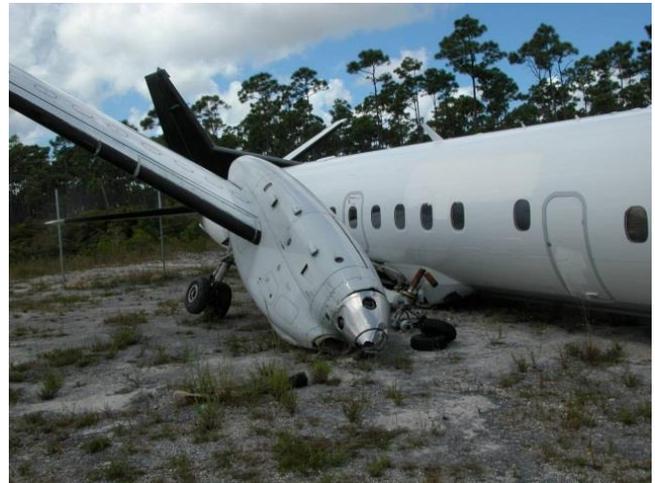
The observations and results represent the status of the aircraft at the time of the field examination. The aircraft had been recovered after the accident and transported to another location for the examination.

The aircraft was visually inspected in order to obtain an overall status of its structure, systems and interior.

It should be emphasized that it has not, for practical reason, been possible to examine all areas of the aircraft. The accesses for inspection of some areas of the aircraft were limited. The lower fuselage/wing area and nose landing gear wheel well are examples of areas that were not fully accessible.
