AIRCRAFT ACCIDENT REPORT

LOSS OF CONTROL

DASSAULT SUD FAN JET FALCON
N28RK

MATTHEW TOWN, INAGUA, BAHAMAS
DECEMBER 17, 2009

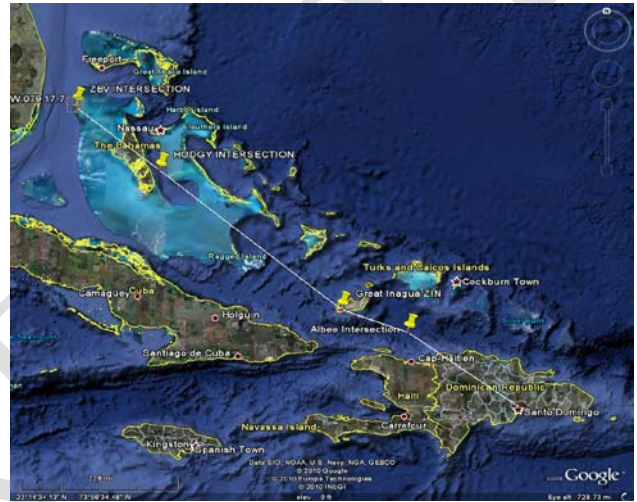
Figure 2 - Flight Path MDJB to ZBV

The accident occurred approximately 6 mile off the filed flight path.

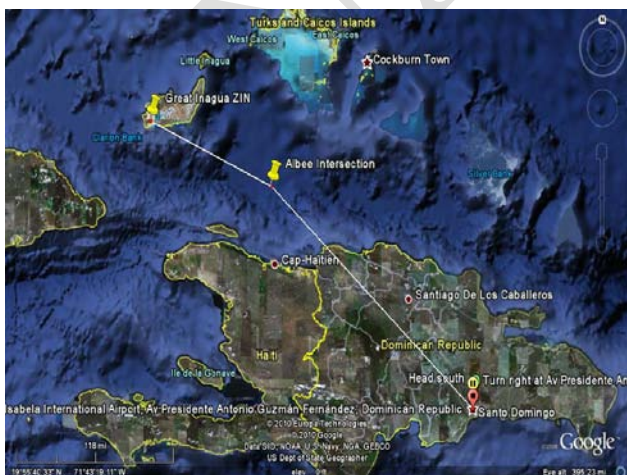
Figure 3 - Flight path expanded view, MDJB to ZIN

Based on radio communications (figure 3) N28RK was level at FL280 when it began a rapid descent and turned off course and ended up crashing in the National Park at Great Inagua.

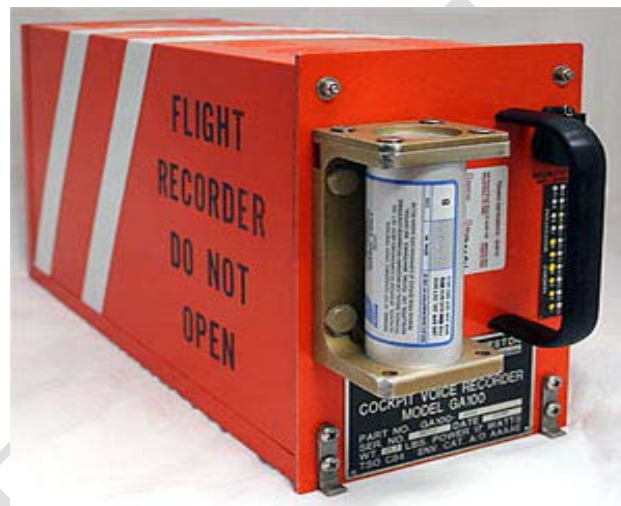
Figure 8 - Cockpit Flight Recorder (CVR) Model GA100 similar to the model installed in N28RK

Successive searches of the area did not locate the internal parts of the CVR. The housing of the CVR was recovered; however the internal components were never recovered. Photo following showed the extent of damage sustained by the CVR.

Due to the unavailability of the recorder the last moments of what took place will not be known.
