AIRCRAFT ACCIDENT REPORT

SUDDEN ENGINE STOPPAGE

PIPER WARRIOR PA-28-151

N444HA

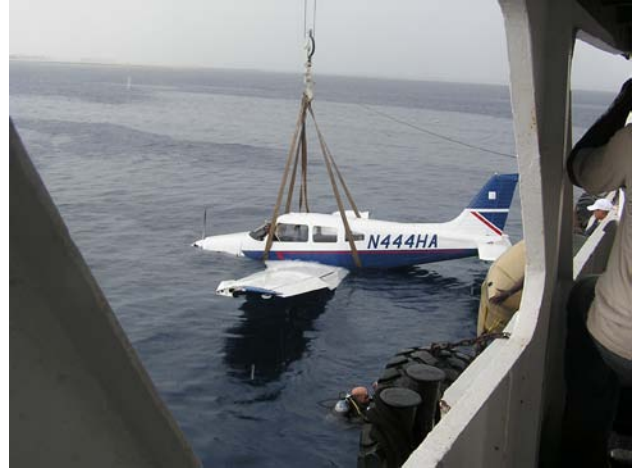
After impact, aircraft N444HA sank in approximately one hundred (100) feet of water. The pilot and the passenger exited the aircraft prior to it sinking and were picked up by a passing vessel in the area.

The aircraft was later recovered from the ocean.

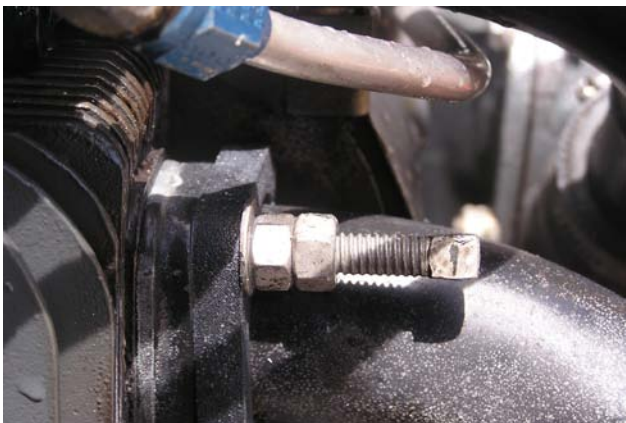
Closer inspections of the aircraft by the Investigation authority revealed several modifications were made to the aircraft fuel systems and wrong hardware used on the exhaust system without the proper paperwork being supplied to justify the modifications. The unapproved modifications were reported to the Federal Aviation Administration for further investigation.
