AIRCRAFT ACCIDENT REPORT

FINAL REPORT FUEL EXHAUSTION

**Flamingo Air Charter
Britten Norman (BN2-A) Islander
C6-ASA
Moss Town, Exuma Bahamas
16 May, 2005**

Report A0516517

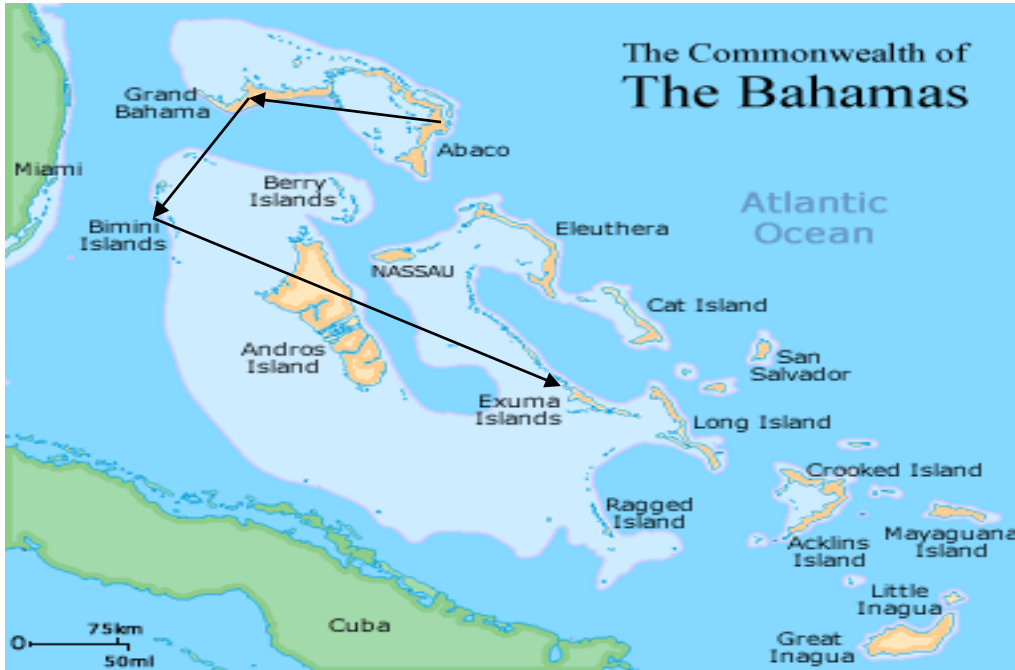
Map of route showing direction and flight path from Marsh Harbour, Abaco to Freeport, Grand Bahama to South Bimini to Moss Town, Exuma.

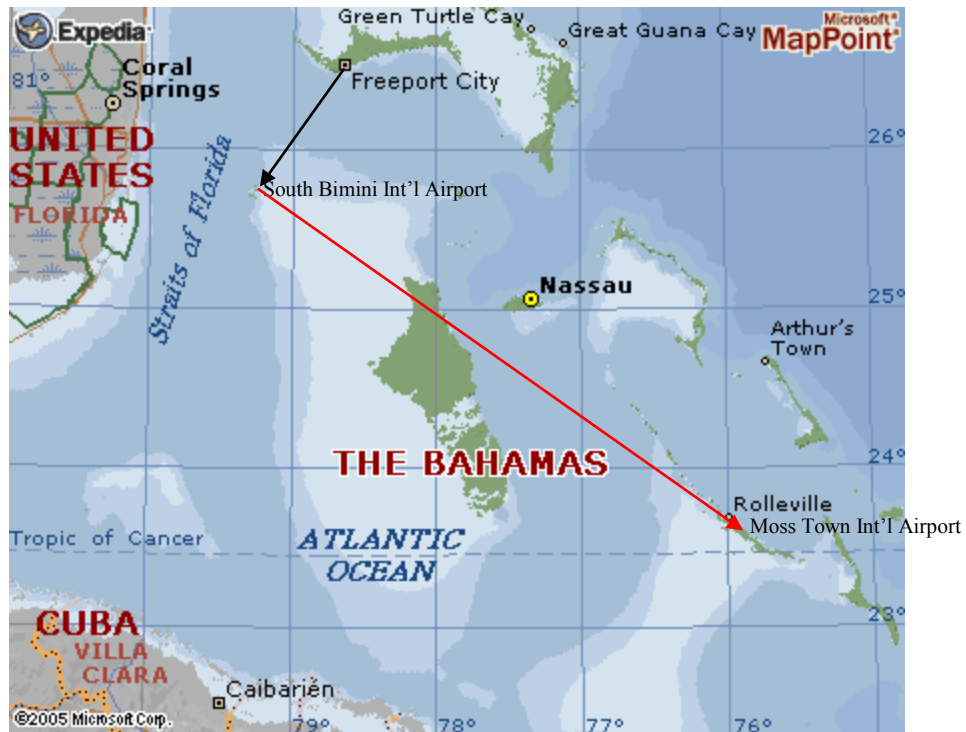
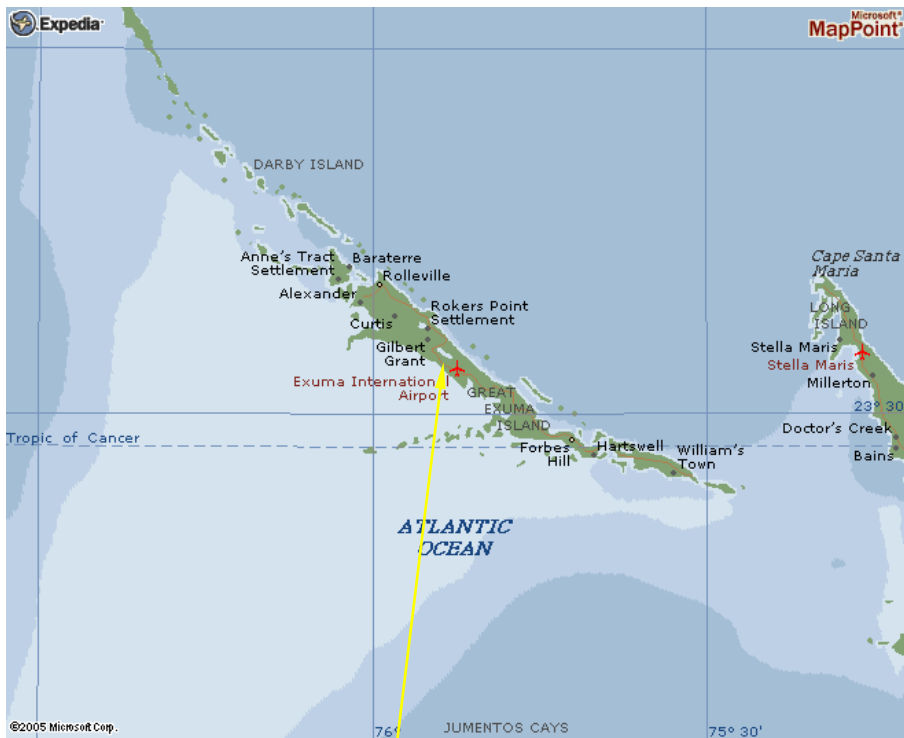
This is a map of the Exuma Islands, Bahamas showing the appropriate crash position of Aircraft C6-ASA. Aircraft C6-ASA crashed appropriate three [3] miles short of runway 12 at Moss Town International Airport, Moss Town, Exuma, Bahamas.
